**Fairfield Run: An Evaluation of Stream Habitat Restoration at the UD
Experimental Watershed**

March 31, 2004

Prepared by:

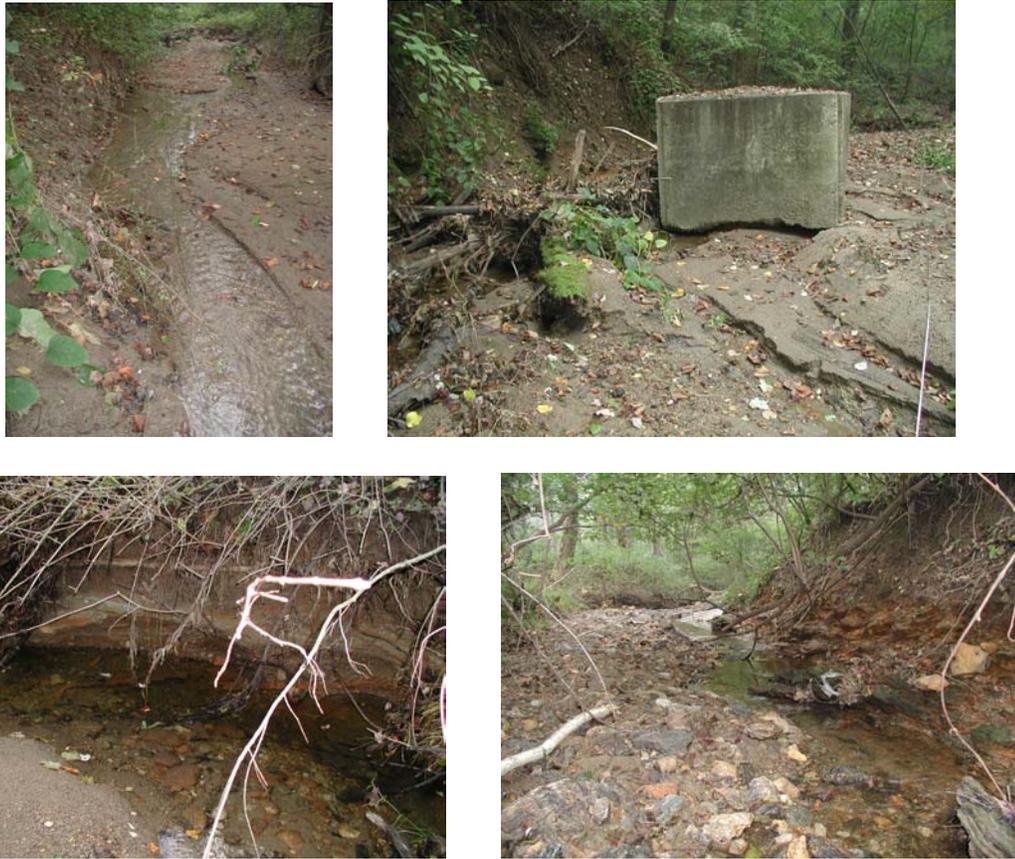
Figure 3.5: Sample Photos of Candidate Stream Restoration Reaches

The first restoration site chosen on Fairfield Run was the reach from 0+2 to 0+5. The downstream end of this reach was degraded by sediment backwashed from the White Clay Creek during storm events. The area from 4+0 to 5+0 was severely eroded on the right bank. The apparent cause of this erosion is that high flows are diverted towards the steep right bank by a sanitary sewer connection adjacent to the normal channel. The second reach chosen as a candidate for restoration was from 0+8 to 0+11. This area also had severe right bank erosion on the outside of meanders. The third reach chosen was from 14+0 to 16+0. This reach had poor bank stability with erosion on outside of meander bends on both banks and a narrow, downcutting channel. Figure 3.5 shows some of the photographs taken at the time of restoration reach selection.

Candidate restoration reaches (clockwise from top left): sedimentation at 3+0, sewer connection and right bank erosion between 4+0 and 5+0, right bank erosion at 10+0, undercut bank at 16+0.
