Blue Hen Creek: An Evaluation of Stream Habitat Restoration at the UD Experimental Watershed

March 31, 2004

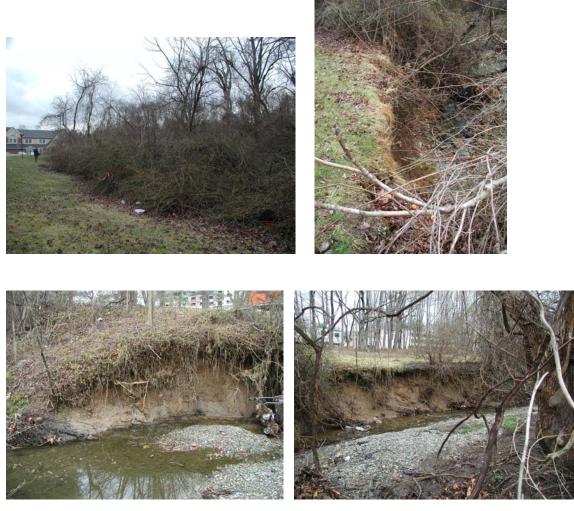
Figure 3.5: Candidate Stream Restoration Sites

Almost the entire bank of Blue Hen Creek from station 11+0 to station 23+0 is covered in multiflora rose. In many cases the rose has or is in the process of choking the native trees to death. This type of habitat is inappropriate for native fauna and needs to be restored to a native vegetation habitat for the health of the stream and to re-create suitable habitat for native wildlife. Other areas along this section of Blue Hen Creek had other stream health problems that need to be addressed through restoration, which is why stations 11+0 to 23+0 were chosen as candidate restoration reaches for this project. Figure 3.5 shows some photographs of areas along Blue Hen Creek that are in need of restoration to bring the stream to its ideal conditions.

Clockwise from top left: multiflora rose along stream bank (14+0), vertical bank (18+0), erosion with litter from dormitories (23+0), longer look at extensiveness of the erosion (23+0).

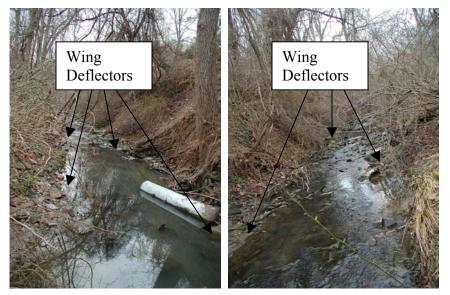
Figure 5.3: Wing Deflectors at Stations 16+0 *and* 17+0

Treatment 4: Wing Deflectors at Stations 16+0 and 17+0. This stretch of Blue Hen Creek has been channelized and needs more variation in the stream flow. A series of deflectors will help to scour pools creating more wildlife habitat within the stream and decrease the channelization that has occurred. Deflectors can either be made out of logs or stones depending on the resources available.

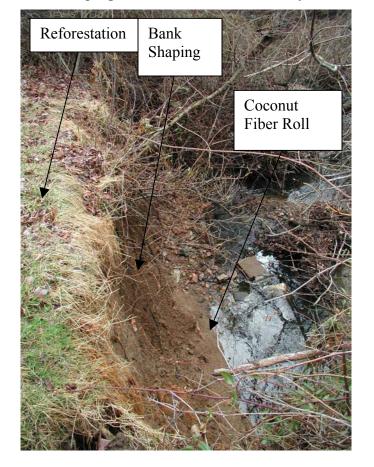
Figure 5.6: Bank Shaping, Coconut Fiber Roll, and Reforestation at18+0

Treatment 5: Bank Shaping, Coconut Fiber Roll, and Reforestation at Station 18+0. The bank at this station is a shear drop down to the stream. Some bank shaping will be necessary to increase the effectiveness of the other restoration techniques being applied at this station. The coconut fiber roll will help protect the bank from further erosion problems from the bottom up and reforestation will provide erosion protection from the top down.

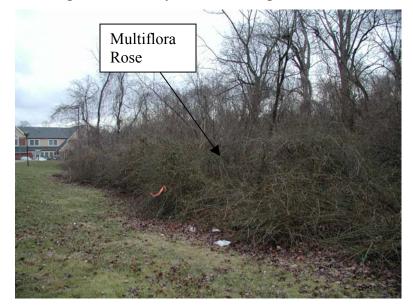
Figure 5.8: Multiflora Rose along Station 19+0

Treatment 6: Hand Cutting of Multiflora Rose and Reforestation at Station 19+0. Multiflora rose is a highly invasive exotic species that is very hard to remove from an area once it has been established. The rose is currently choking many of the native trees currently along the stream banks to death so removal of this species needs to happen. Two types of removal treatments are recommended for Blue Hen Creek to determine which type is better suited for this area and what removal procedures are feasible given the resources available. Removal treatments must be reapplied three to four times a year for four to five years for the treatments to be effective. Station 19+0 was selected for hand cutting treatments because of its dense population of the rose and because it is a decent distance from station 14+0. The stations with different treatments should not be too close together to allow for clearer observations of treatment effectiveness. The area along the stream bank that has the multiflora rose removed needs to be reforested for two reasons. One, if the bank is left bare it will be subject to erosion problems and two, with nothing taking its place the multiflora rose will simply re-establish itself along the bank.

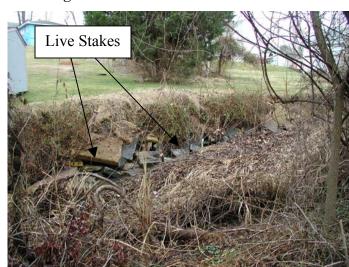
Treatment 7: Live Stakes at Station 21+0. At some point small concrete slabs were placed along the bank at station 21+0. It provides poor wildlife habitat but with some vegetation placed in and around the slabs it could provide habitat as well as providing bank stability for the stream.

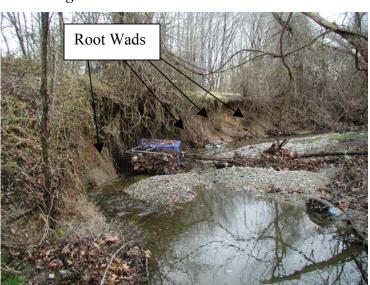
Figure 5.11: Root Wads at Station 23+0

Treatment 8: Root Wads at Station 23+0. The bank at station 23+0 is severely eroded and will continue to do so without pushing the stream away from the right bank.
