# **Water Quality Sampling Field Report**

## **First State National Park Brandywine-Piedmont Watershed 2015-2016**

April 2016

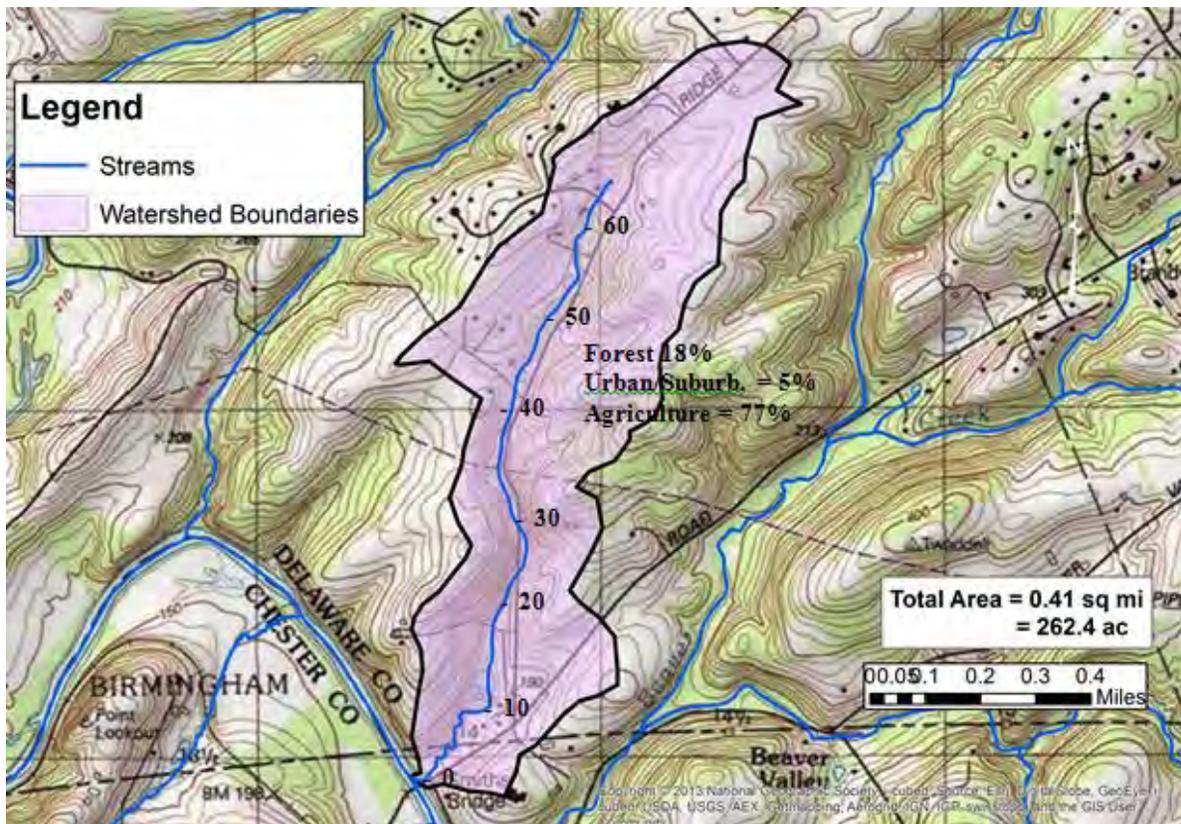
Figure 2.1. Ridge Run watershed delineation and topography

The 262-acre Ridge Run watershed borders the northerly boundary of the FSNP Woodlawn unit and forms in the headwaters at 400 feet above sea level in Pennsylvania and flows for 1.5 miles into Delaware to the confluence with the Brandywine Creek at Smith's Bridge. The watershed is lightly developed (0.3% impervious) and land use is 19% forest/wetlands, 5% urban/suburban, and 77% agriculture primarily meadow, horse farms, and some corn and soybeans. The steeply sloped watershed (12% slopes) is covered by soils in all four hydrologic soil groups. Geology of the watershed is the Wissahickon Formation gneiss.

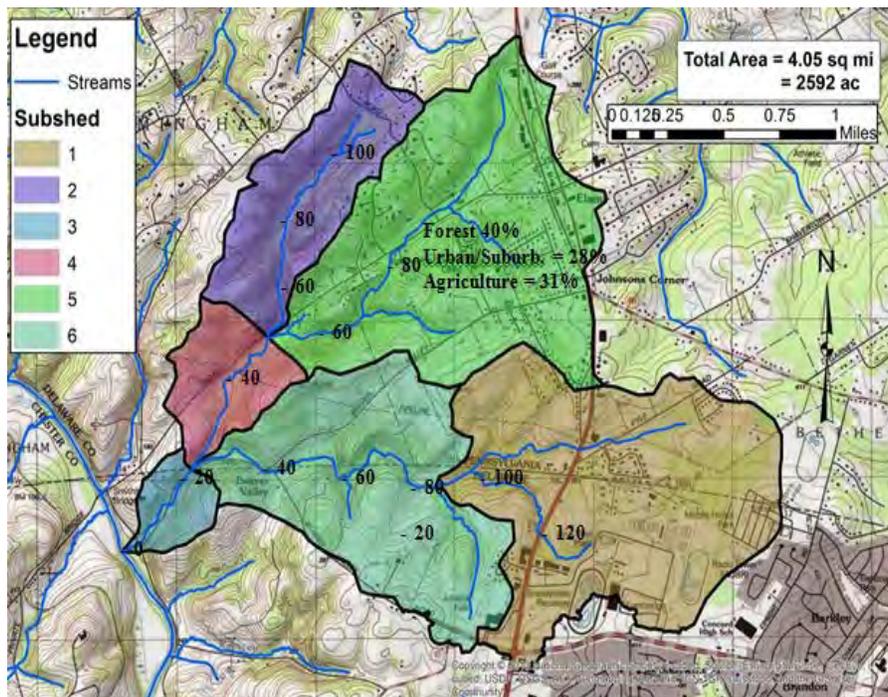
**Figure 2.2.** Beaver Creek watershed delineation and topography

The Beaver Creek watershed is the largest watershed surveyed, and it drains 4 square miles from the north and south forks and main stem of the stream. It covers the northerly third of the First State National Park. The north fork of Beaver Creek originates near the densely developed shopping centers and neighborhoods along Concord Pike in Pennsylvania and flows southwest for three miles through horse farms into the forested First State National Park before joining the main stem about a half mile upstream from the Brandywine Creek. The south fork forms along the Delaware/Pennsylvania state line near the Brandywine Town Center shopping mall and flows west for four miles under Concord Pike. It then flows through horse farms and the forested Woodlawn tract before combining with the north fork near Beaver Valley Road, which is the location of one of the water quality sampling sites. The main stem flows for a half mile along Beaver Valley Road to the confluence with the Brandywine at a popular beach known as Peter's Rock. The watershed is moderately developed (9% impervious) mostly in the upper third near Concord Pike and mostly undeveloped in the stream valleys down below near the Brandywine. Watershed land use is 41% forest/wetlands, 28% urban/suburban, and 31% agriculture primarily horse farms and meadow. The steeply sloped watershed (9% slopes) is covered by soils of hydrologic soil group A. The geology of the watershed is mostly formed by the Wissahickon Formation gneiss, although the north fork is underlain by an outcrop of the Cockeysville marble, a high water yield carbonate rock that provides buffering capacity to the stream for trout populations.

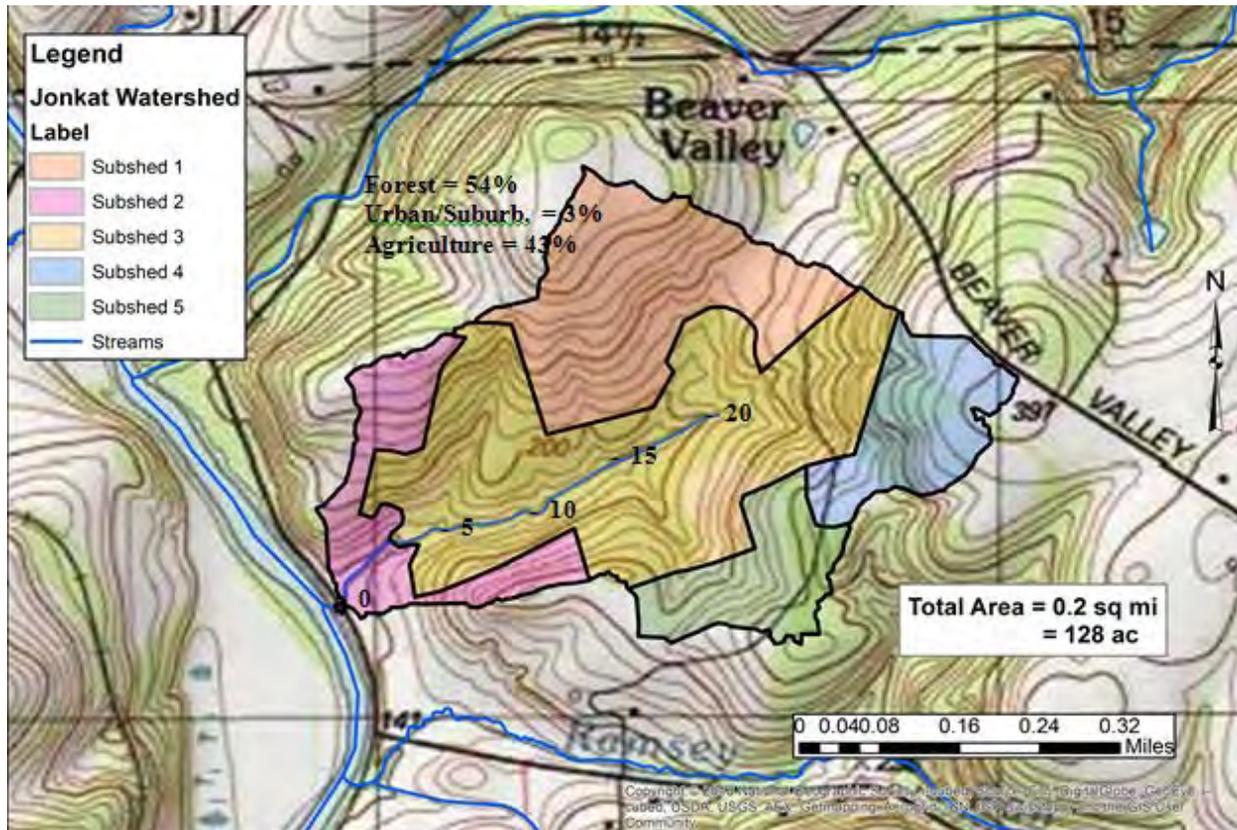
Figure 2.3. Talley Run watershed delineation and topography

The 128-acre Talley Run watershed lies entirely within Delaware in the Woodlawn tract of FSNP. The small creek forms on a 400 ft. high hill near Beaver Valley Road and flows for  $\frac{3}{4}$  mile through a beautiful valley cupped by trail system down to elevation 70 above mean sea level (msl) to feed the Brandywine Creek (Figure 21 and 22). The watershed is lightly developed (0% impervious) and land use is 54% forest/wetlands, 3% urban/suburban, and 43% agriculture (primarily horse farms, meadows, and corn/soybeans). The steeply sloped (13%) watershed is covered by soils of hydrologic soil group A and B. The geology of the watershed is the Wissahickon Formation gneiss.

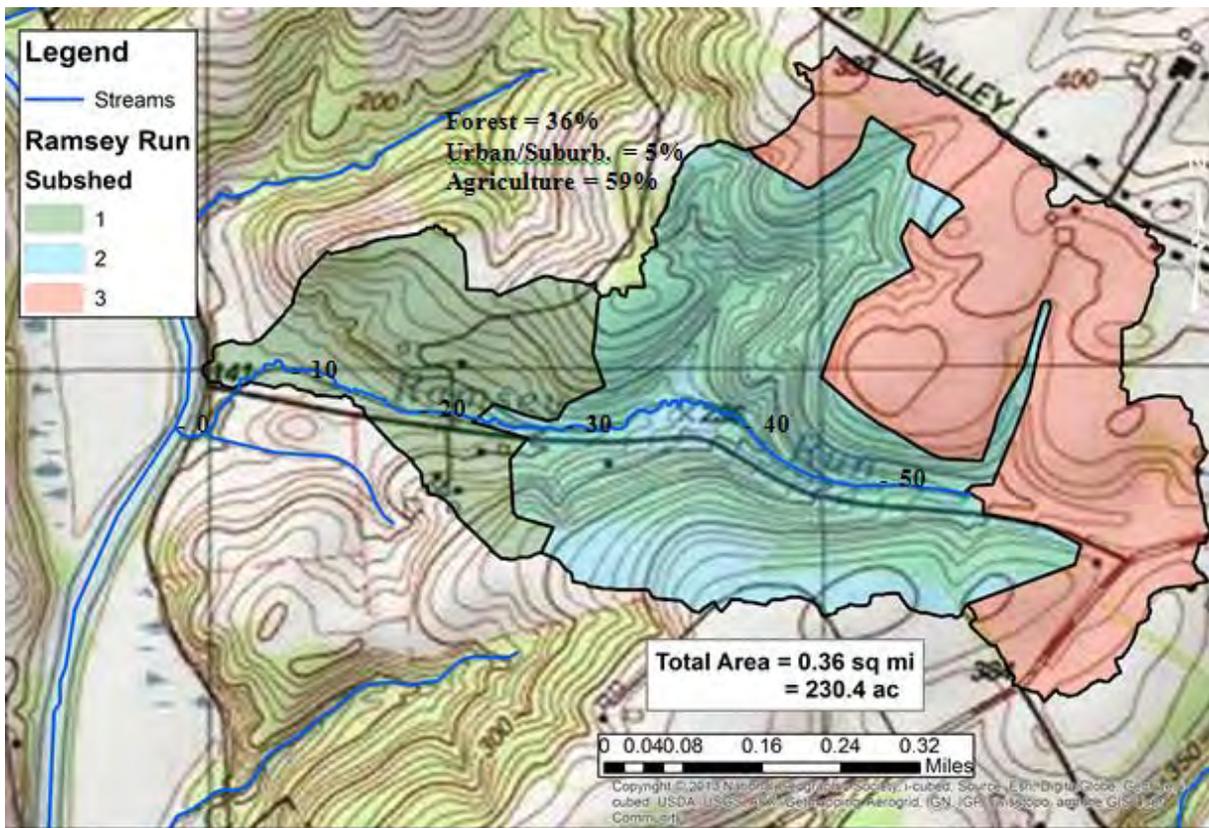
**Figure 2.4.** Ramsey Run watershed delineation and topography

The 230-acre Ramsey Run watershed drains the Ramsey Farm and rises at 420 feet msl and flows for a mile along the road and then through a bridge under the foot trail along Brandywine Creek (Figures 23 and 24). The watershed is almost entirely undeveloped (0.2% impervious) and land use is 36% forest/wetlands, 5% urban/suburban, and 59% agriculture primarily pumpkin farm, meadow, and horse farm. The steeply sloped (11%) watershed is covered by soils are % hydrologic soil group A and. The geology of the

watershed is the Wissahickon Formation gneiss with an outcrop of amphibolite downstream near the Brandywine.

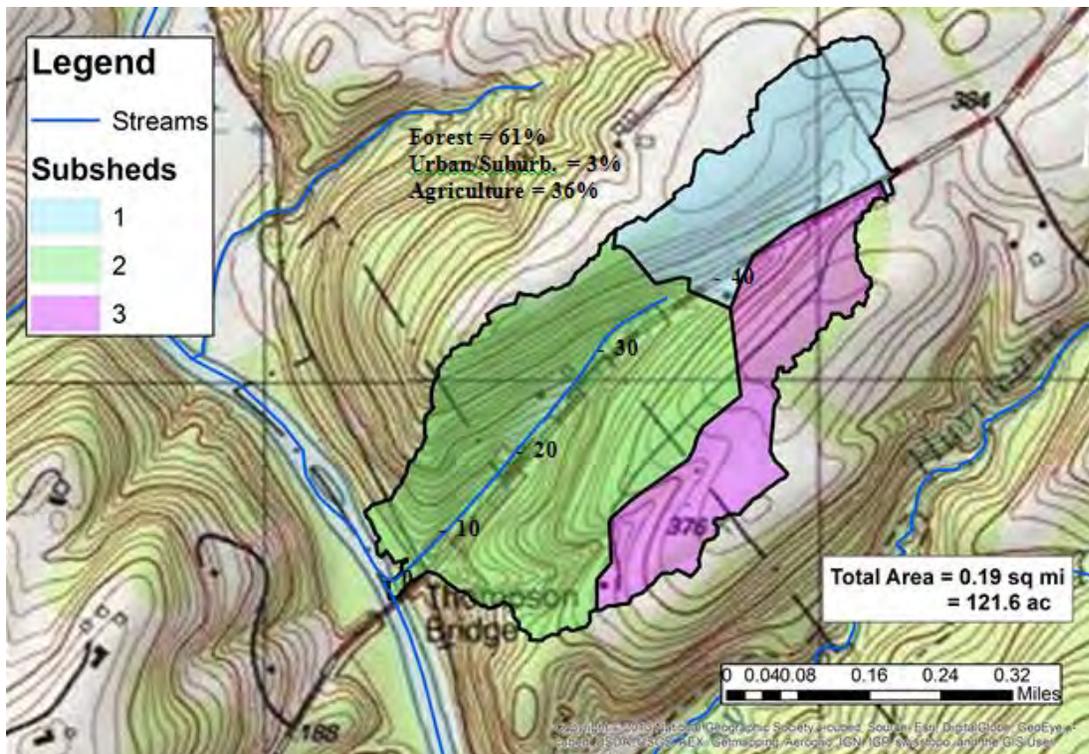
**Figure 2.5.** Carney Run watershed delineation and topography

The 122-acre Carney Run watershed originates at 400 ft. above sea level and flows for almost a mile along the road to join the Brandywine Creek just upstream from Thompson Bridge. The watershed is lightly developed (0.1% impervious) and land use is 61% forest/wetlands, 3% urban/suburban, and 36% agriculture primarily horse farm, meadow, and corn/soybeans. The steeply sloped (15%) watershed is covered by soils are % hydrologic soil group A and. The geology of the watershed is the Wissahickon Formation gneiss.

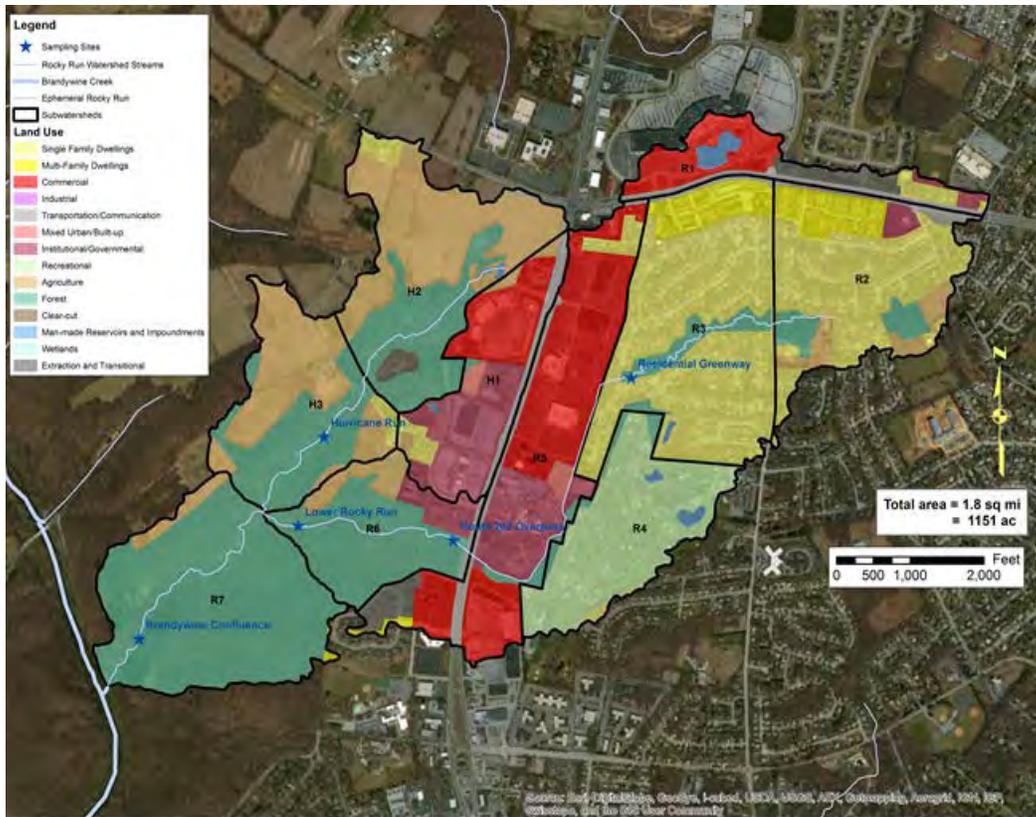
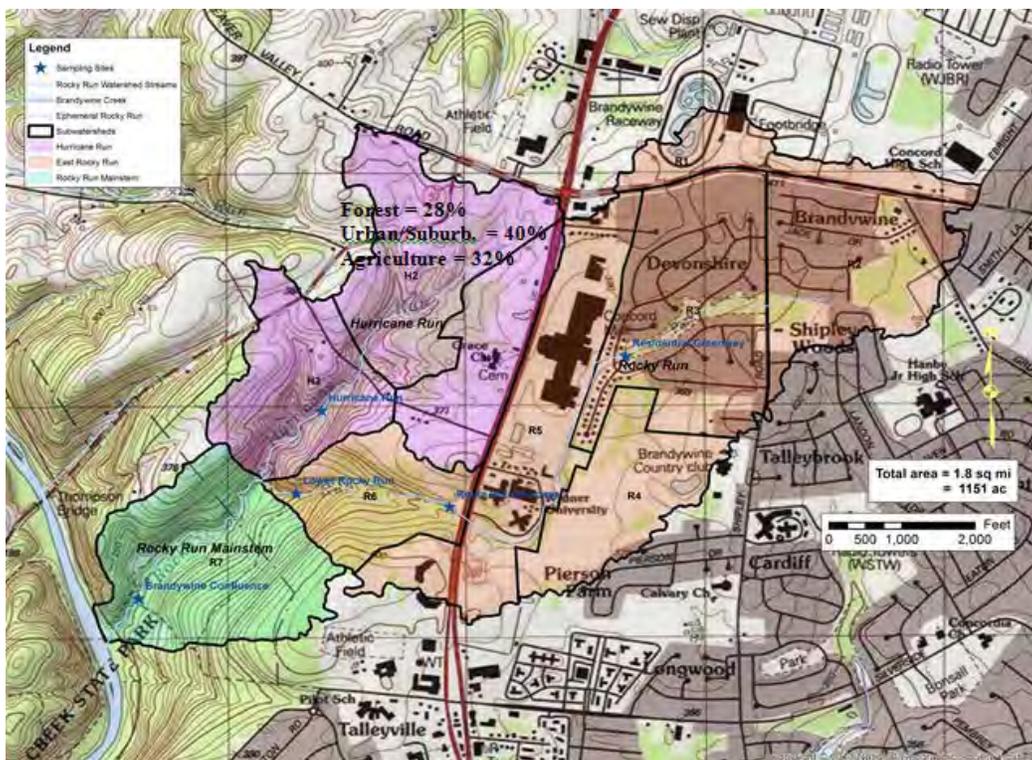
The Rocky Run watershed drains 1.8 square miles from the north (Hurricane Run) and south forks and main stem of the stream and covers the southerly portion of the First State National Park before flowing west through the Brandywine Creek State Park. Hurricane Run originates near the densely developed shopping centers and neighborhoods along Concord Pike in Pennsylvania and flows southwest for two miles through into the forested First State National Park before joining the main stem about a half mile upstream from the Brandywine Creek. The south fork forms in the neighborhoods of New Castle County behind Concord Mall near the Brandywine Town Center shopping mall and flows west for four miles under Concord Pike then into the forested Brandywine Creek State Park. The main stem flows for a half mile to the confluence with the Brandywine about a half-mile south of Thompson's Bridge. The watershed is highly developed (19% impervious) in the upper third near Concord Pike and mostly undeveloped in the stream valleys down below near the Brandywine. Watershed land use is 28% forest/wetlands, 40% urban/suburban, and 32% agriculture (primarily corn, soybean, and meadow). The steeply sloped watershed (10% slopes) is covered by soils from hydrologic soil group A. The geology of the watershed is mostly formed by the Wissahickon Formation gneiss, although the north fork is underlain by an outcrop of the Cockeysville marble, a high water yield carbonate rock that buffers the acidity of the stream for trout populations.

Figure 2.6. Rocky Run watershed land use map

Figure 2.7. Rocky Run watershed delineation and topography

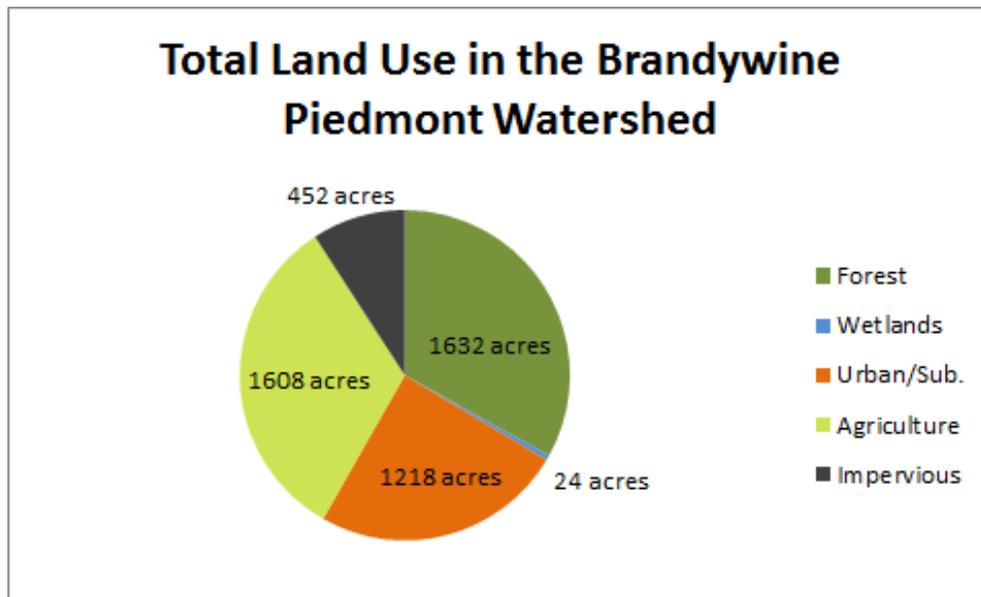
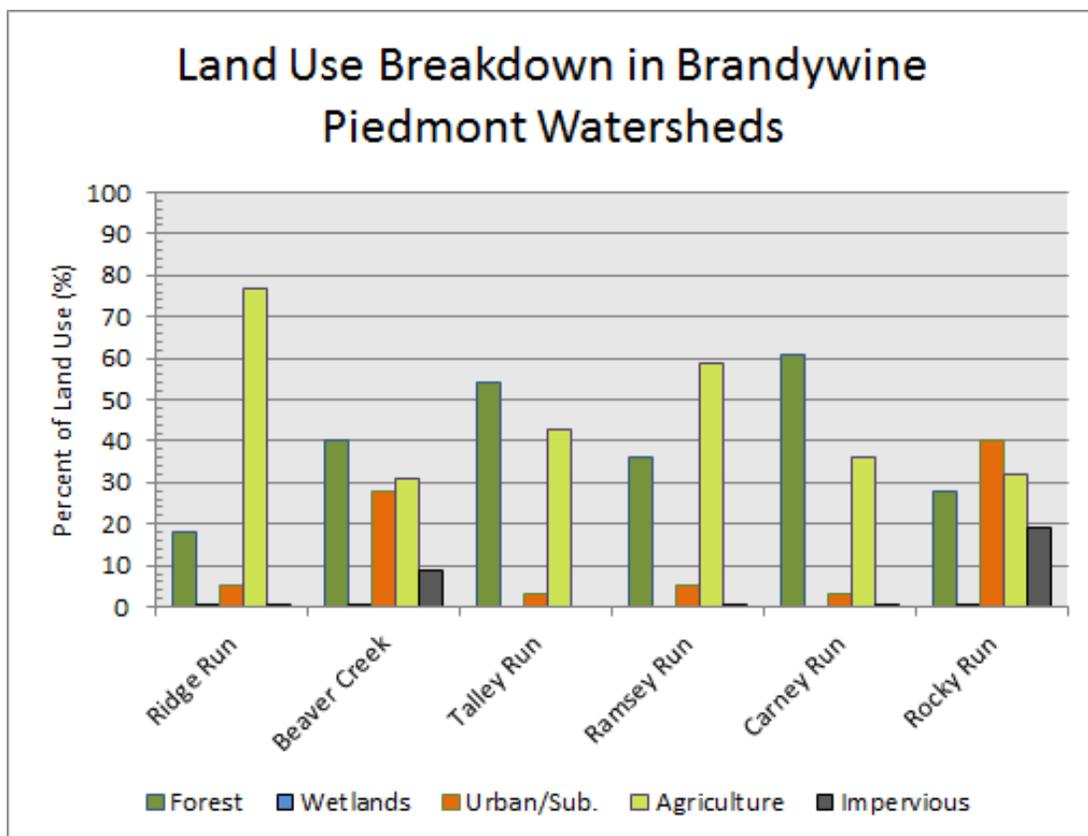
The six streams that flow through the First State National Historical Park capture a drainage area of 4,485 acres or 7.0 square miles. Land use in the six watersheds covers 36% forest, 1% wetlands, 27% urban/suburban, and 36% agriculture with an overall impervious coverage of 10% (Table 2.1 and Figure 2.2). Watershed land use is mostly urban/suburban and commercial to the east on the 400 feet heights of the Piedmont plateau along Concord Pike (Route 202) and changes to agriculture as the streams flow west and downstream over 300 feet in elevation through the steeply sloped forested valleys to the Brandywine Creek. The flat Piedmont heights were developed and farmed and the forested, steeply sloped stream valleys were conserved in a nearly natural state. The least developed watersheds are small catchments (< 300 acres) such as Ridge Run, Talley Run, Ramsey Run, and Carney Run that do not extend too far east from the banks of the Brandywine into the urbanized/commercialized Route 202 corridor.

**Figure 2.8.** Land use in the Brandywine Piedmont watershed

**Figure 2.9.** Land use by sub-watershed in the Brandywine Piedmont watersheds

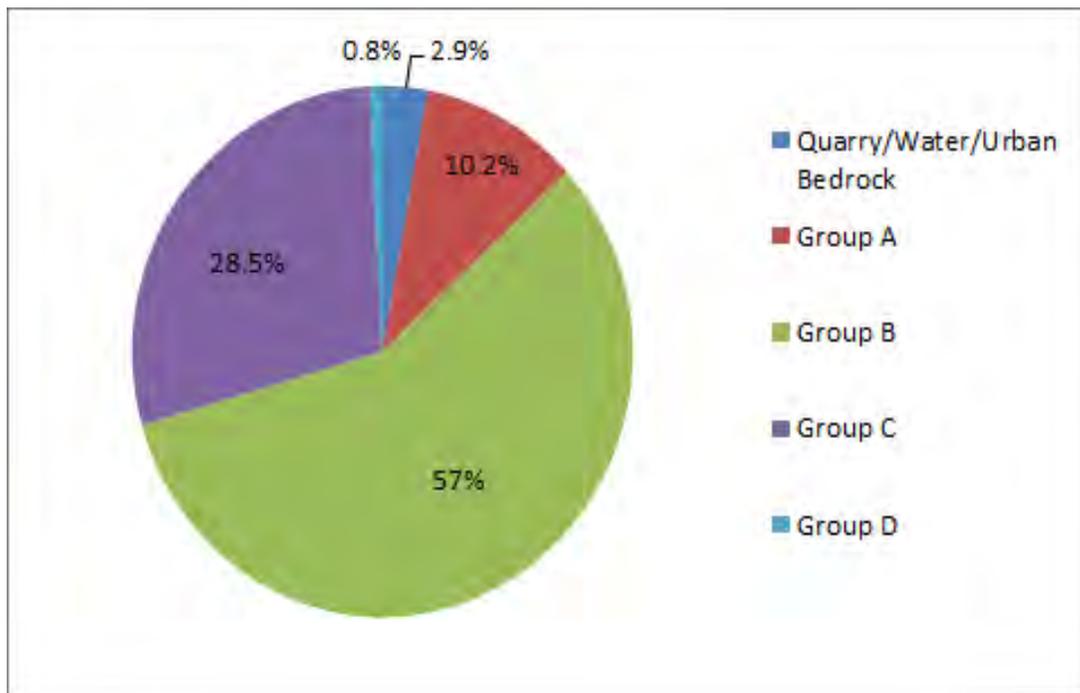
According to the USDA soil survey, 2.9% of the FSNHP watershed soils are classified as quarry/water/urban bed rock, 10.2% are hydrologic soil group A (moderate permeability), 57% are HSG B (moderately drained), 28.5% are HSG C (low permeability), and 0.8% are HSG D (poorly drained/wetlands). To summarize, This data is represented graphically in Figure 2.6 below. The four hydrologic soil groups are:

**Figure 2.13.** USDA Soil Survey - FSNHP watershed hydrologic soil group classifications

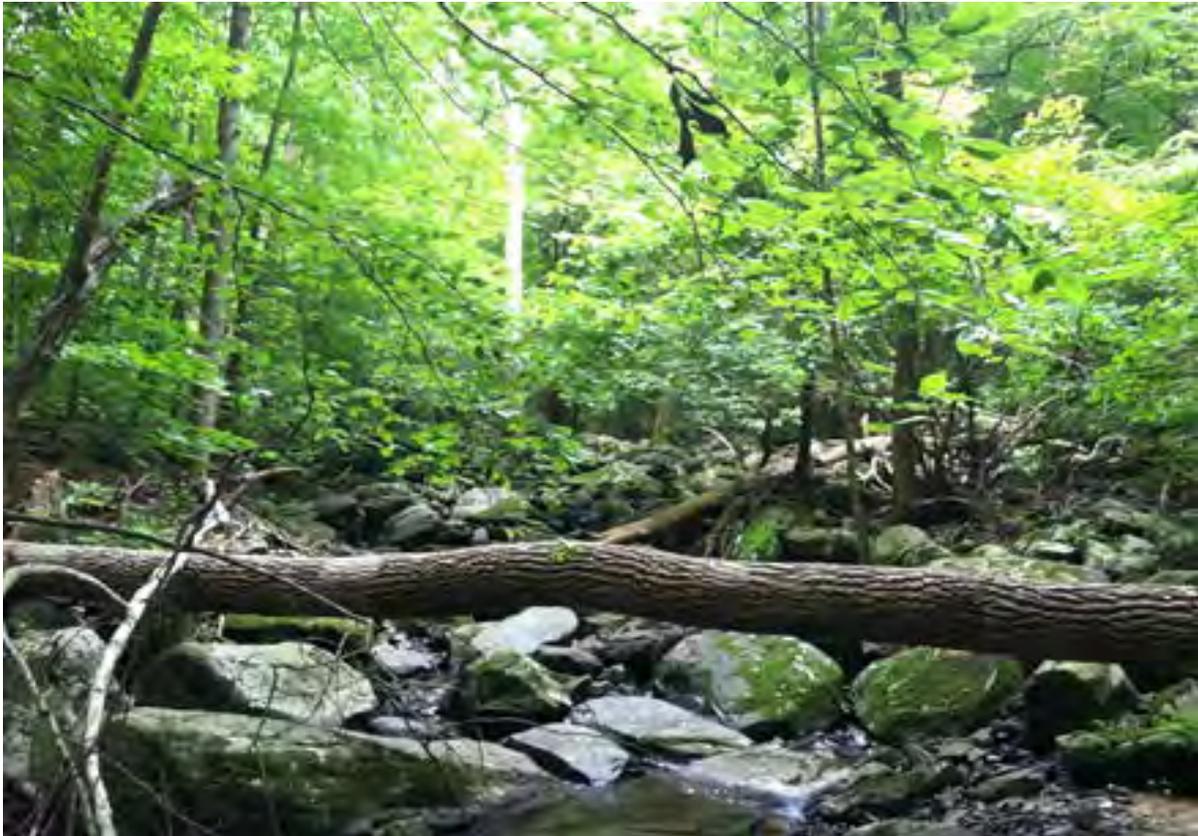
FSNP watersheds are underlain by outcrops of the Wissahickon Formation gneiss (Wilmington Blue Rock), which are blue-green in color and form large erosion resistant boulder and cobble complexes in the beds of the streams that tumble through the Piedmont (Figure 2.7). Rock types include mostly Wissahickon Formation, Amphibolite, and Cockeysville Marble.

**Figure 2.14.** Wilmington Blue Rock boulder complex in Beaver Creek, FSNHP, 2014

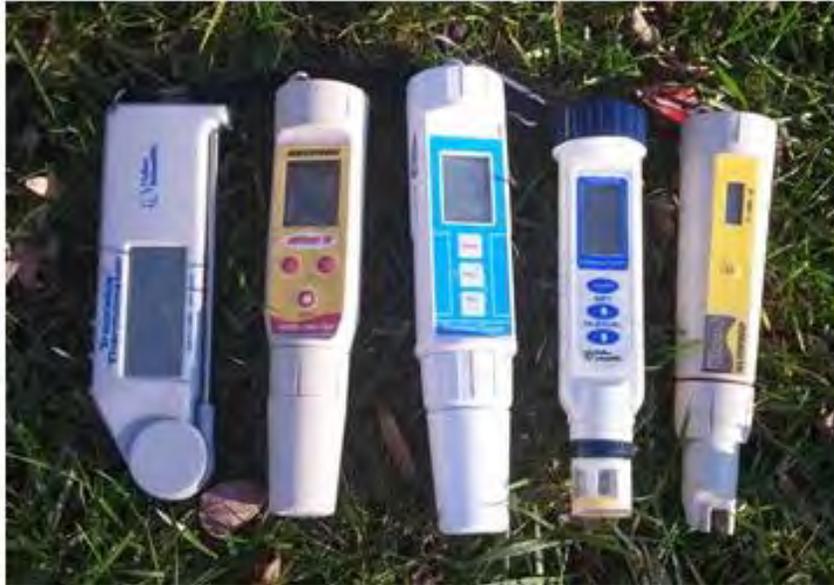
**Figure 3.1.** Water quality probes (Left to right: temperature, pH, DO, and conductivity from Wilmington; TDScan conductivity from University of Delaware) Monitoring probes from the City of Wilmington (pH, DO, temperature, conductivity) and University of Delaware (TDScan 3 conductivity probe, turbidity meter) - Figures 3.1 and 3.4

The parameters tested at each of the stream sampling locations include pH, conductivity, temperature, turbidity, and dissolved oxygen. The pH, conductivity, and dissolved oxygen probes (Figure 3.1) were calibrated once a week using standardized procedures to ensure quality control. For example, buffer solutions of pH 4, 7, and 10 were used to calibrate the pH probe. To prevent damage to the probes, a beaker was filled with stream water and brought to a safe location for the chemical assessment. After each use, the probes were wiped off with a Kimwipe to prevent damage.

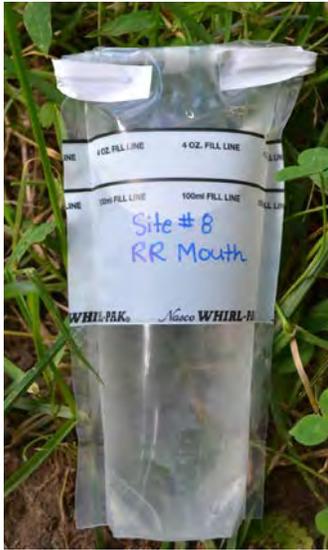
**Figure 3.3.** (above left) Whirl-pak bags for TSS testing

To test for turbidity (TSS), water samples were collected, stored, and transported to the City of Wilmington Water Quality Lab in 4oz Nasco Whirl-pak bags labeled with the stream name and location number prior to sampling (Figure 3.3). Using a 100ml beaker, the Whirl-pak bags were filled with stream water to the minimum sampling volume (4oz line). The tabs on either side of the Whirl-pak bags were then pulled to seal it tightly. The top of the bags were folded twice and flipped over once. The tabs were then folded inwards towards the bag to secure and prevent leakage. The Whirl-pak bags were placed upright in an ice-filled cooler immediately after sampling occurred. A second method of analyzing turbidity was using an MI 415 Turbidity meter borrowed from the University of Delaware. Vials of water were wiped with Kimwipes before each reading in order to ensure accuracy.

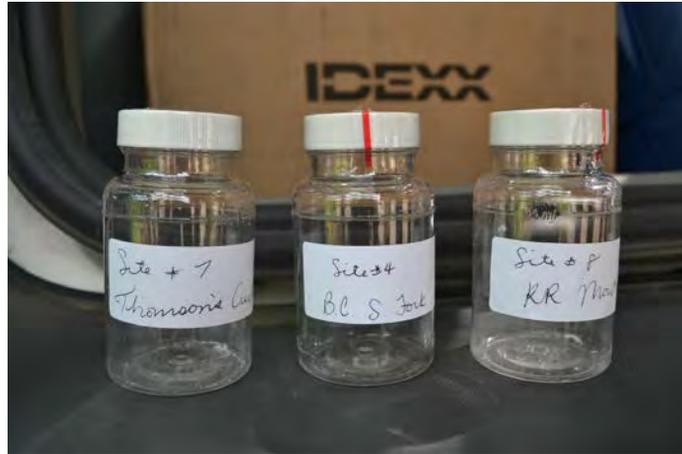
**Figure 3.2.** (above right) IDEXX sterilized and sealed 100mL bottles for bacterial testing

- 4 oz. Nasco Whirl-pak bags - Fig. 3.3
- 100 ml Idexx sterilized and sealed bottles - Fig. 3.2
- 500 ml Nalgene sample bottles
- 100 ml plastic beakers
- Kimwipes
- 3 buffer solutions (pH 4, 7, and 10) for pH probe calibration
- Ice cooler and ice
- Label tags - Fig. 3.2
- Chain of Custody forms
- Field notebook, pen, and watch for time and latitude/longitude measurements

Bacterial quality was tested through enterococci analysis. The City of Wilmington Water Quality Lab provided 100ml sterilized bottles for bacterial (enterococci) sampling (Figure 3.2), and team members were taught to use the proper technique for sampling by lab staff. Stream water was collected mid-stream in a plastic beaker and poured into a sterilized bottle until filled to the 100ml line. All team members practiced a sterile technique by refraining from touching the mouth of the bottle and setting the lid down while opening, sampling, and closing the bottle. The samples were immediately stored in an ice cooler with a temperature control and transported to the City of Wilmington Water Quality Lab within no more than three hours of collection. TSS and bacterial samples were collected twice during low flow stream conditions in the month of July.

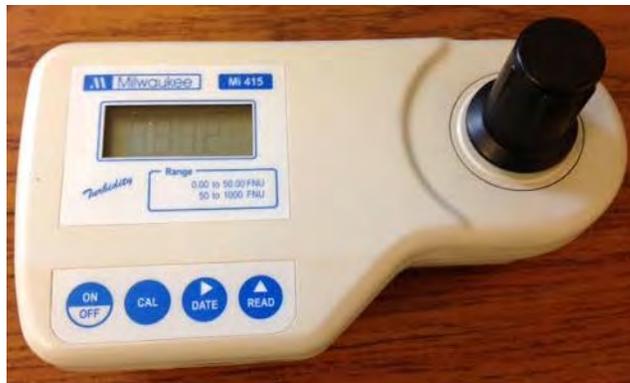
**Figure 3.4.** Turbidity meter, University of Delaware

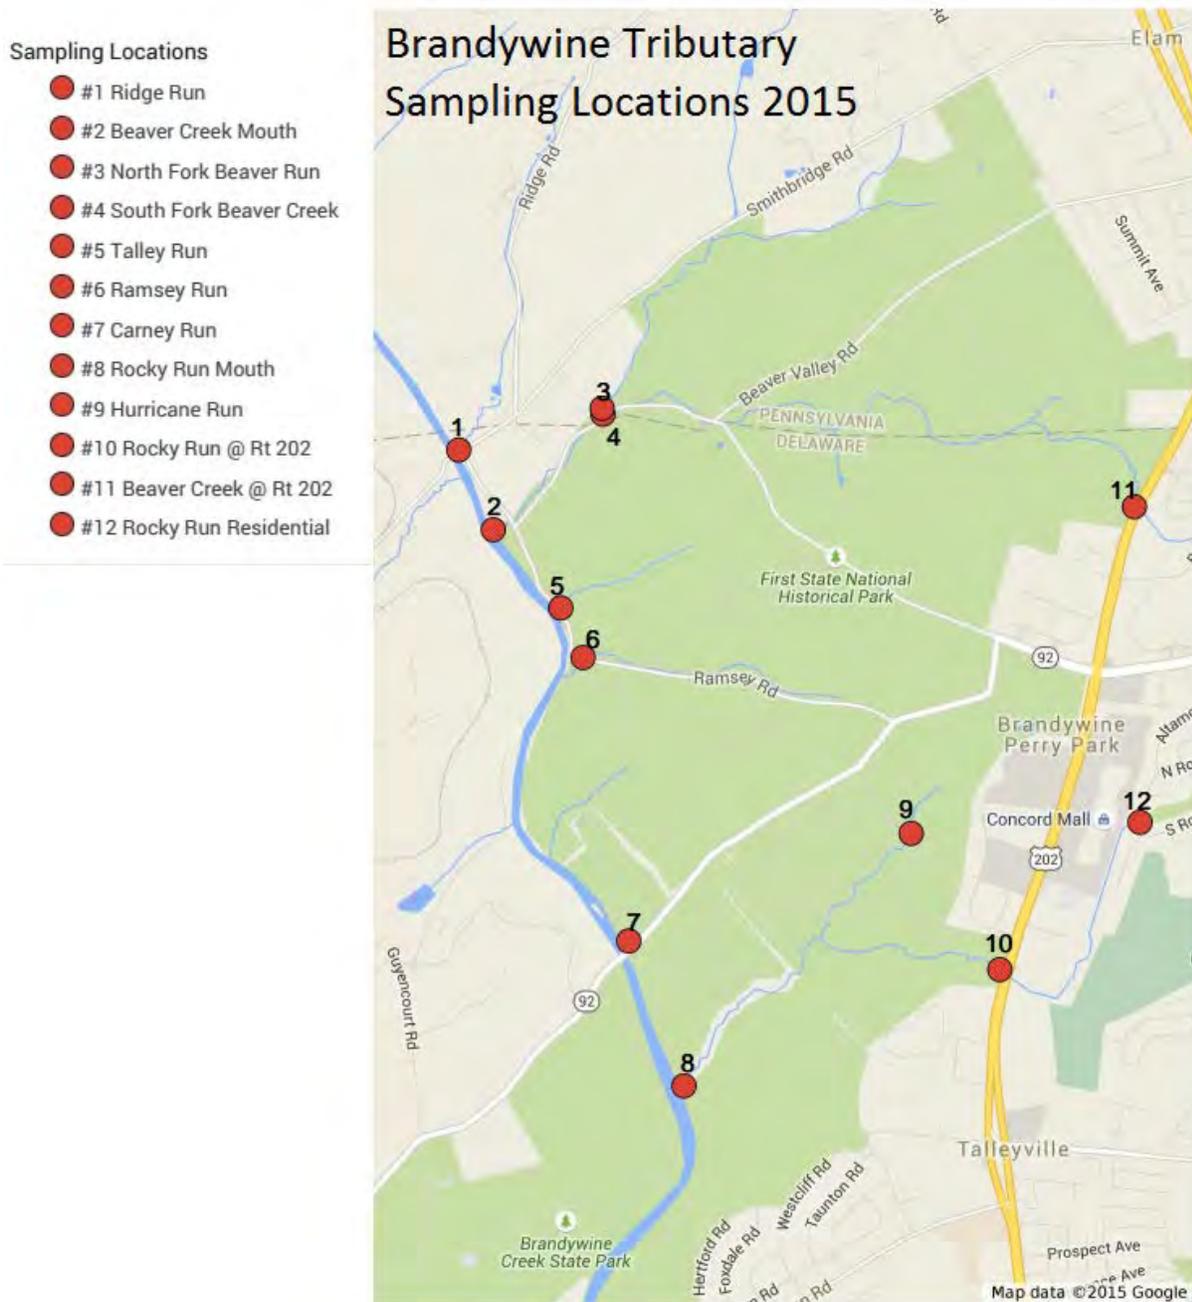
**Figure 3.5.** Sampling location map

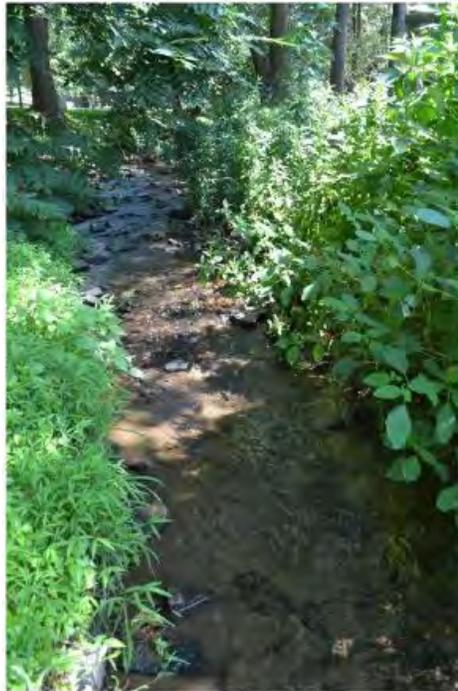
**Site 1 Ridge Run:** Located slightly south of the border of Pennsylvania and Delaware, this is the northernmost tributary flowing into the Brandywine Creek in the First State National Historical Park (Fig. 3.6). This stream meanders into a private parcel of land containing a horse farm, grassy lawns, and housing areas along Smithbridge Road. The sampling site was downstream from these areas near the mouth of the tributary. On one side of the stream there is evidence of a narrow strip of vegetative buffer between the road and the tributary. There is some overhanging vegetation and little to no bank erosion.

**Figure 3.6.** Site 1: Ridge Run, July 2015 (facing upstream)

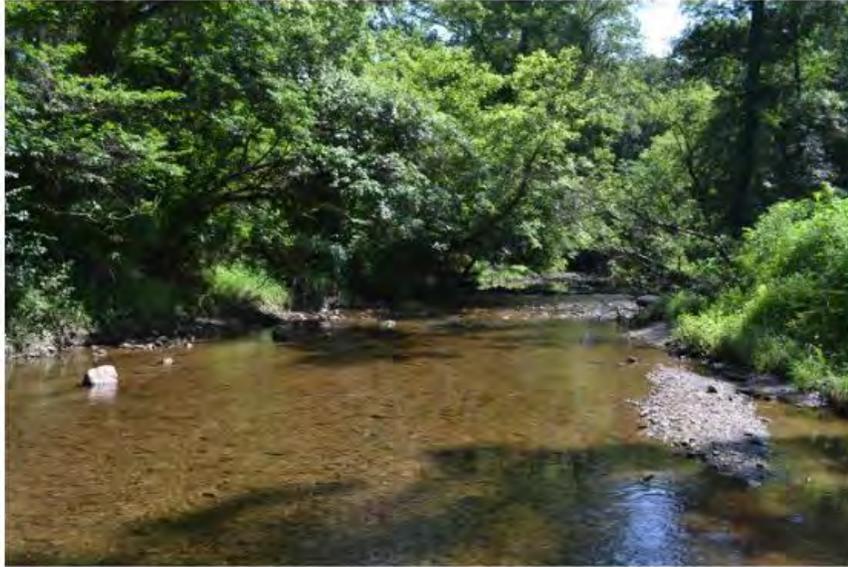
**Site 2: Beaver Creek Mouth:** Water samples were taken before the confluence of Beaver Creek and the Brandywine Creek (Fig 3.7). As shown in Figure 3.7, the stream is observed to be moderate in width (10-50m), shallow, and slow moving. Boulders and cobble were the main substrates found in this location. There is moderate bank erosion taking place on the right hand-side facing upstream, whereas on the left side there is minimal erosion due to the stabilization of the banks from the trees. On most days where sampling occurred, there have been signs of an overwhelming amount of trash deposited on the banks of the tributary due to the adjacent recreational state park area.

**Figure 3.7.** Site 2: Beaver Creek Mouth, July 2015 (facing upstream)

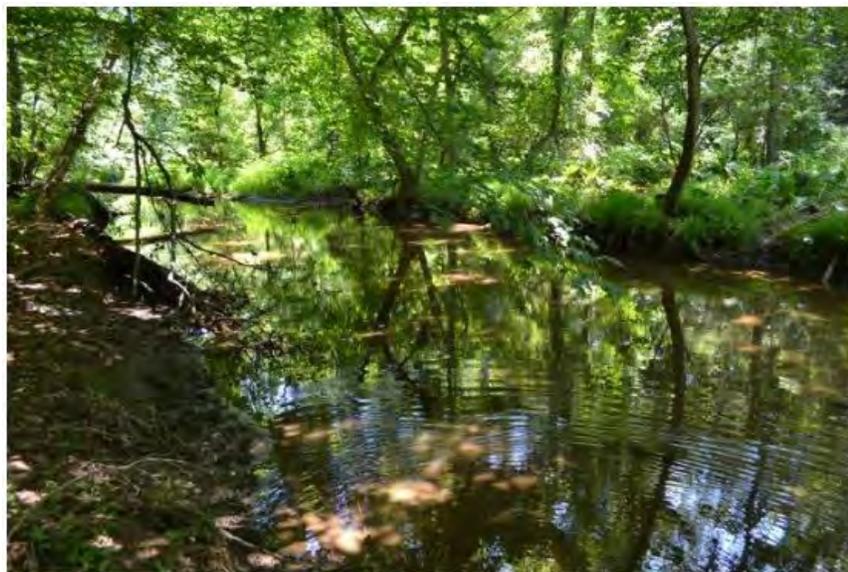
**Site 3: Beaver Creek North Fork:** Located further upstream and to the north of Beaver Creek Mouth, the north fork originates near the Concord Pike in Pennsylvania before entering the forested areas of the First State National Historical Park (Fig. 3.8). The area that was chosen for this site is located right before the confluence of Beaver Creek North and South. This study site is covered by overhanging vegetation and is characterized by deep pools, slow velocity, and no undercutting of the banks on either side. The northern fork does not run adjacent to any trails or roads, making it less susceptible to pollution from agricultural, industrial, commercial, or residential runoff.

**Figure 3.8.** Site 3: Beaver Creek North Fork, July 2015 (facing upstream)

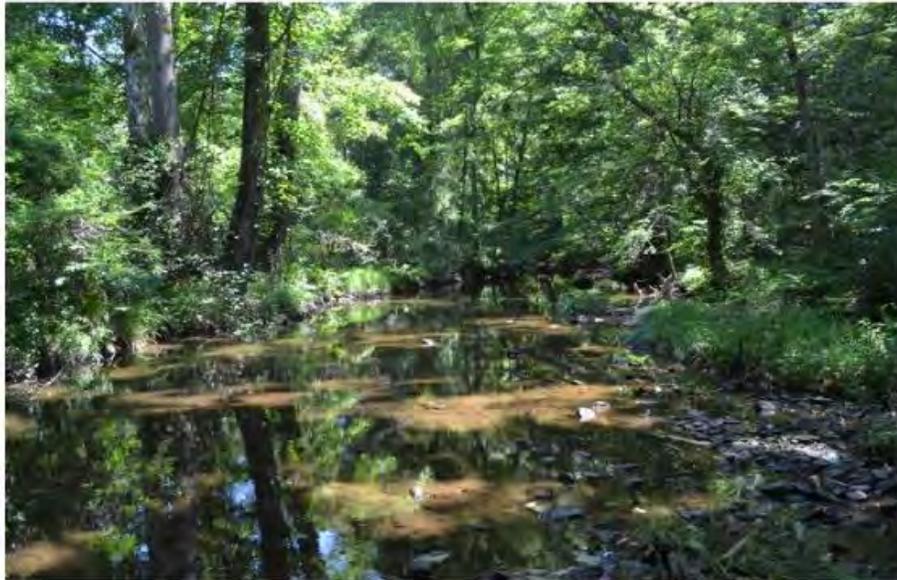
**Site 4: Beaver Creek South Fork:** Similar to the north fork, the south fork of Beaver Creek originates in a heavily developed area and flows past the Concord Pike and into the National Park (Fig. 3.9). The stream meanders along the Beaver Valley Road and becomes narrower upstream. This site has both riffle and run sections where the velocity of the stream varies. There is an approximately five-foot-high vegetative hill between the tributary and the road at the sampling site, which is about 50 feet away from the intersection of the north and south forks.

**Figure 3.9.** Site 4: Beaver Creek South Fork, July 2015 (facing upstream)

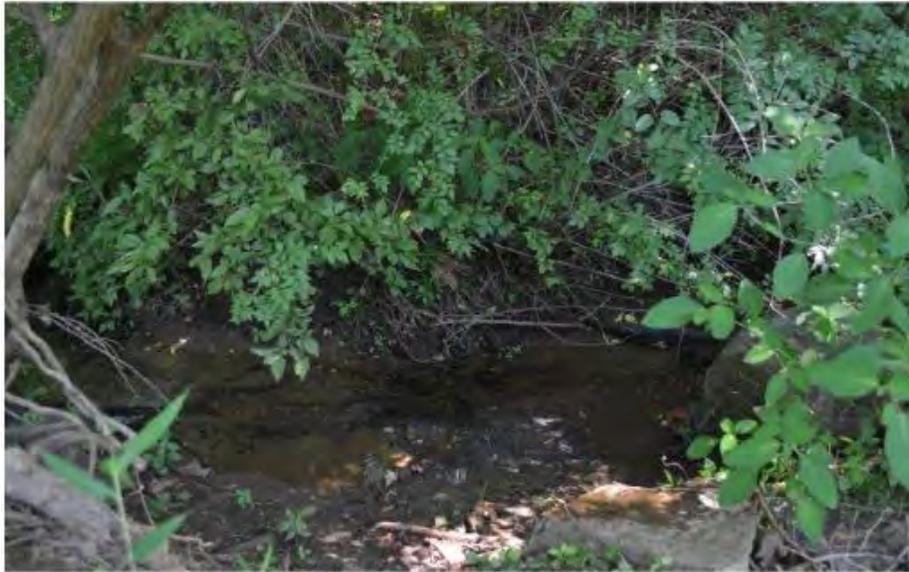
**Site 5: Talley Run:** This specific location of Talley Run runs alongside Brandywine Creek Road and is covered by a heavy understory growth of vegetation (Fig. 3.10). There is very minimal vegetation acting as a buffer on the left side of the tributary facing upstream. This area of the stream has the characteristics of an intermittent stream such as its shallow depth, small width, but well-defined channel. There is no noticeable amount of erosion occurring at this sample site. The samples were taken near the mouth of the tributary several feet upstream of where it crosses underneath Brandywine Creek Road.

**Figure 3.10.** Site 5: Talley Run, July 2015

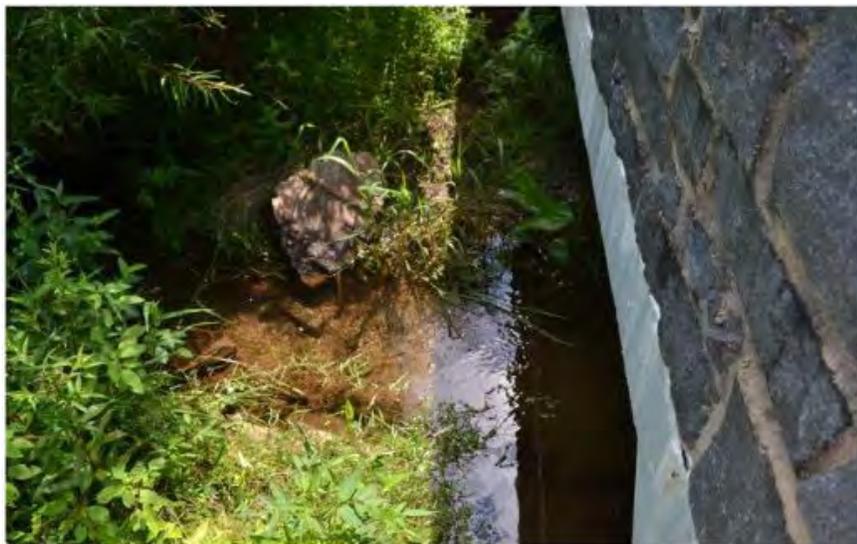
**Site 6: Ramsey Run:** Ramsey Run flows right underneath Ramsey Road before it converges with the Brandywine Creek (Fig. 3.11). There is lots of vegetation, (tall grasses, trees, wildflowers) on either side of this narrow stream, keeping the banks stabilized. The sampling site was directly upstream from the bridge where Ramsey Run crosses the road. The result of storm water runoff entering the stream from Ramsey Road, which often had polluted puddles, should be considered as a concern for nonpoint source pollution due to its close proximity.

**Figure 3.11.** Site 6: Ramsey Road, July 2014

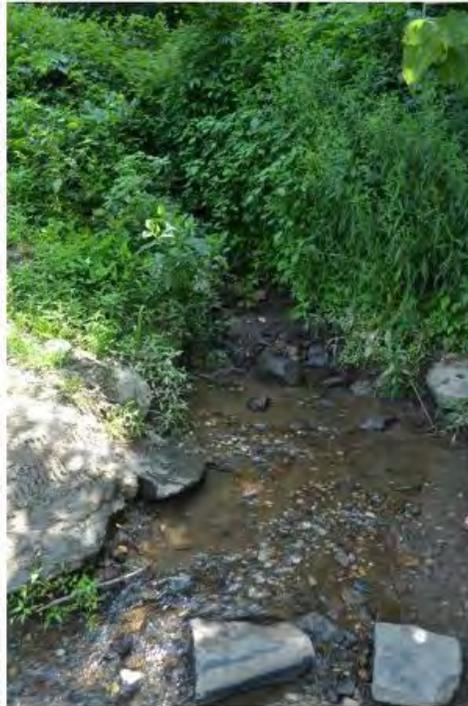
**Site 7: Carney Run:** The location chosen for this sampling site is situated at the mouth of the tributary and directly downstream of a pedestrian trail bridge (Fig. 3.12). The stream consists of substrate such as gravel and boulder in areas that are visible and are not covered by vegetation. Both banks are overgrown with dense vegetation. Carney Run runs directly alongside Thompson's Bridge Road and is characterized by low flow.

**Figure 3.12.** Site 7: Carney Run, July 2015 (facing upstream)

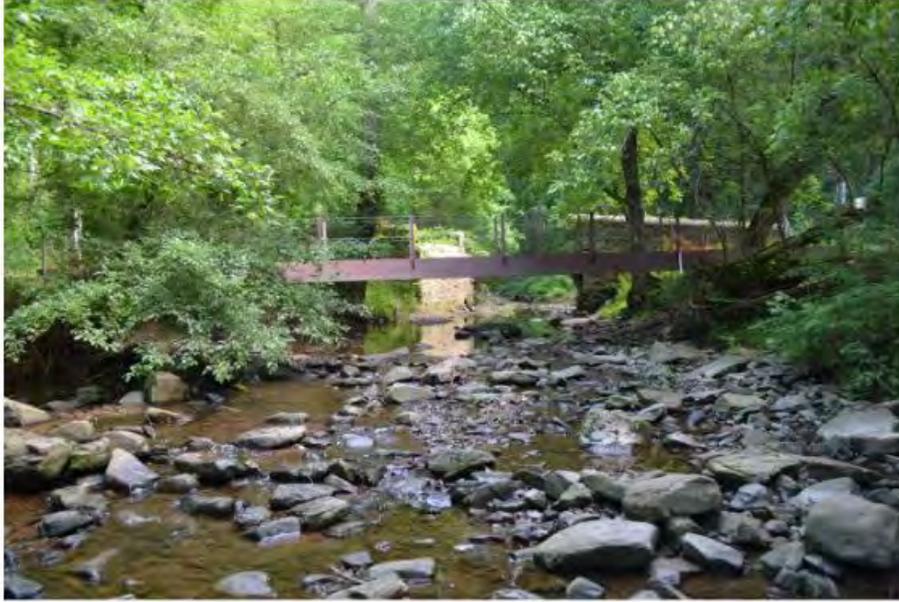
**Site 8: Rocky Run Mouth:** This section of the stream is located near heavily used hiking and biking recreational trails (Fig. 3.13). There are big boulders scattered around in the stream with established trees lining both sides of the banks for stability. Stream sampling occurred between the mouth at the Brandywine Creek and a temporary pedestrian trail bridge that was built after the permanent bridge was wiped out in a large storm. Construction on the new bridge began in August 2015 and was completed that winter, which may have influenced our fall samples since our sampling site was directly downstream of the construction area. This section is located downstream of Hurricane Run and Rocky Run's confluence, so the water quality is a combination of all six of Rocky Run's sub-sheds after it flows through the protected areas of FSNHP.

**Figure 3.13.** Site 8: Rocky Run Mouth, July 2015 (facing upstream)

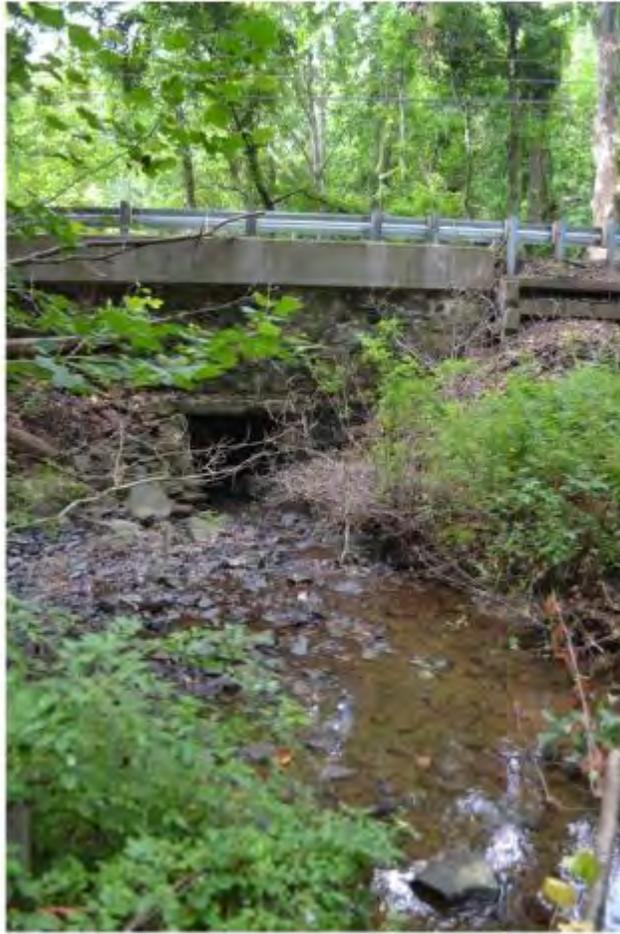
**Site 9: Hurricane Run:** At this shaded sampling site, the banks of Hurricane Run display moderate signs of erosion and drying up (Fig. 3.14). Due to a recent storm, there are also dead trees lying across the stream. The substrate in this section of the stream is mostly composed of cobblestones and gravel. The sampling site is directly upstream of where the tributary crosses beneath Woodlawn Road and flows into an extensive hiking/biking trail system.

**Figure 3.14.** Site 9: Hurricane Run, July 2015 (facing downstream toward Woodlawn Rd.)
