# **Water Quality Sampling Field Report**

## **First State National Park Brandywine-Piedmont Watershed 2015-2016**

April 2016

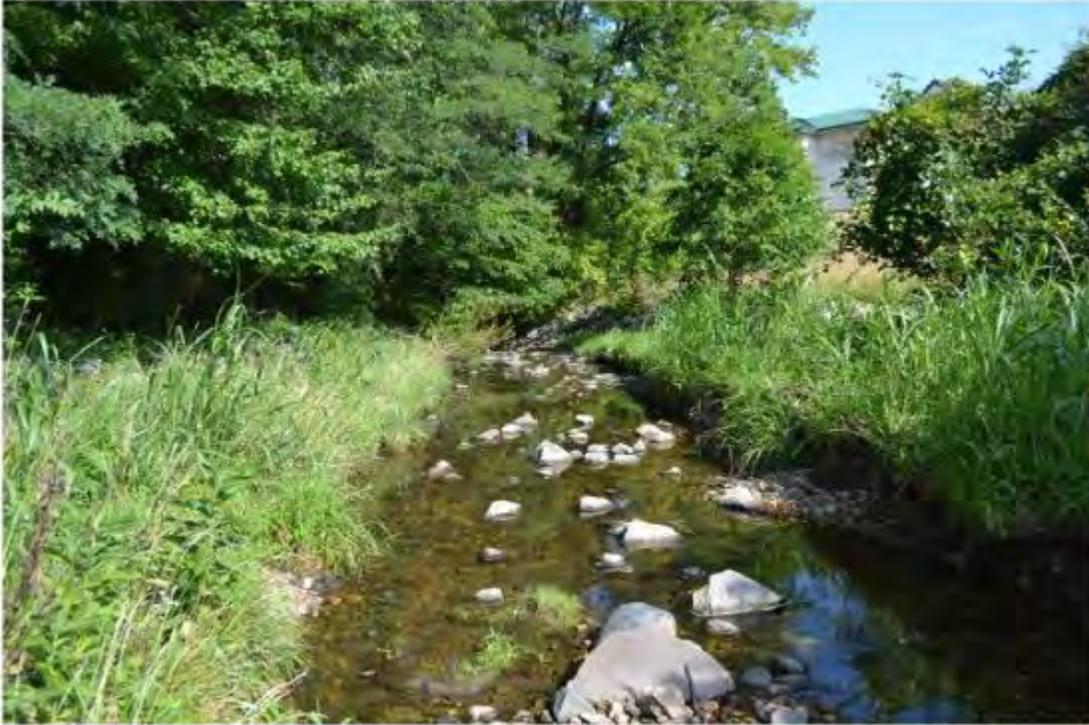
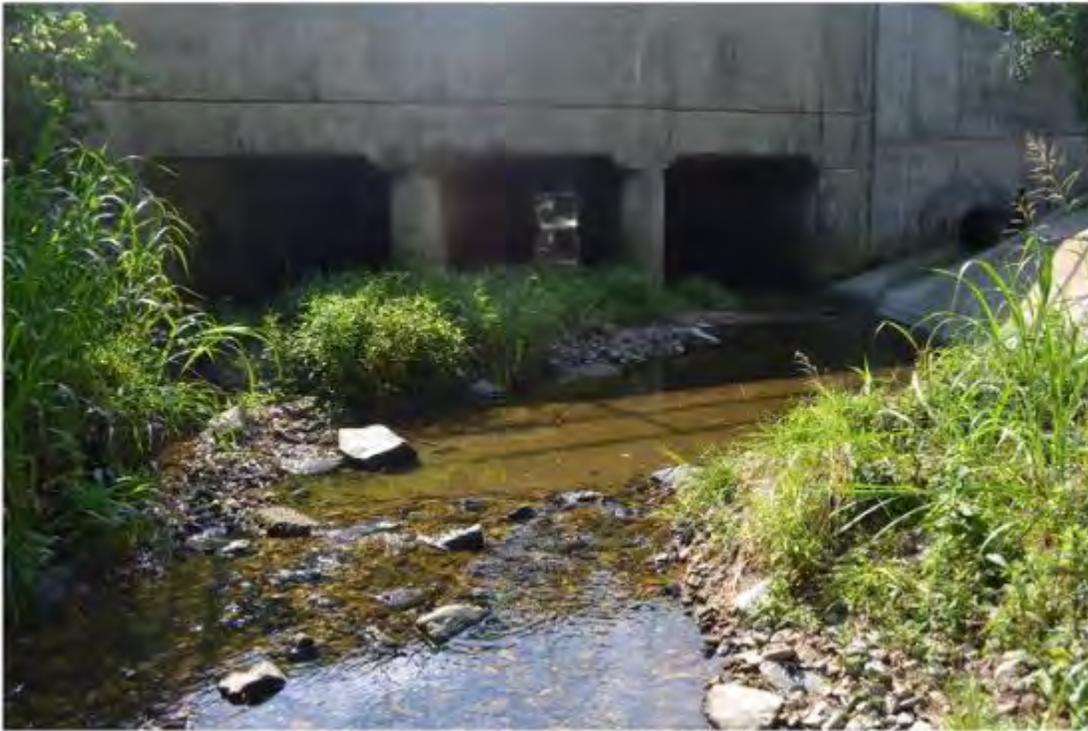
**Site 10: Rocky Run at Route 202:** This area is located between the National Park Boundary and downstream (west) of the Concord Pike (Route 202) overpass (Figures 3.15 and 3.16). Long grasses cover the banks on either side of the stream. Slightly upstream and through the tunnels (Figure 3.16), the stream banks are channelized with concrete as it passes through the Concord Mall complex. On several occasions, there was a discoloration of the stream that made it look opaque/milky. There are also large pipes leading into Rocky Run that most likely drain the roadways and nearby urbanized areas, which may have an influence on water quality.

**Figure 3.15.** Site 10: Rocky Run at Route 202, July 2015 (facing downstream)

**Figure 3.16.** Site 10: Rocky Run at Route 202, July 2015 (facing upstream toward Rt. 202)

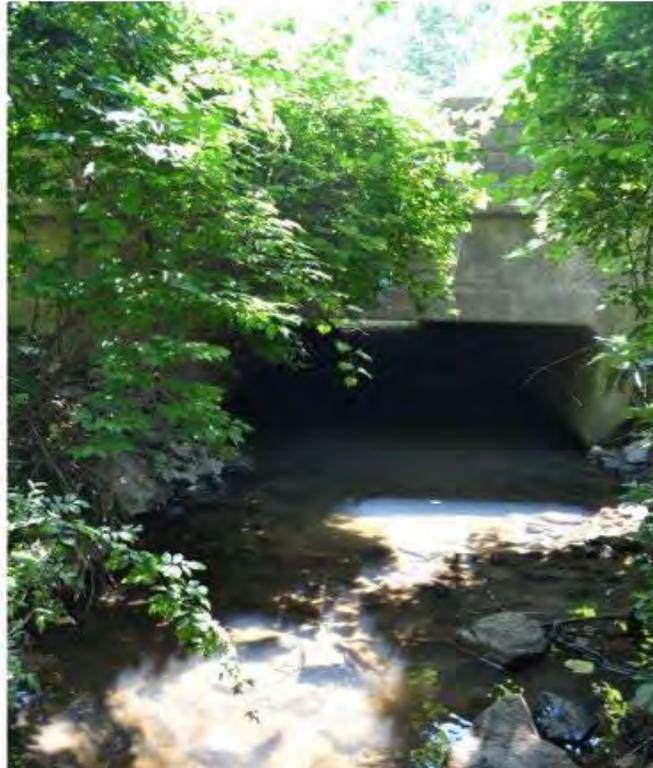
**Site 11: Beaver Creek at Route 202:** Beaver Creek also runs underneath the Concord Pike before it enters the National Park (Fig. 3.17). At this location, the vegetation is very dense and the banks on either side are steep. There is a lot of trash (broken bottles, plastic bags) scattered on the banks. The color of the water is murky but not to the degree found at the pool of water before the tunnel at Site 12 (Figure 3.18). The stream velocity was slow and there was little to no channel sinuosity. The sampling site was directly downhill and downstream from a horse farm and therefore is in danger of high nutrient levels.

**Figure 3.17.** Site 11: Beaver Creek at Route 202, July 2015 (facing upstream)

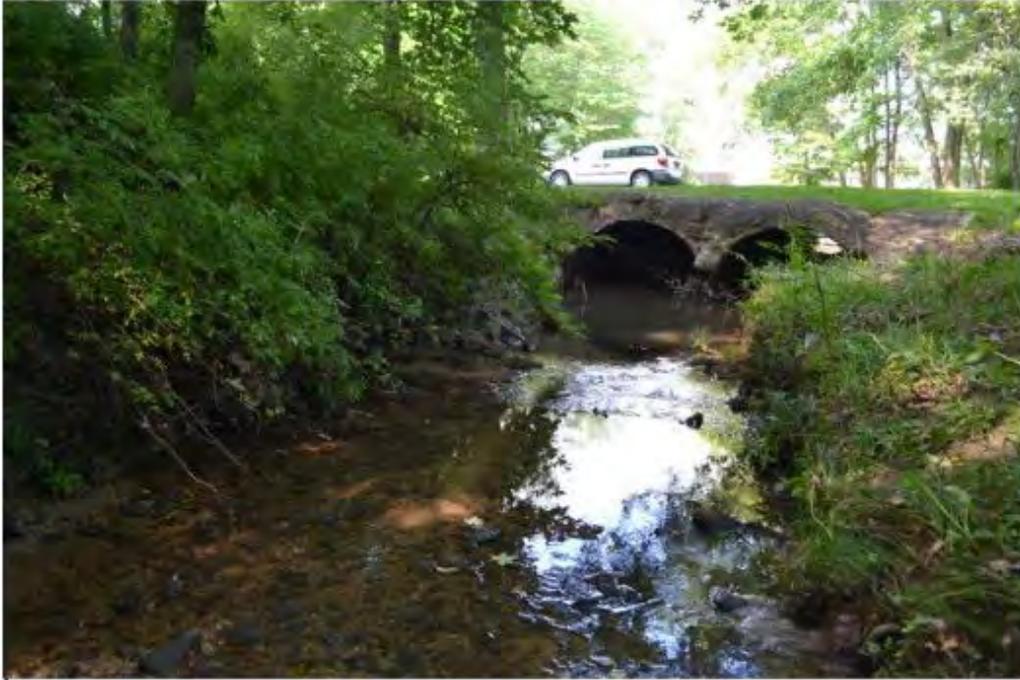
**Site 12: Rocky Run Residential:** Rocky Run originates slightly upstream of this residential area (Fig. 3.18). A deep pool of water is collected right downstream of the sampling site before the stream enters the tunnel and becomes channelized by concrete. The coloration of the pool is sometimes noted as copper orange, murky and opaque. The banks on either side of Rocky Run are steep and eroded. This site was chosen because it is downstream of a suburban community but directly upstream of the Concord Mall and Route 202 area, which is very developed.

**Figure 3.18.** Site 12: Rocky Run Residential, July 2015 (facing downstream toward Rt. 202)

Rocky Run at Residential Greenway is another example of a tributary that may be impacted more seriously by commercialized areas as indicated by high turbidity and dangerous levels of bacteria. However, other results show that water quality conditions at the mouth of Rocky Run are within healthy conditions, which suggests that the protected vegetation in the First State National Historical Park may help restore the water quality of unhealthy streams.

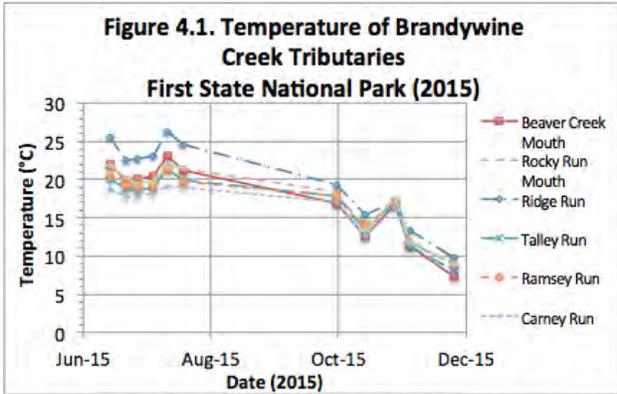
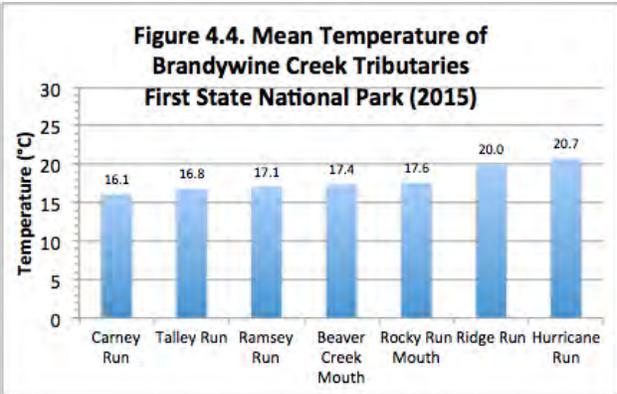
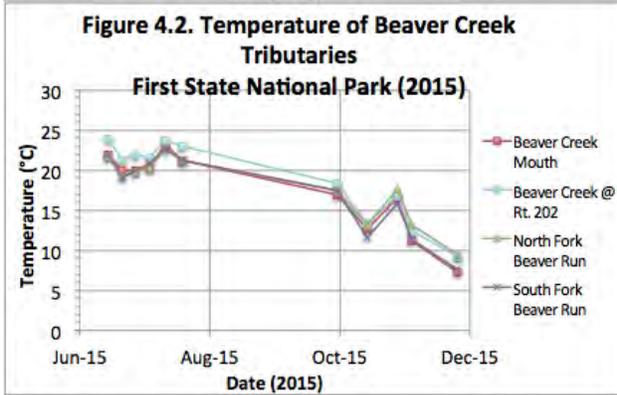
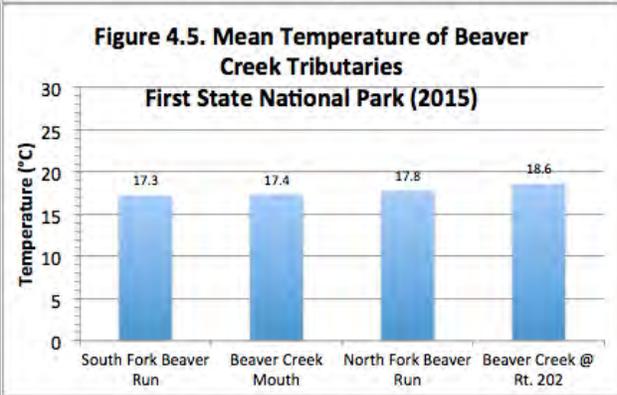
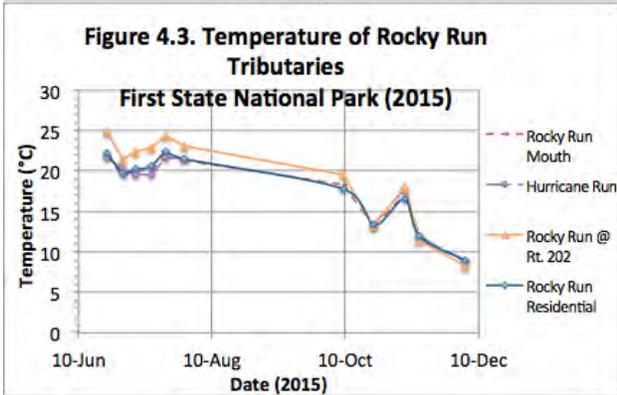
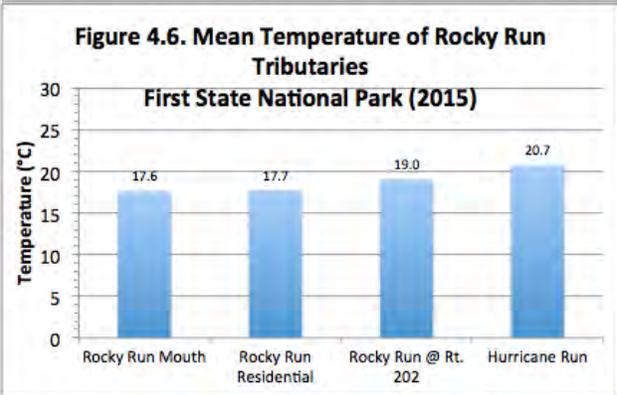
**Temperature:** Temperature is also an important factor for water quality sampling as it can alter other chemical parameters, such as dissolved oxygen (high temperature reduces oxygen levels), conductivity, and pH. Temperature is crucial for maintaining the metabolism of an aquatic ecosystem. For example, temperature fluctuations can affect the success of organisms living in the water, as some organisms may have a higher tolerance to temperature changes than others. As stated in the EPA Delaware Freshwater Quality Standards manual, no human-induced increase of the true daily mean temperature above 82°F (27°C) should be allowed. According to Figures 4.4 through 4.6, Hurricane Run has the highest mean water temperature of 20.7°C, followed by Ridge Run with a mean temperature of 20°C. The lowest mean temperature of 16.1°C is recorded at Carney Run. Overall, there were no temperature issues in the twelve sampling sites for June through December 2015.

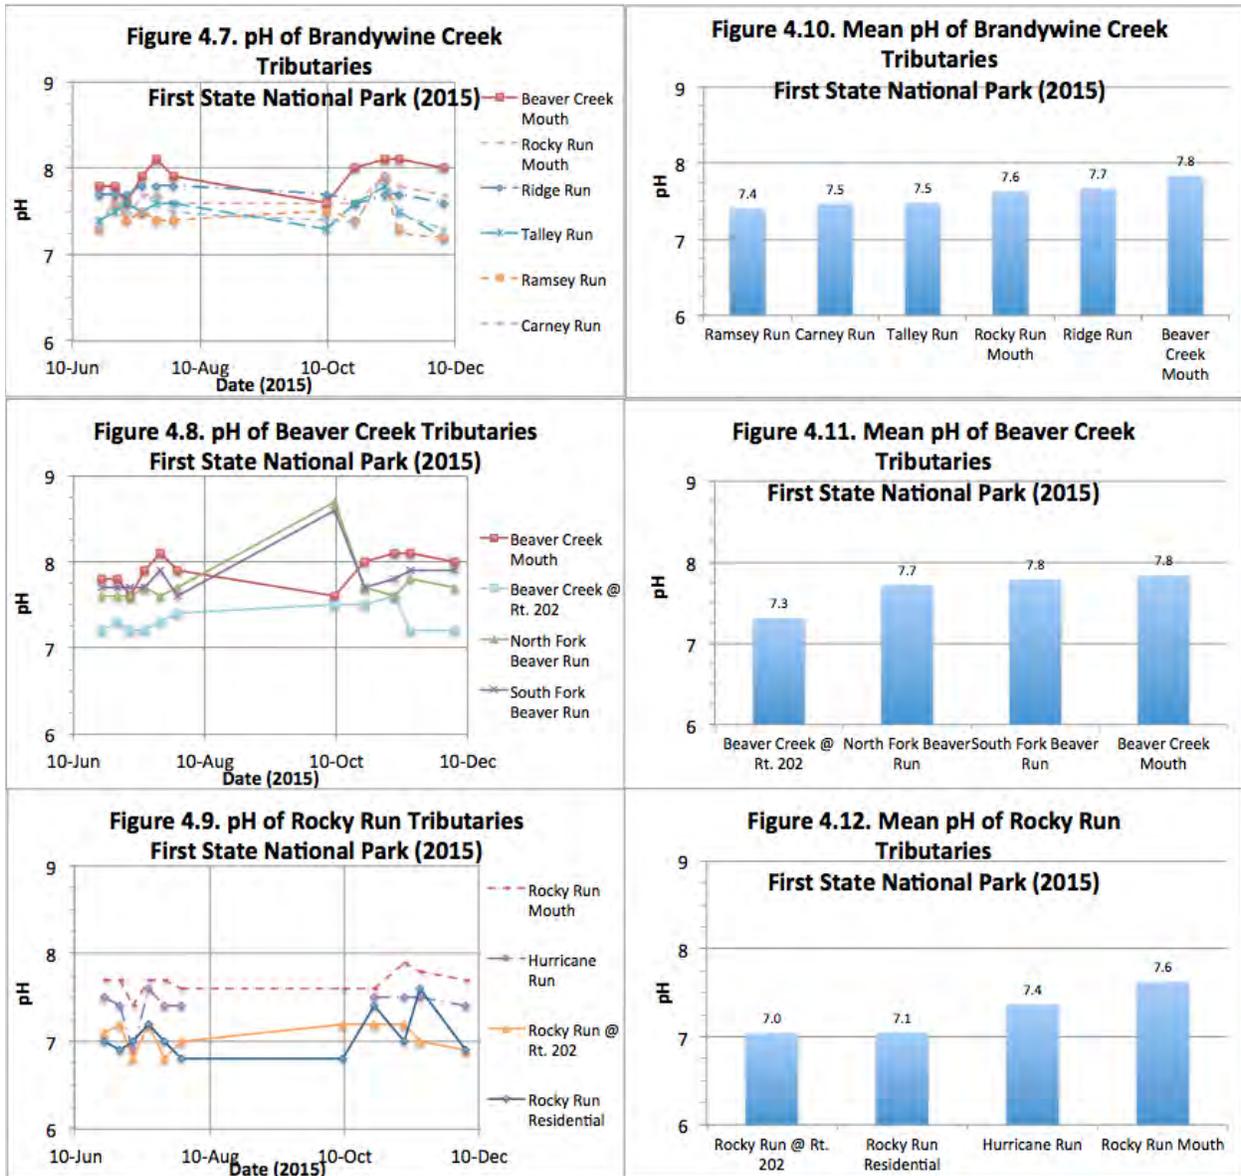
**pH:** According to the EPA Delaware Freshwater Quality Standards manual, all waters in the state of Delaware should have a pH in the range of 6.5 and 8.5 units in its unaltered state. The pH levels of the tributaries observed at each sampling site all fit within this range, thereby showing that there are no impairments in the pH levels (Figure 4.7 through 4.12). Rocky Run at 202 has the lowest average pH value of 7.04 whereas Beaver Creek Mouth has the highest average pH at a value of 7.83.

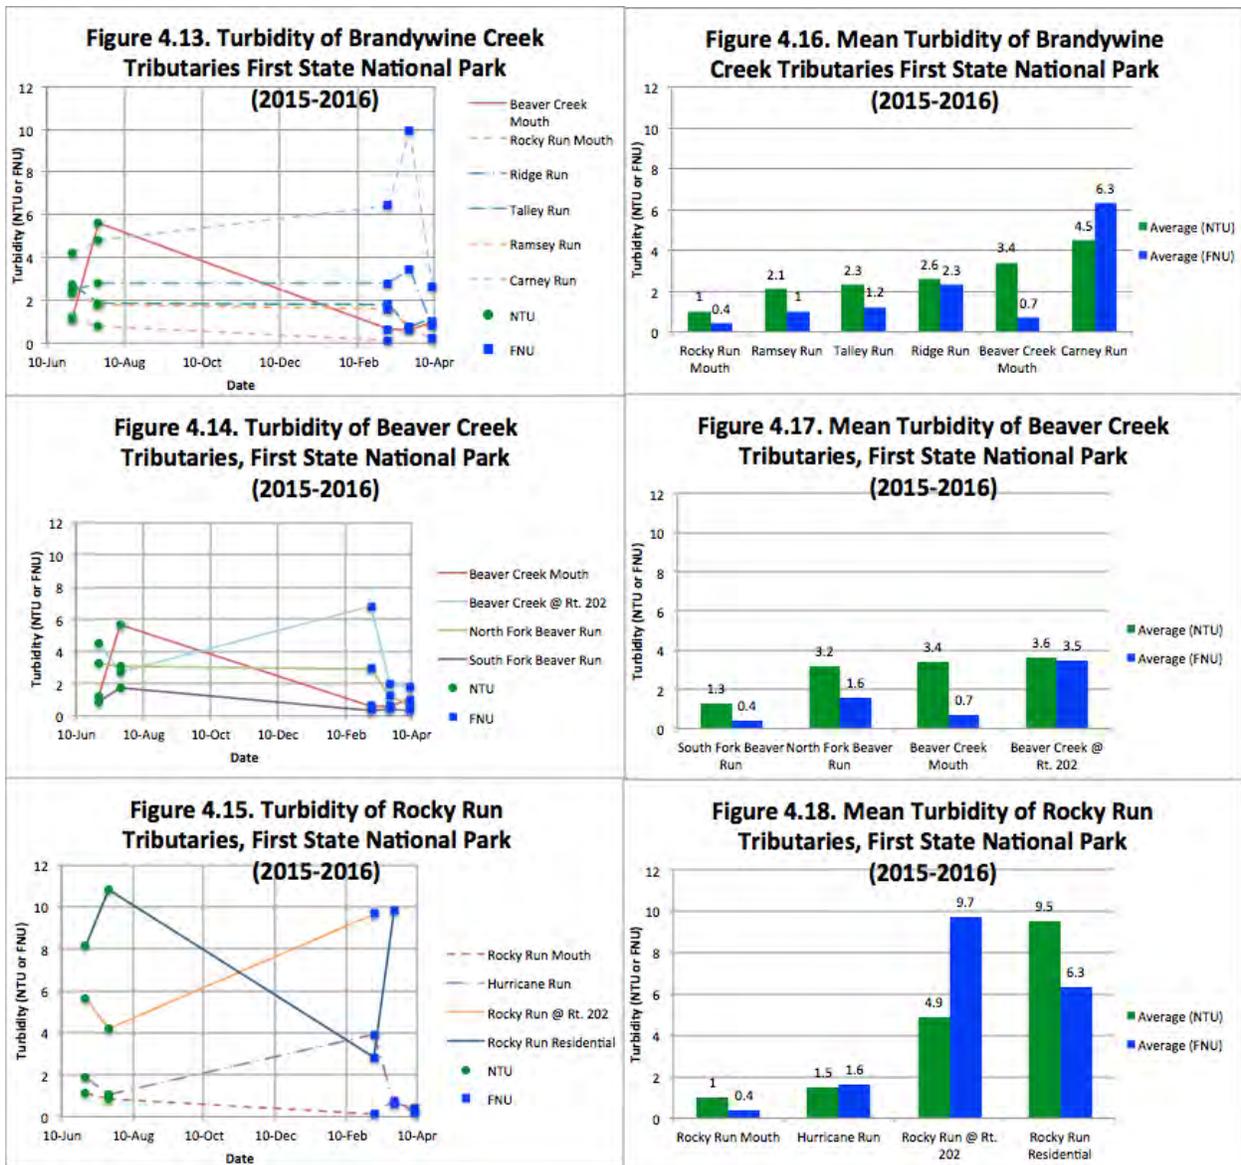
**Turbidity:** Turbidity measures both suspended and dissolved particulate matter in water, and is essentially a measure of water murkiness. The higher the turbidity, the “muddier” the water is. Turbidity is an important factor for water quality analysis because it may be a

sign of pollution such as phosphorus pollutants that cause algae to grow. High turbidities have a variety of harmful effects on aquatic wildlife, including prevented development, modified movement and migrations, reducing food availability and growth, decreasing resistance to disease, or death. Additionally, waters with high turbidities are generally less aesthetic for recreational purposes. Turbidity should not exceed a level of 10 NTUs. Data was analyzed twice in NTUs at the Wilmington lab in the summer and three times in FNU, a similar measurement, in the fall with a turbidity meter on site. According to figure 4.18, the upper Rocky Run sites (Rocky Run at Route 202 and Rocky Run Residential) have the most concern for exceeding 10 NTUs or FNUs. However, Rocky Run mouth has the lowest turbidity of all the sites, so there is little concern for turbid water entering the Brandywine Creek.

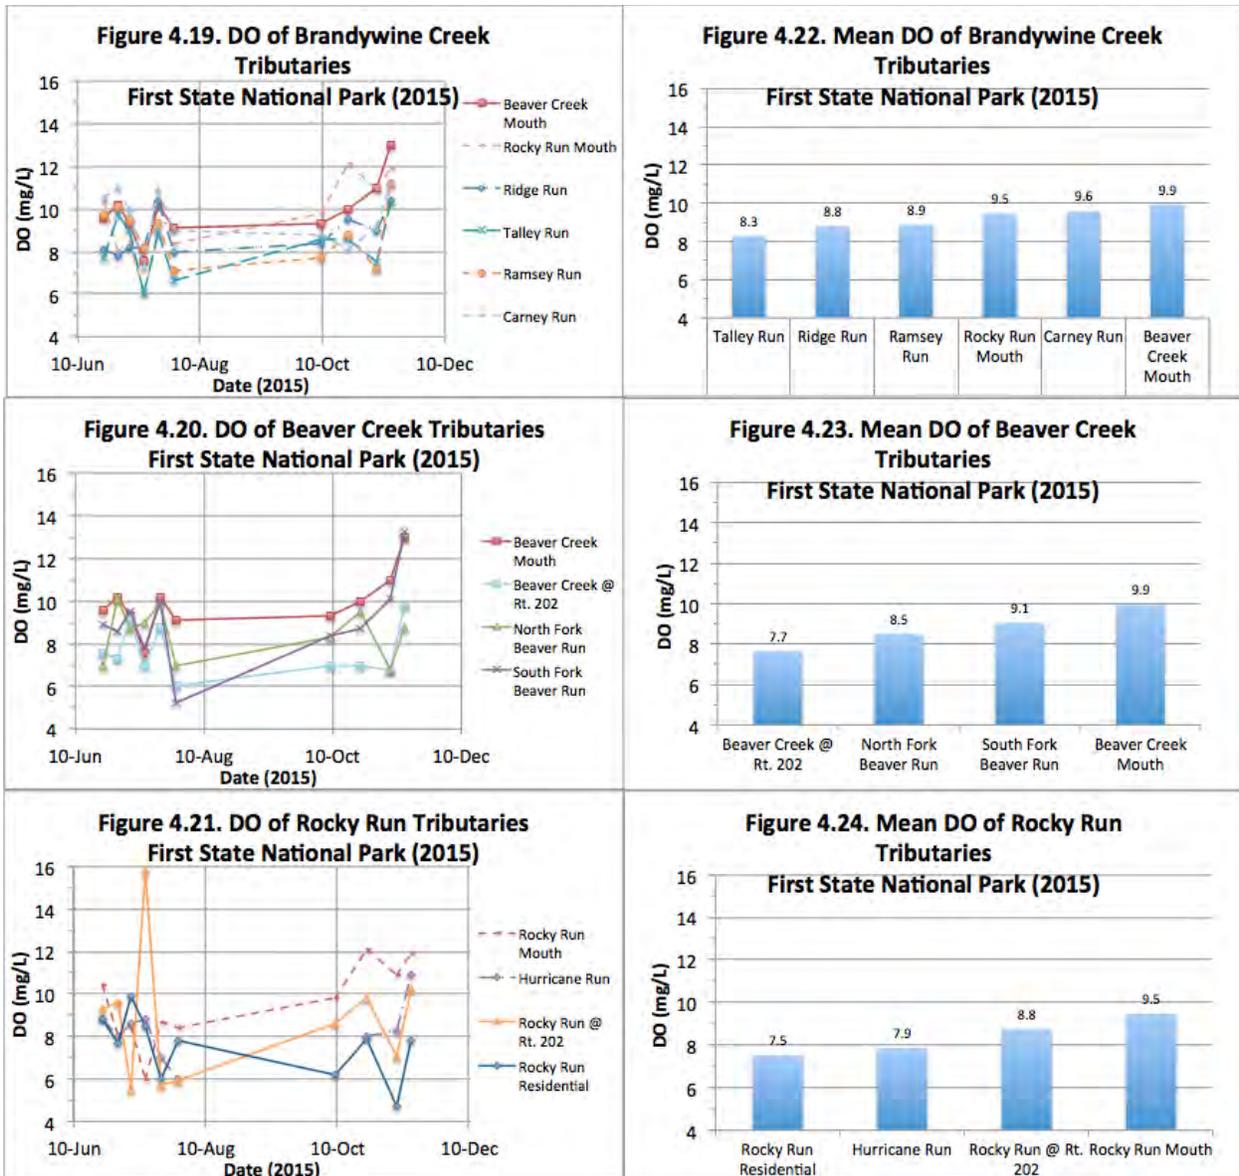
**Dissolved Oxygen (DO):** Fish, macroinvertebrates, plants and bacteria rely on dissolved oxygen to survive. A healthy stream, according to the Water Quality Standards manual, should not have a dissolved oxygen average below 5.5 mg/L. These conditions might occur in slow-moving, narrow waterways with little aquatic plant life. Fish species exposed to less than 5.5 mg/L of dissolved oxygen will have impaired functionality and lower survival rates. Looking at Figures 4.22 through 4.24, the tributaries in the First State National Historical Park all have average dissolved oxygen levels between 7 mg/L and 10 mg/L. The tributary with the lowest average dissolved oxygen (7.53 mg/L) is Rocky Run Residential and the tributary with the highest average dissolved oxygen (9.93 mg/L) is Beaver Creek Mouth. Rocky Run at Route 202 had three instances of coming within 0.2 mg/L of the standard in the month of July, which may be an area of concern for that tributary but not for the Brandywine.

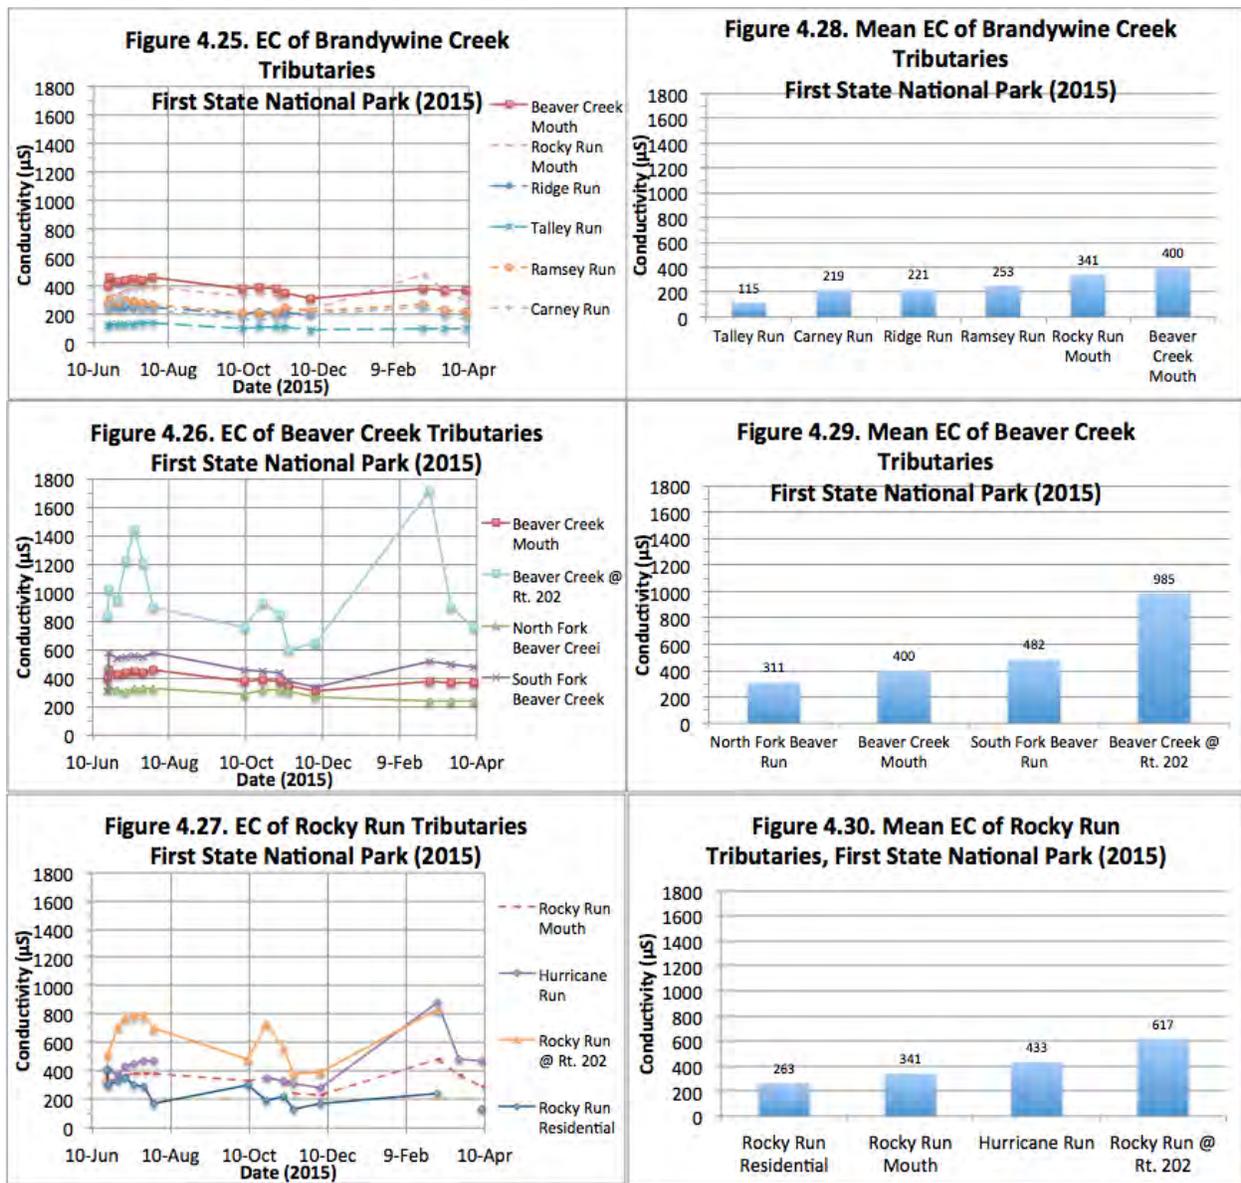
**Electrical Conductivity (EC):** A sudden change in conductivity can indicate pollution due to an increased influx of ions from an external source such as agricultural runoff or residential waste leakage. For aquatic organisms, the ideal value of conductivity is between 150 $\mu$ S and 500 $\mu$ S. However, normal conductivity levels for surface waters are expected to range from 50 $\mu$ S to 1500 $\mu$ S. As seen in Figure 4.29, the highest mean conductivity is found at Beaver Creek at Route 202 with a mean of 985 $\mu$ S. This high value is not ideal for aquatic organisms and may be damaging to the ecosystem. On March 4th, 2016, the conductivity for Beaver Creek at Route 202 spiked at a dangerously high level of 1720 $\mu$ S. We expect this was due to agricultural runoff from the adjacent horse farm. Talley Run has the lowest

mean conductivity of 115 $\mu$ S (Figure 4.28), which may actually indicate low nutrient levels for aquatic life.

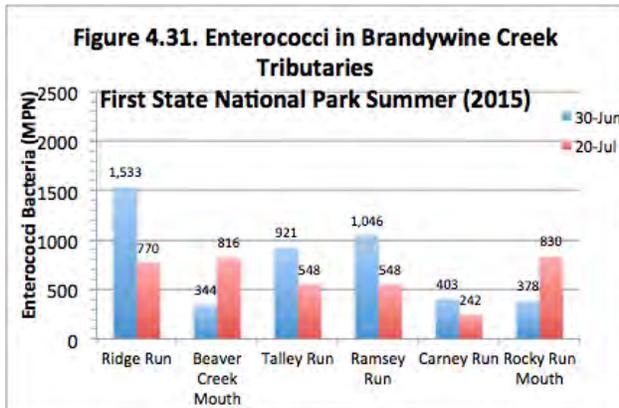
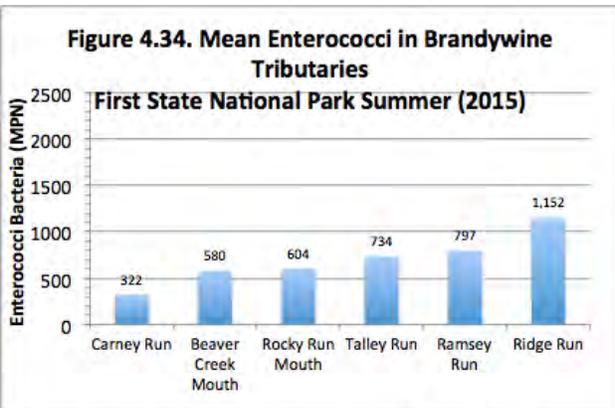
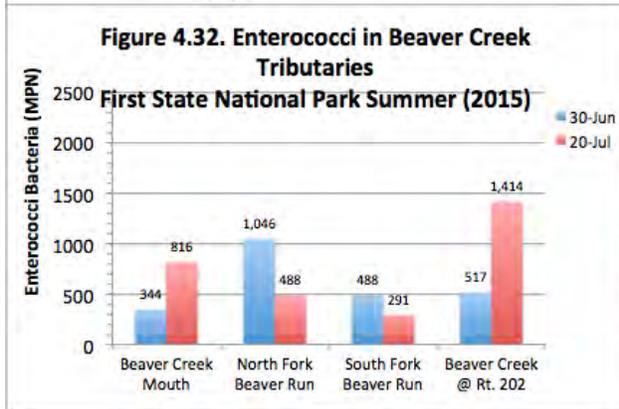
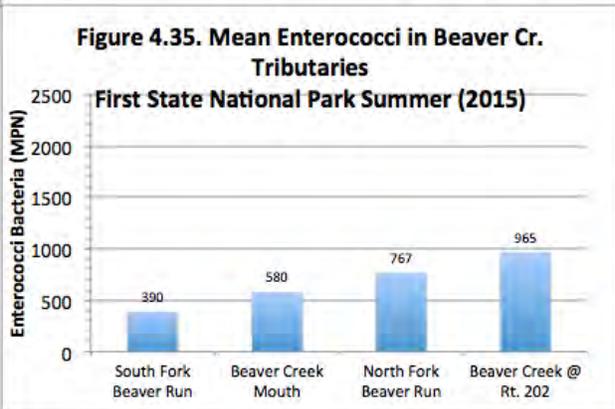
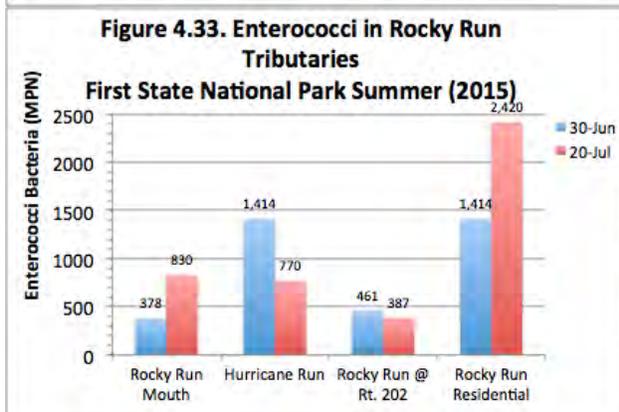
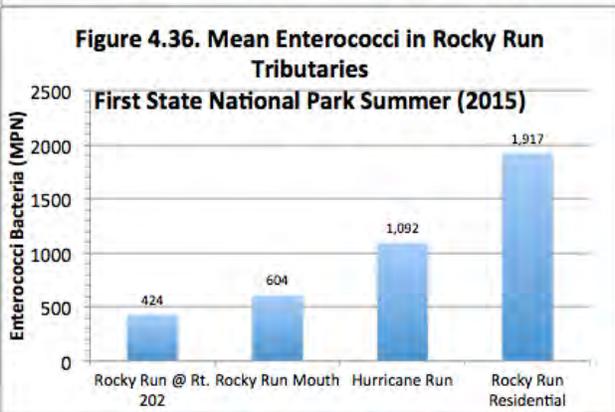
Bacterial sampling should be re-done at these sample sites as the bacterial levels seemed abnormally high. If bacteria levels are indeed verified to be this high, then further measures to enforce people from swimming in these tributaries should be taken.
