Project Report

White Clay Creek Wild and Scenic River Shad Restoration Project (Removal of Dam No. 1)

New Castle County
Wilmington, Delaware

Final Draft August 31, 2011

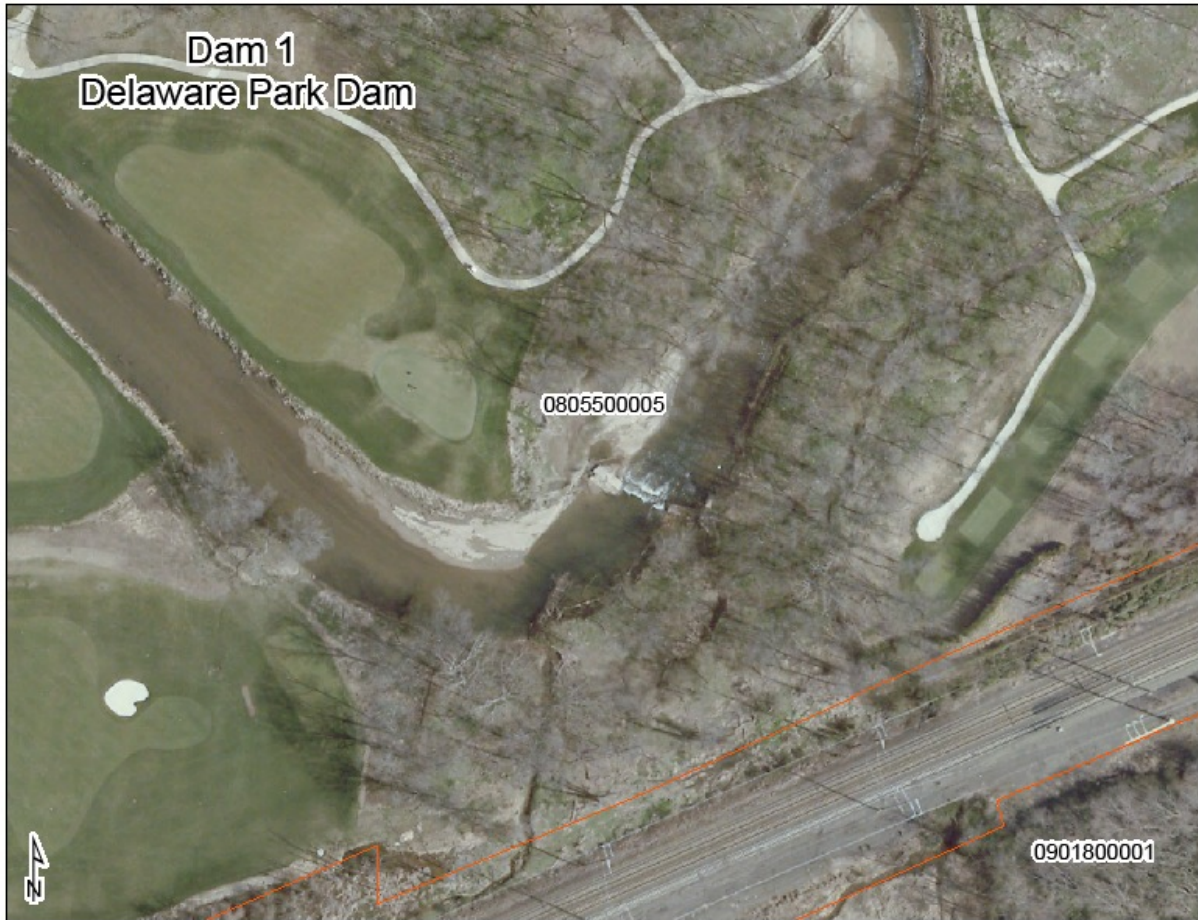
Figure 2. Dam No. 1 proposed for removal along White Clay Creek at Delaware Park

breached along the right stream bank (looking upstream) and was damaged by floods from Hurricane Floyd in September 1999, Tropical Storm Henri in September 2003, and lately by Hurricane Irene on August 28, 2011.

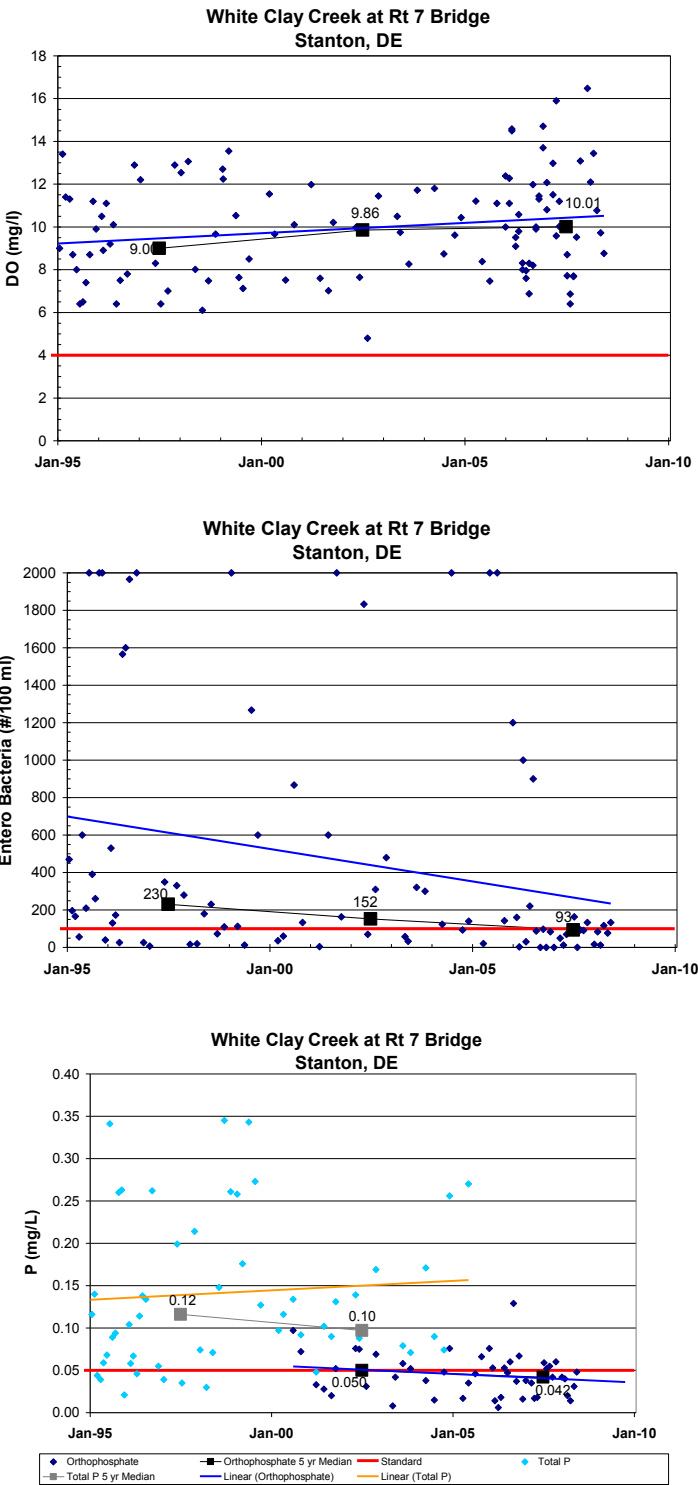
Water quality along the White Clay Creek at Stanton (just downstream from Dam No. 1) has improved between 1995 and 2009 for dissolved oxygen, phosphorus, and bacteria

Figure 4. Dissolved oxygen, bacteria, and phosphorus along White Clay Creek at Stanton, 1995-2009

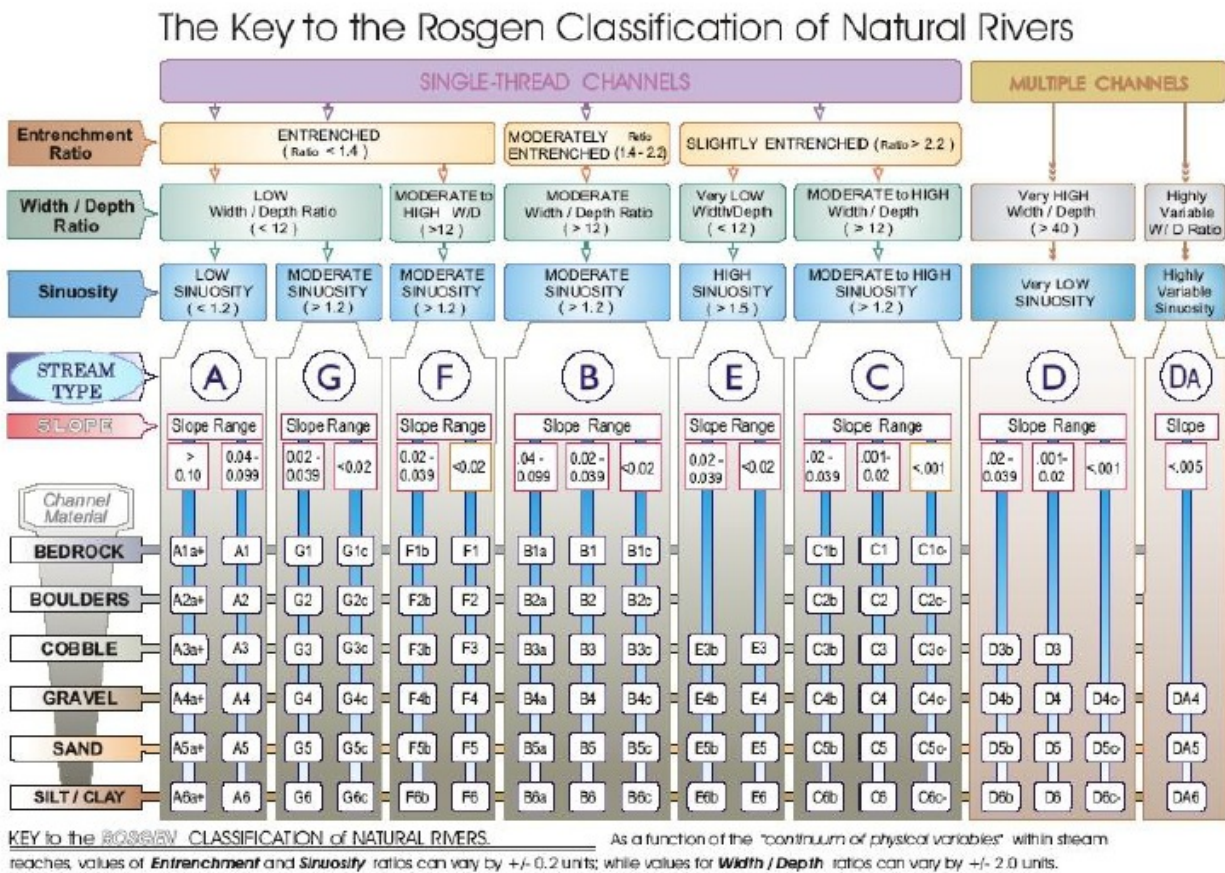
The Rosgen model uses six characteristics to classify streams as described in *Stream Restoration: A Natural Channel Design Handbook*, prepared by the North Carolina Stream Restoration Institute. The following flow chart is used to classify streams according to the Rosgen Model.

Figure 6. Rosgen classification of natural rivers

The first step in the Rosgen model is to determine the number of stream channels. A stream with multiple or braided channels must have at least three distinguishable channels over the observed length of the stream. This stage of the classification can be made with aerial photographs or field observation. White Clay Creek is a classic single thread stream channel

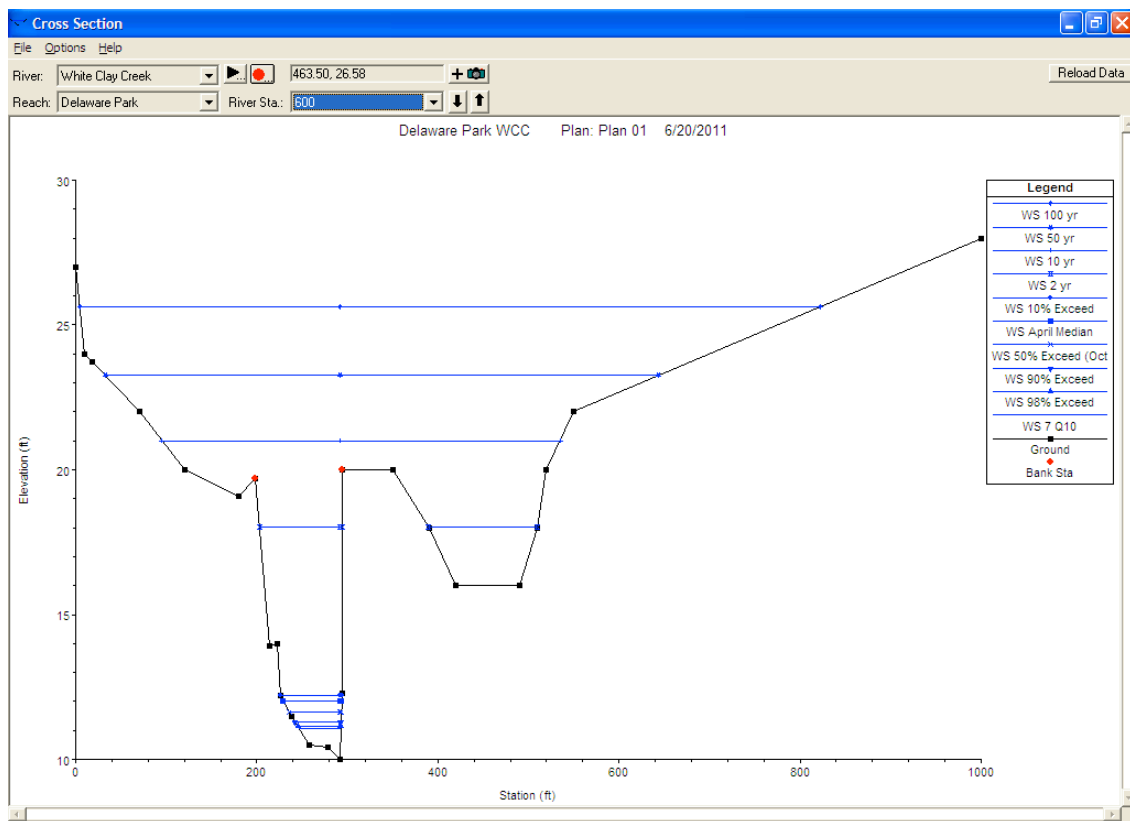
Figure 18. White Clay Creek HECRAS cross section existing station. 6+00

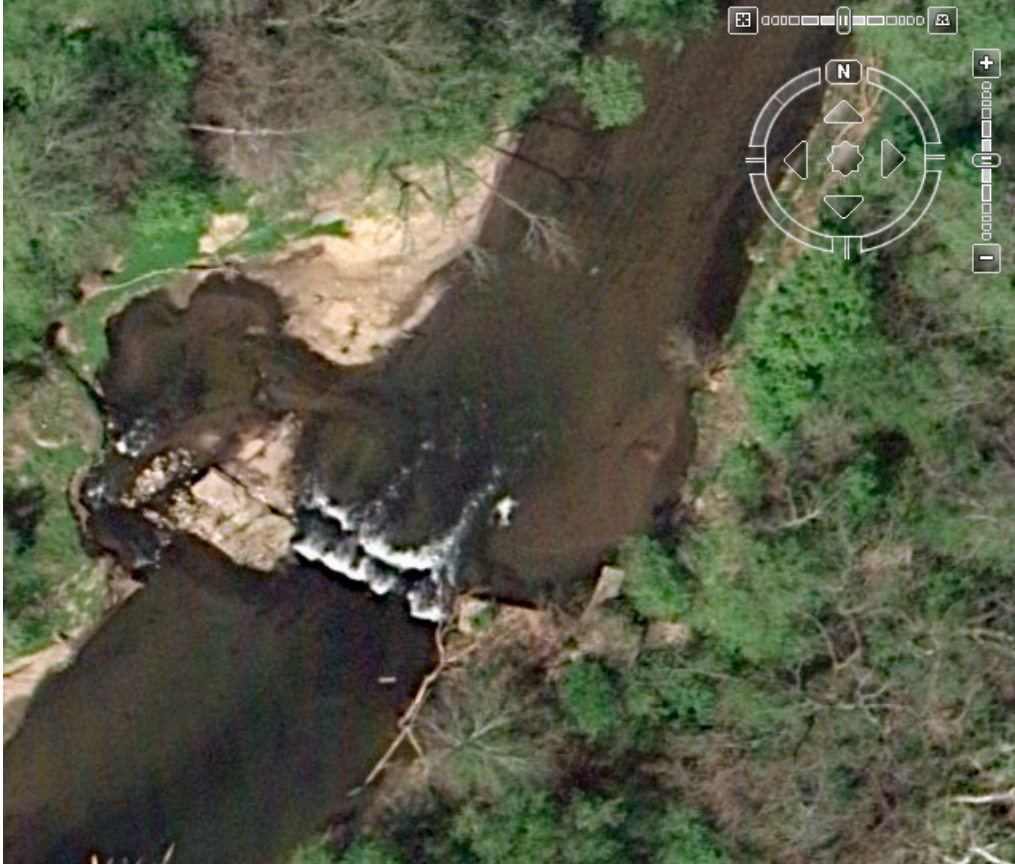
Photo 3. Plan view of White Clay Creek Dam No. 1. Note breach along overbank to left.

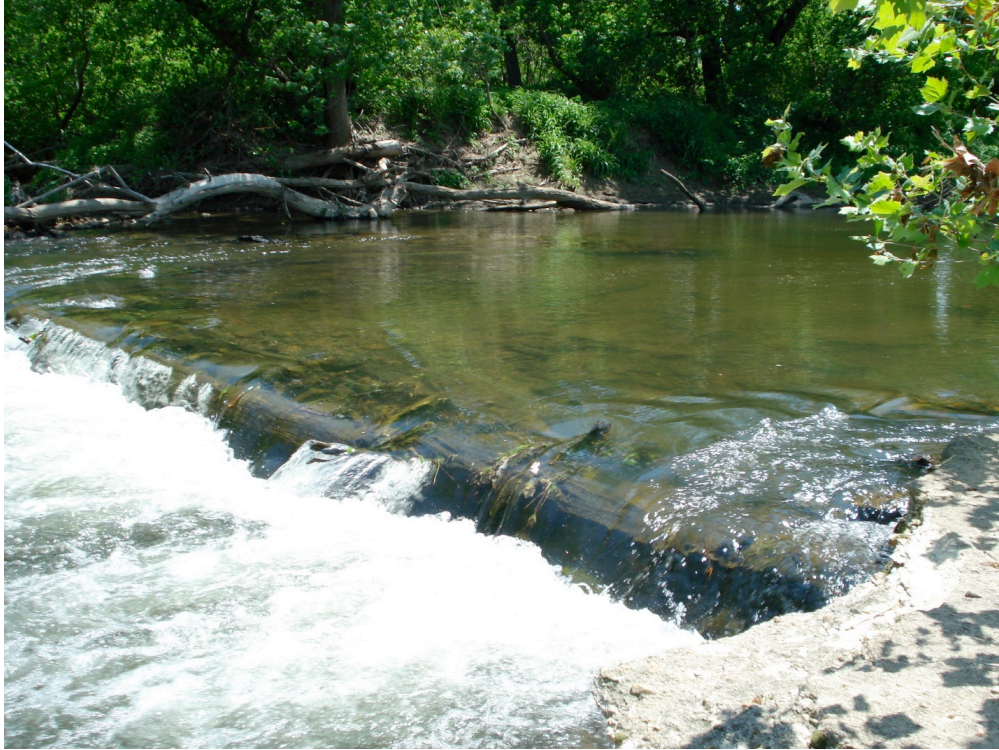
Photo 5. Dam No. 1 along White Clay Creek (RM 4.2) at Delaware Park, note timber frame

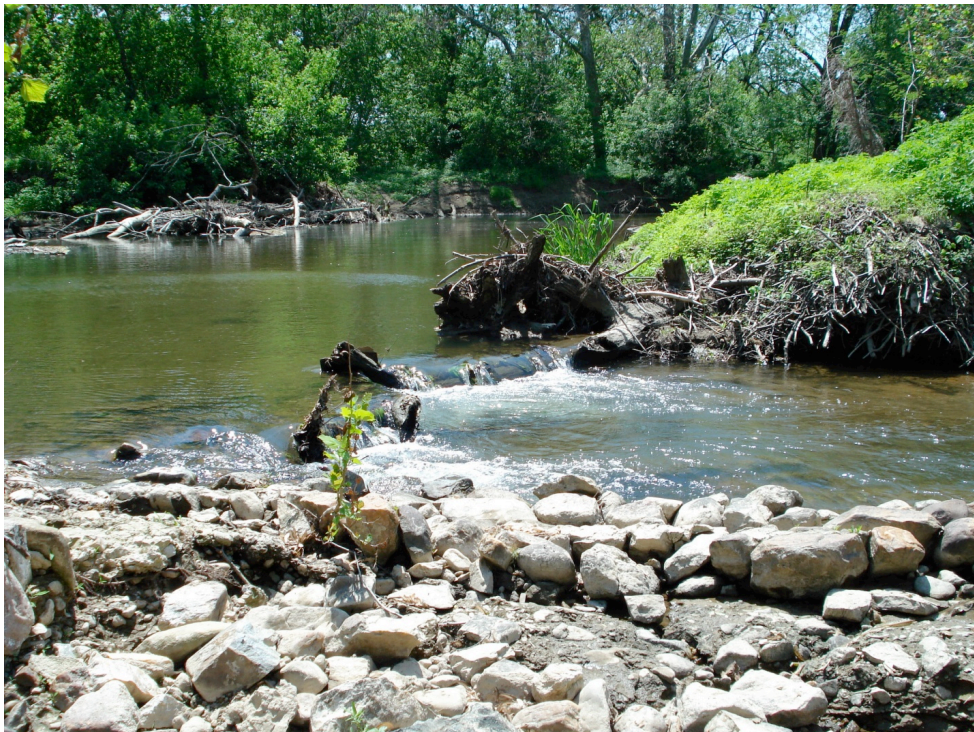
Photo 6. Dam No. 1 along White Clay Creek looking upstream at partial breach

Dam No. 1, an old rock fill and timber dam, is breached along the right stream bank (looking upstream) and was heavily damaged by floods from Hurricane Floyd in September 1999 and Tropical Storm Henri in September 2003 and continues to be damaged by more recent storms

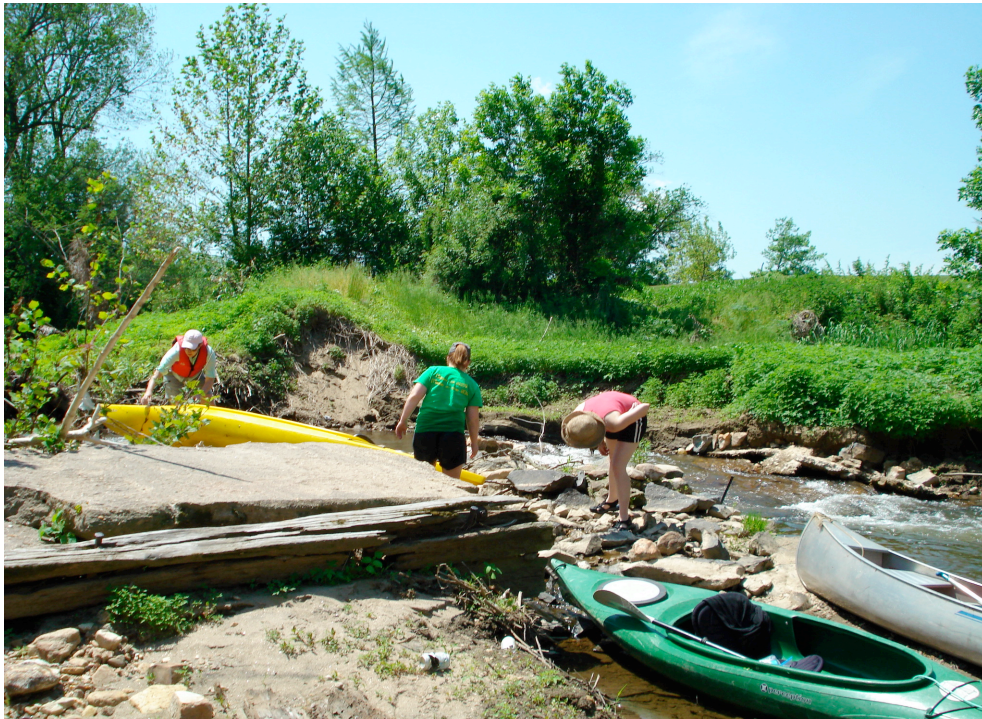
Photo 8. Dam No. 1 along White Clay Creek at Delaware Park upstream at partial breach

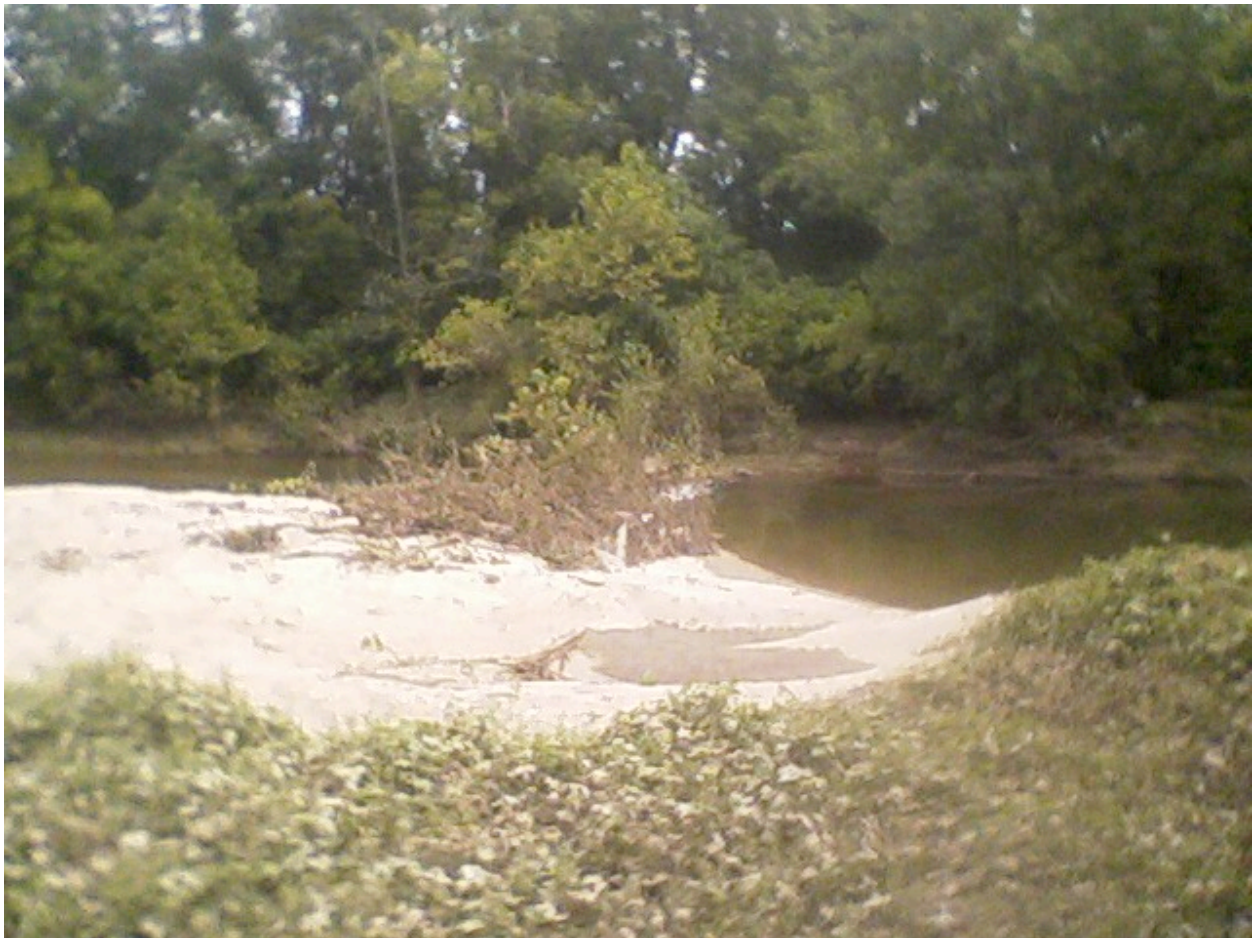
Photo 12. Dam No. 1 on Sep 1, 2011 just 4 days after Hurricane Irene (Aug 28, 2011).
