Christina Basin

Targeted Watershed Grant

Final Report

December 2008

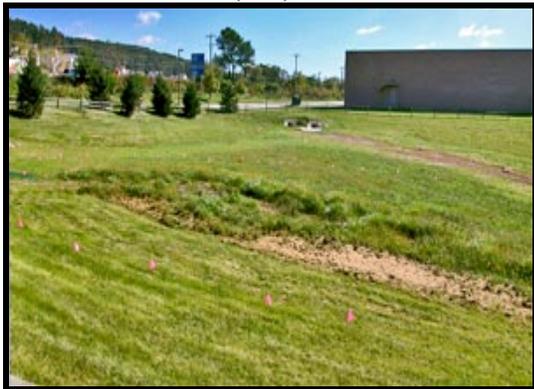
Figure 3.2. All Saints cemetery restoration of Balls Run stream (DE).

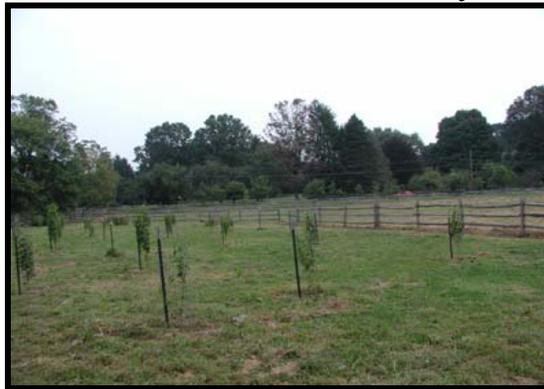
Figure 3.3. Floodplain forest restoration, confluence of Bucktoe and Red Clay Creeks (PA).

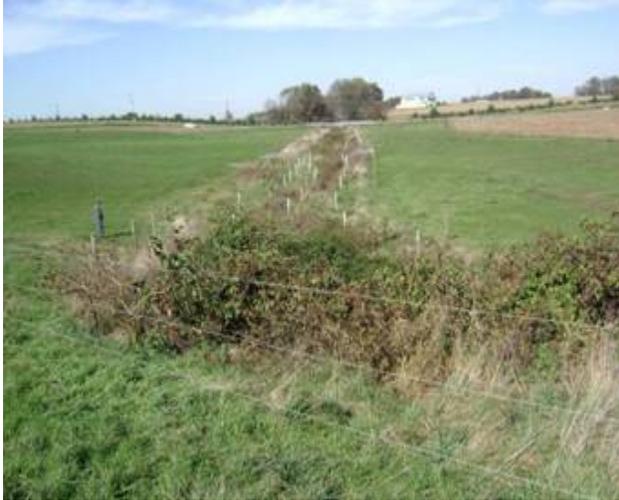
Figure 3.8. Stream bank fencing at Glenville Farms.

A total of 8,025 feet of stream fencing was installed on agricultural lands, almost three times the proposed 2,700 feet. The stream fencing installed will keep livestock out of the streams and therefore protect stream banks from erosion caused by animal access. The fencing will also establish buffer zones to filter pollution from stormwater runoff (Figures 3.8 and 3.9). The site locations and linear stream footage of stream fencing installed are listed below (Table 3.10).

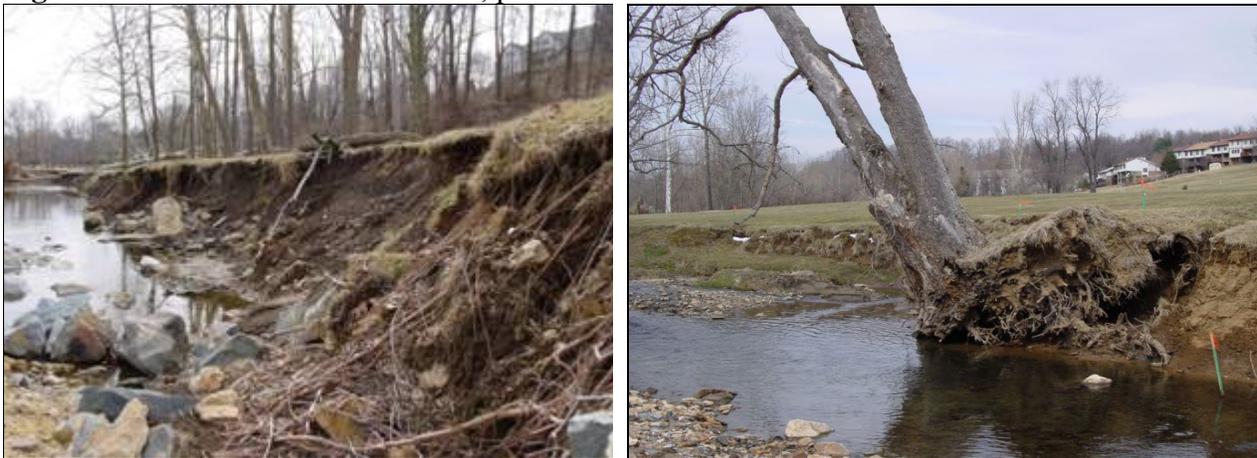
Figure 3.15. Three Little Bakers site, pre-restoration.

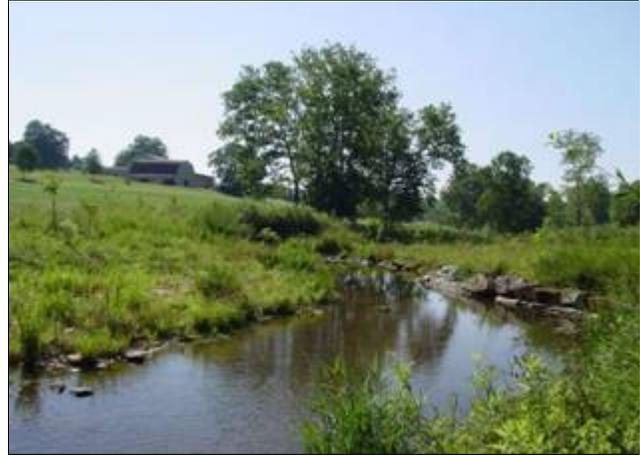
Figure 3.19. Three Little Bakers site, post-construction with stabilized stream banks.

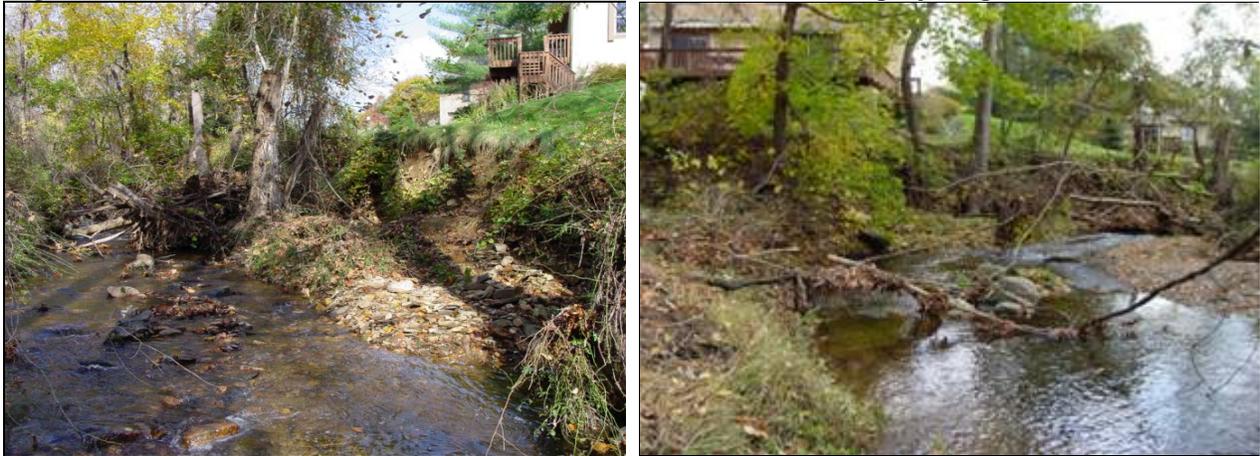
Figure 3.20. Meadowdale stream restoration and bank stabilization project, pre-restoration.

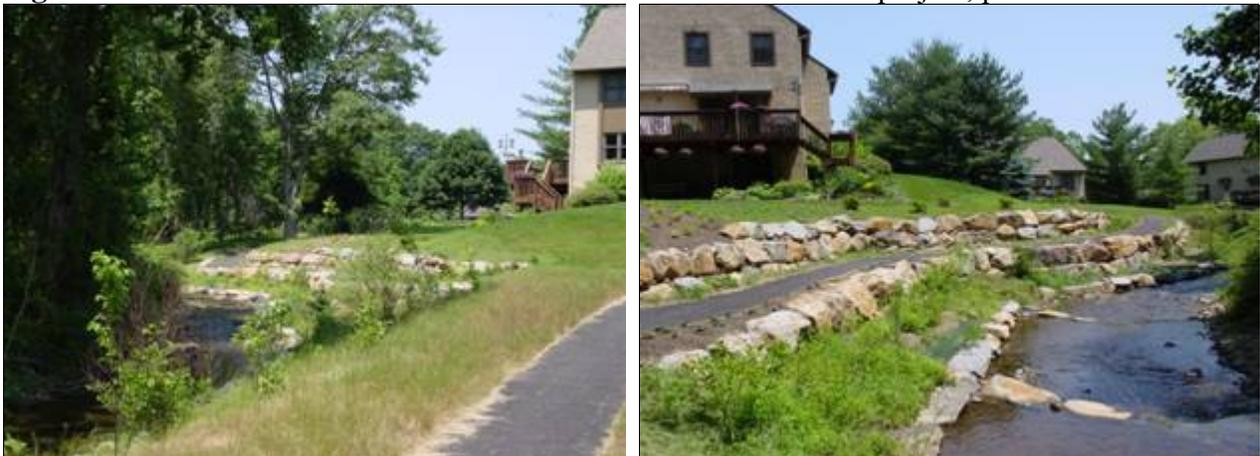
Figure 3.21. Meadowdale stream restoration and bank stabilization project, post-restoration.

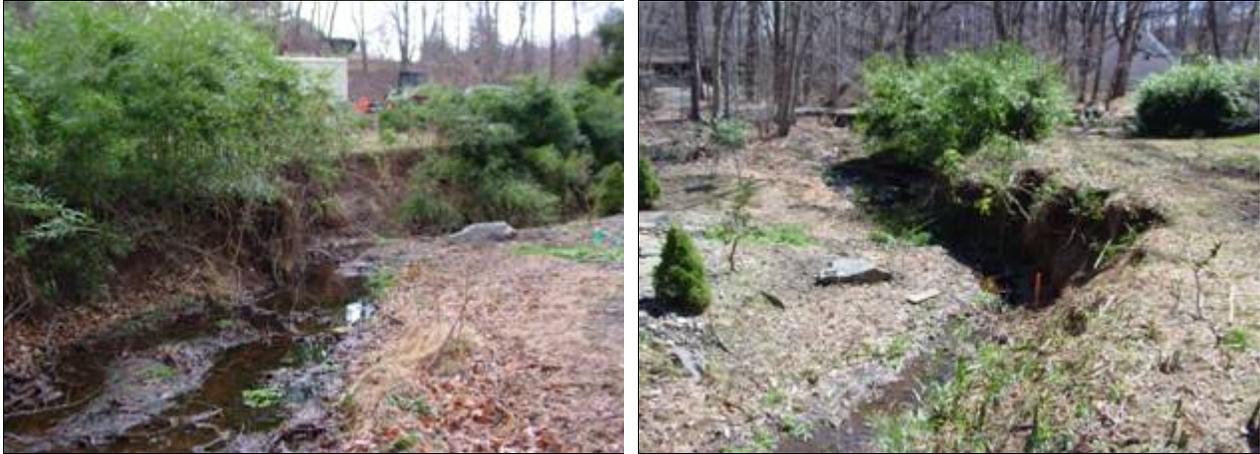
Figure 3.22. Hickory Spring road stream restoration project, pre-restoration.

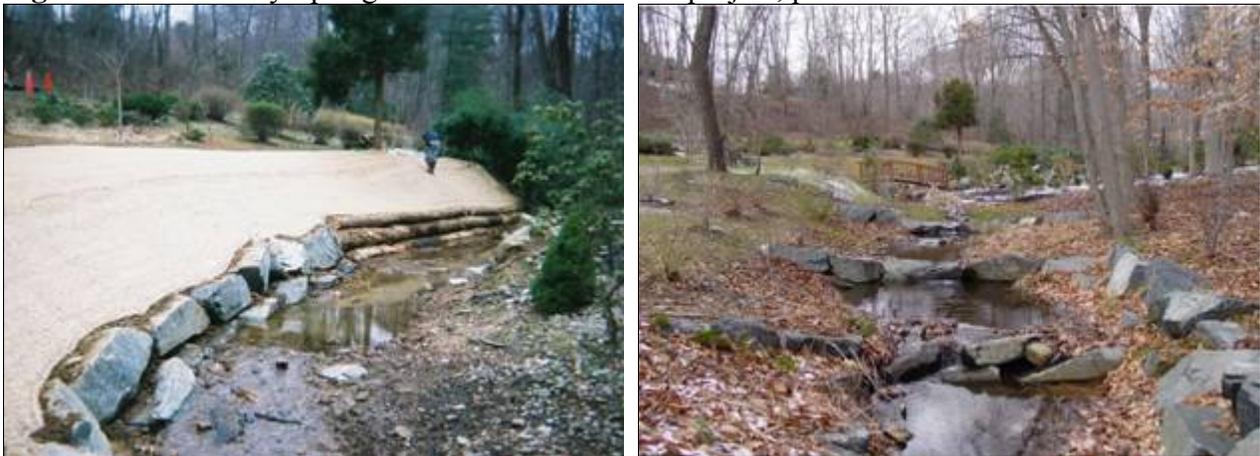
Figure 3.23. Hickory Spring road stream restoration project, post-restoration.

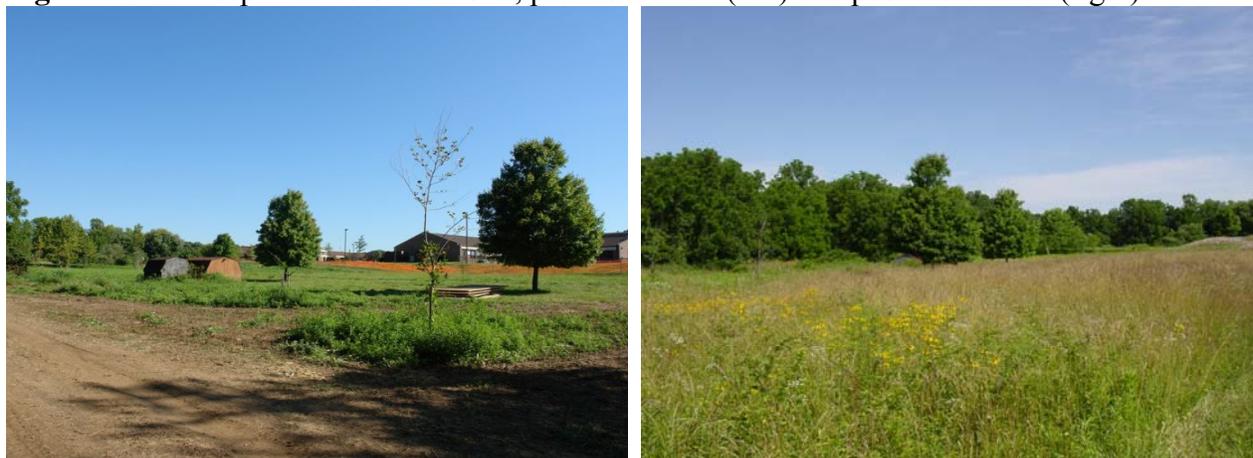
Figure 3.24. Independence School Site, pre-restoration (left) and post-restoration (right).

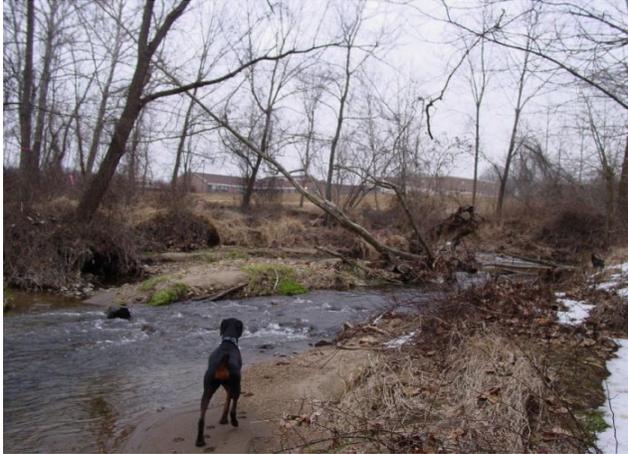
Figure 3.26. A degraded reach choked with debris blockage and sediment bars (before).

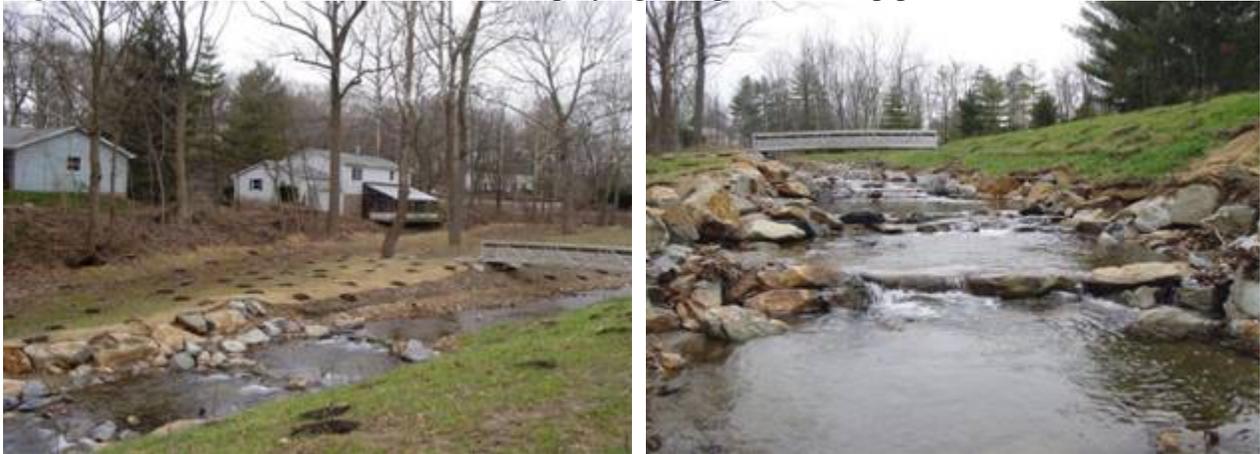
Figure 3.30. Relocated stream channel displaying a sequence of step pools.

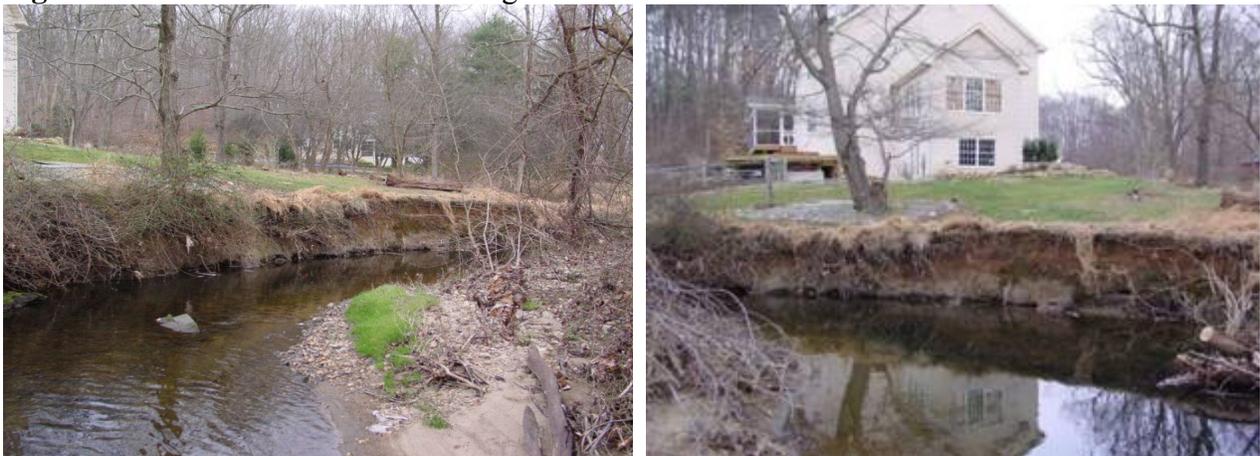
Figure 3.31. Severe bank erosion along Mill Creek at the Romanelli site.

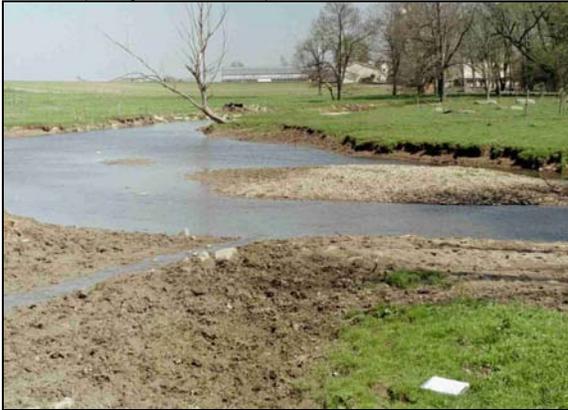
Figure 4.3. Lower Fisher farm pasture pre-BMP (May 18, 2004).

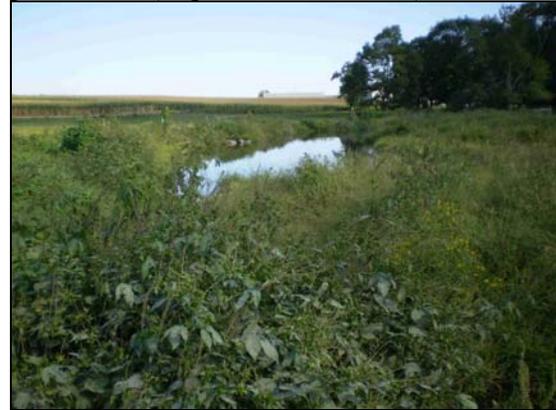
Figure 4.4. Lower Fisher farm pasture post-BMP (September 19, 2007).

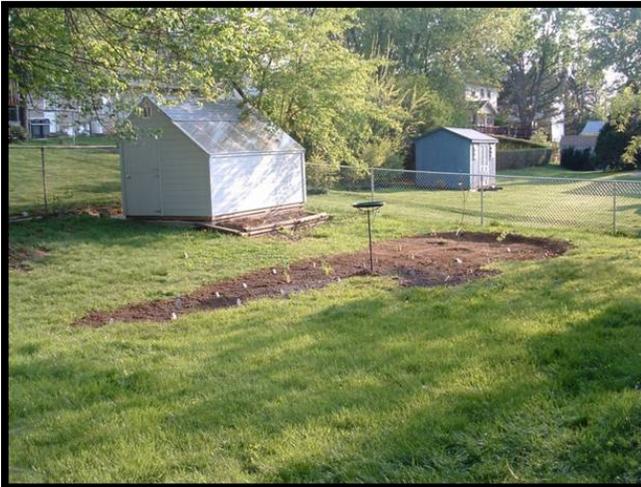
The Smartyard was strategically located to replace a portion of the lawn and to intercept the flow of water across the property, allowing it to percolate more slowly into the ground.

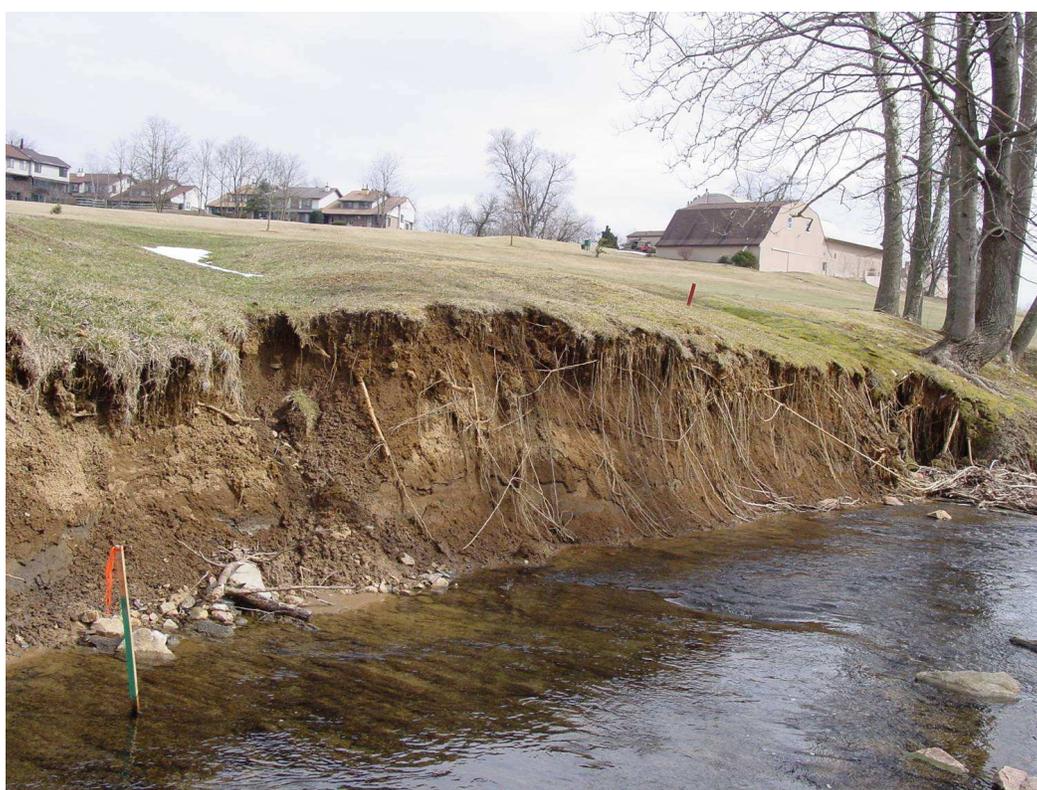
Figure 1. Pre-restoration photo: Severe bank erosion along the Pike Creek mainstem at the Three Little Bakers Golf Course (Source: DNREC 2002)

A Riparian Corridor Stream Inventory Study conducted by the DNREC's Whole Basin Piedmont Team in 1998-99 and a Christina River Watershed Restoration Study conducted in 1999 identified the upper Pike Creek as a segment in need of restoration. The stream was shown to have significant bank erosion that contributed to heavy sediment loads and degraded aquatic habitat. Deep entrenchment with nearly vertical eroding banks (Figs. 1 and 2) was evident in several segments and numerous mid-channel bars had formed from the heavy sedimentation (DNREC 1999).

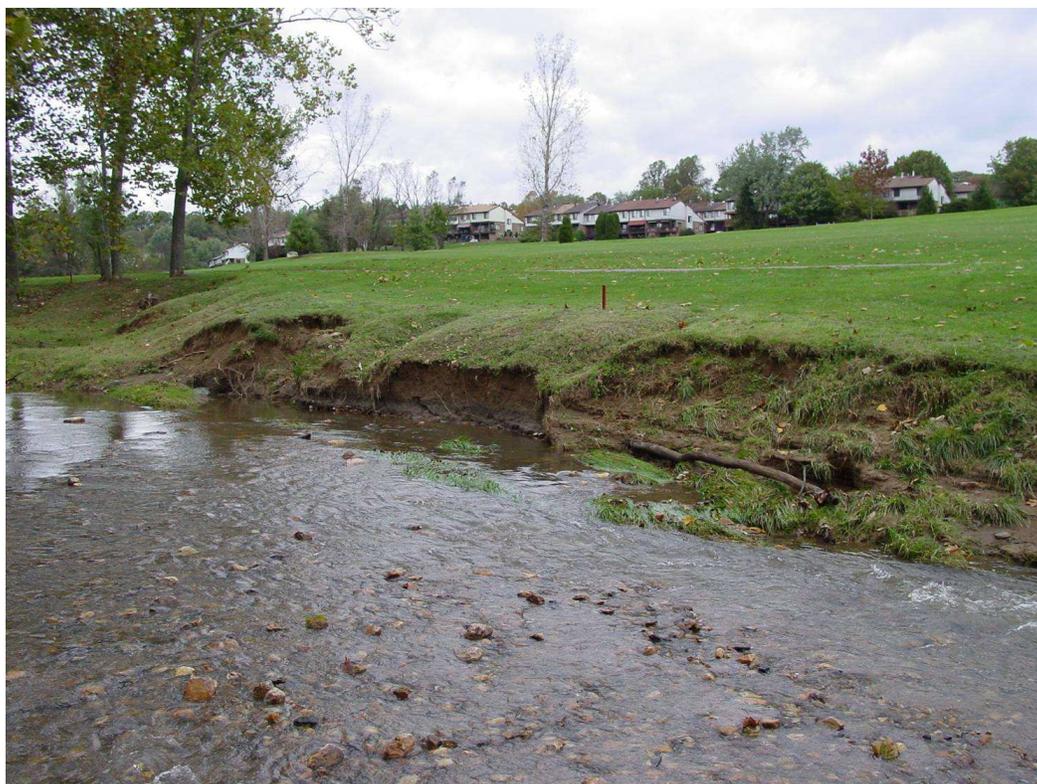
Figure 2. Pre-restoration photo: Bank erosion and slumping along Pike Creek at the Three Little Bakers Golf Course (Source: DNREC 2002).

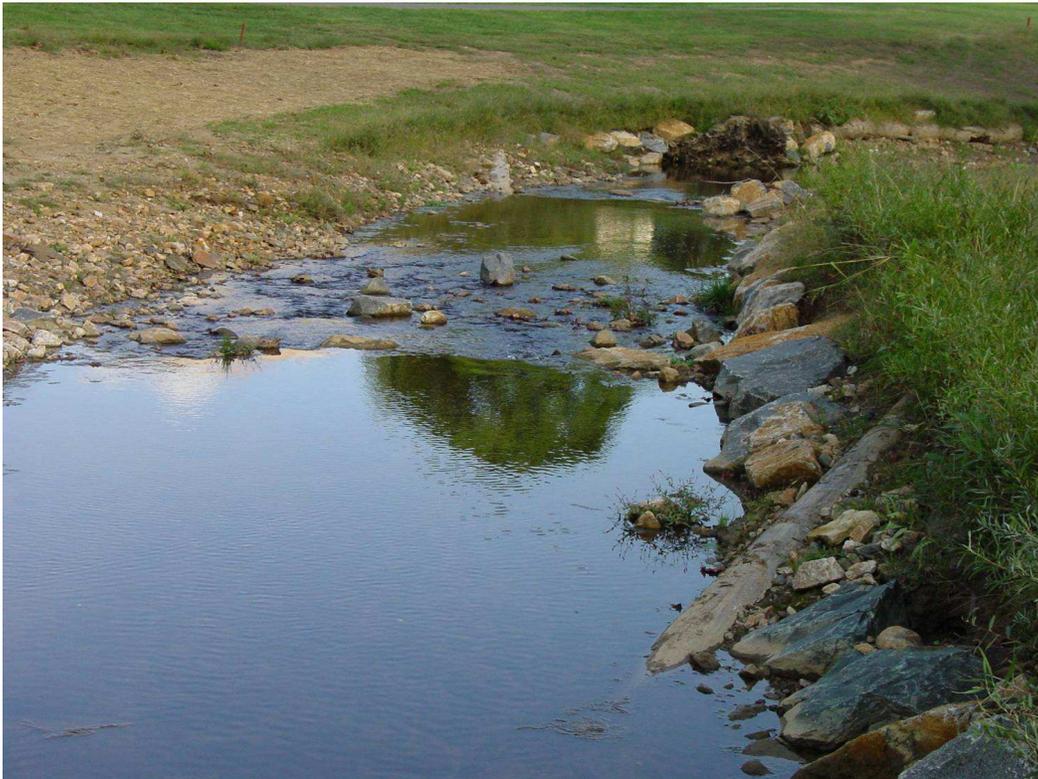
Figure 3. Post-restoration photo: Log vane (lower right corner) installed for hydrologic directional control and bank stabilization (Source: DNREC 2005).

DNREC implemented the Pike Creek restoration project at Three Little Bakers Golf Course in 2002. This phase of restoration was completed in the summer of 2005 (Table 1). The goal of this project was to stabilize 5000 linear feet of stream channel using natural channel design geomorphologic techniques (DNREC 1999, Rosgen 1996). These techniques attempt to return a stream or stream reach to morphological equilibrium by reducing bank erosion and restoring sediment transport and turbidity levels to those that would occur under stable stream conditions comparable to pre-urbanization conditions. Reduction in sediment loads to the stream will serve to reduce suspended solids in the stream, thereby improving water quality and aquatic habitat, and controlling aggradation and degradation. The project also attempted to stabilize the streambed and bank, by introducing rock, log and cross vanes, meandering bends, and creating riffle-pool sequences (Figs. 3 and 4). Streamside wetlands and riparian wetland and upland plantings (Figs. 5, 6 and 7) were also included to further stabilize the banks, improve and maintain water quality, provide shade, riparian habitat and organic matter for ecological processes.

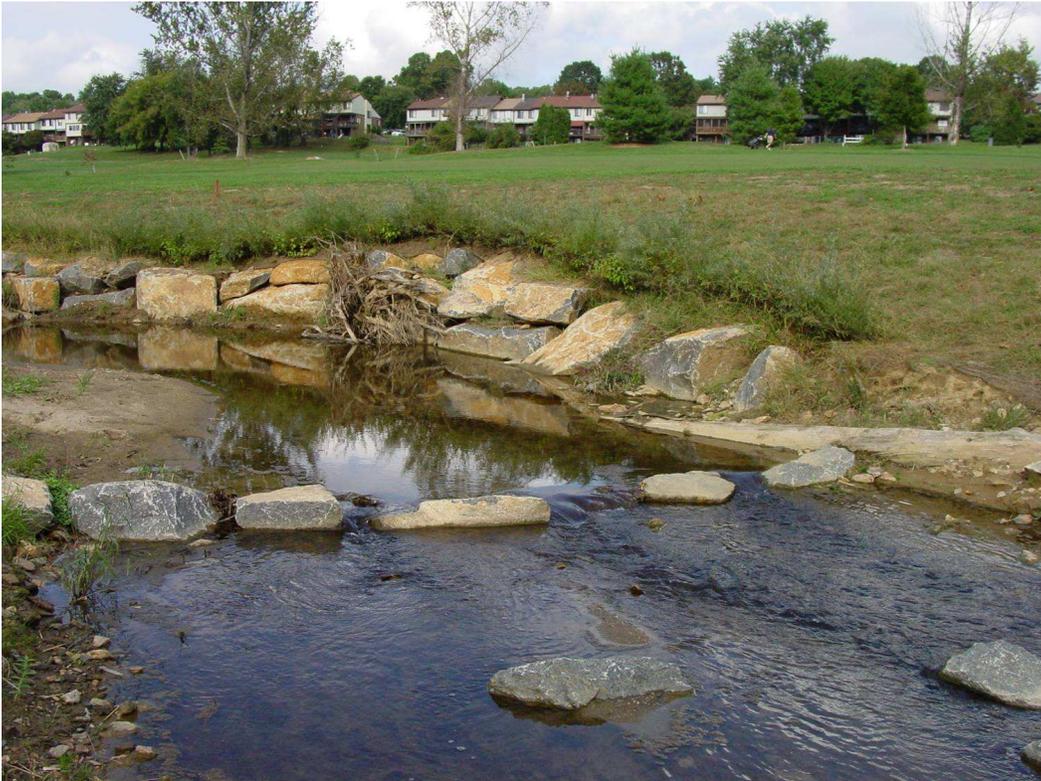
Figure 4. Post-restoration photo: Rock toe and vane, cross vane, and rootwad installed for bank stabilization, and hydrologic direction and grade control (Source: DNREC 2005).

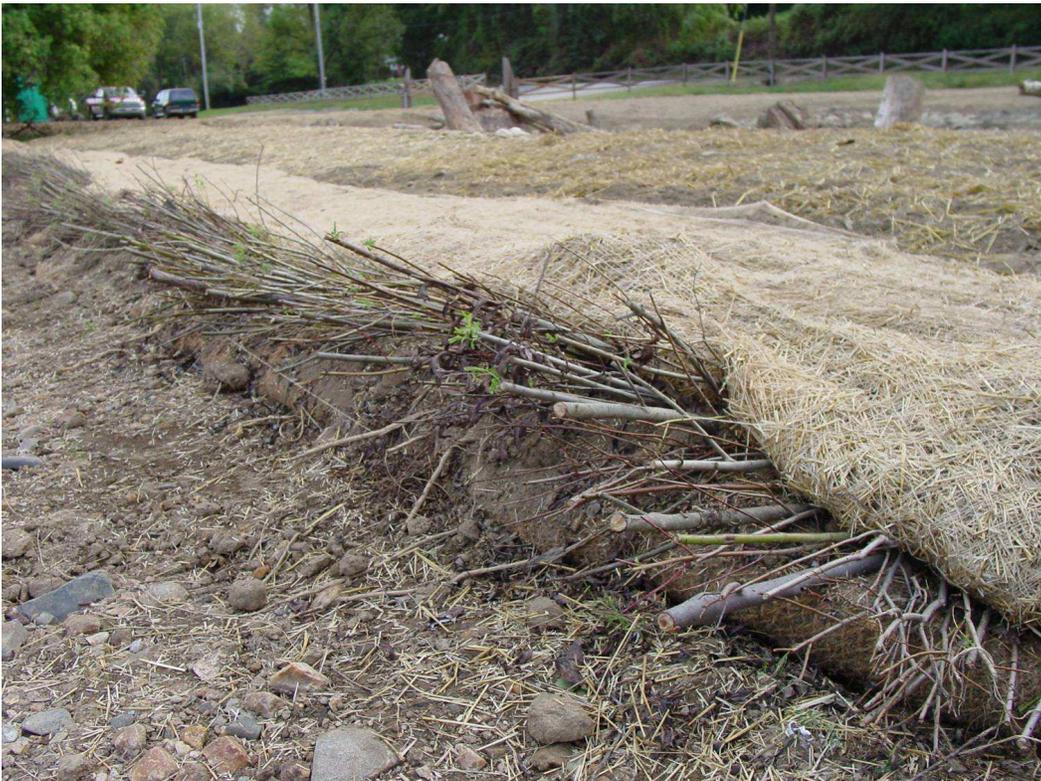
Figure 5. Post-restoration photo: Live riparian willow sprigs (*Salix sp.*) and coir matting installed for bank stabilization and to establish a riparian buffer (Source: DNREC 2005).

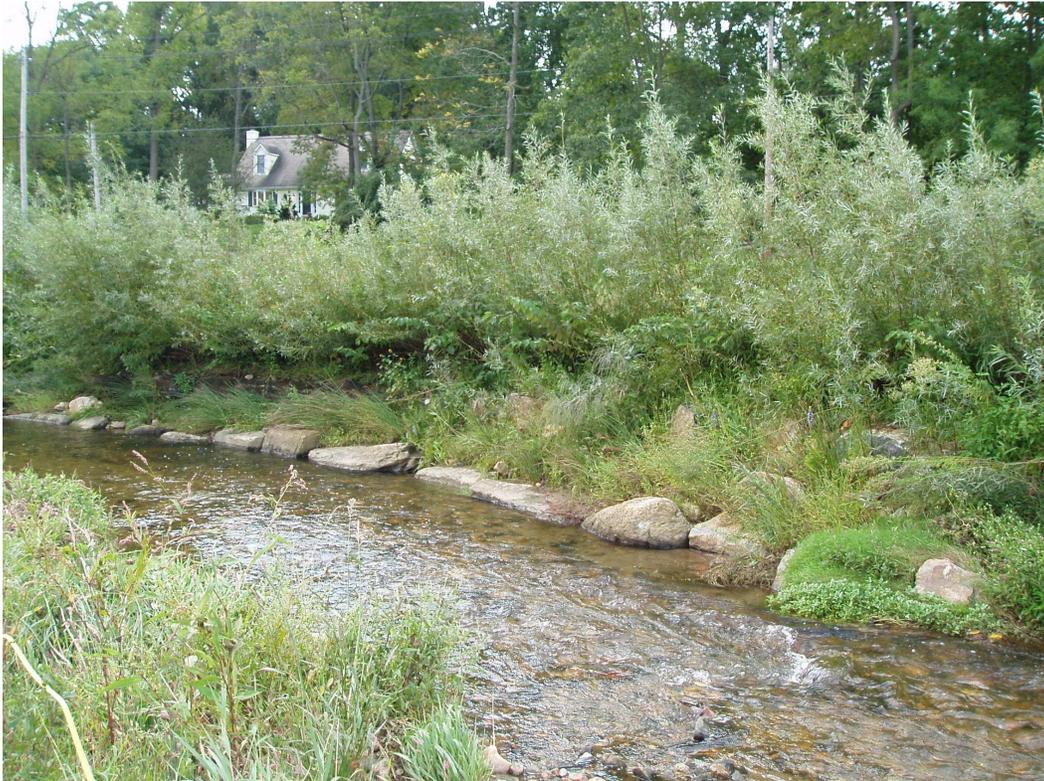
Figure 6. Post - restoration: Willow plantings one year post-restoration (same area pictured in Fig. 5 above)(Source: J. Meyer 2006).

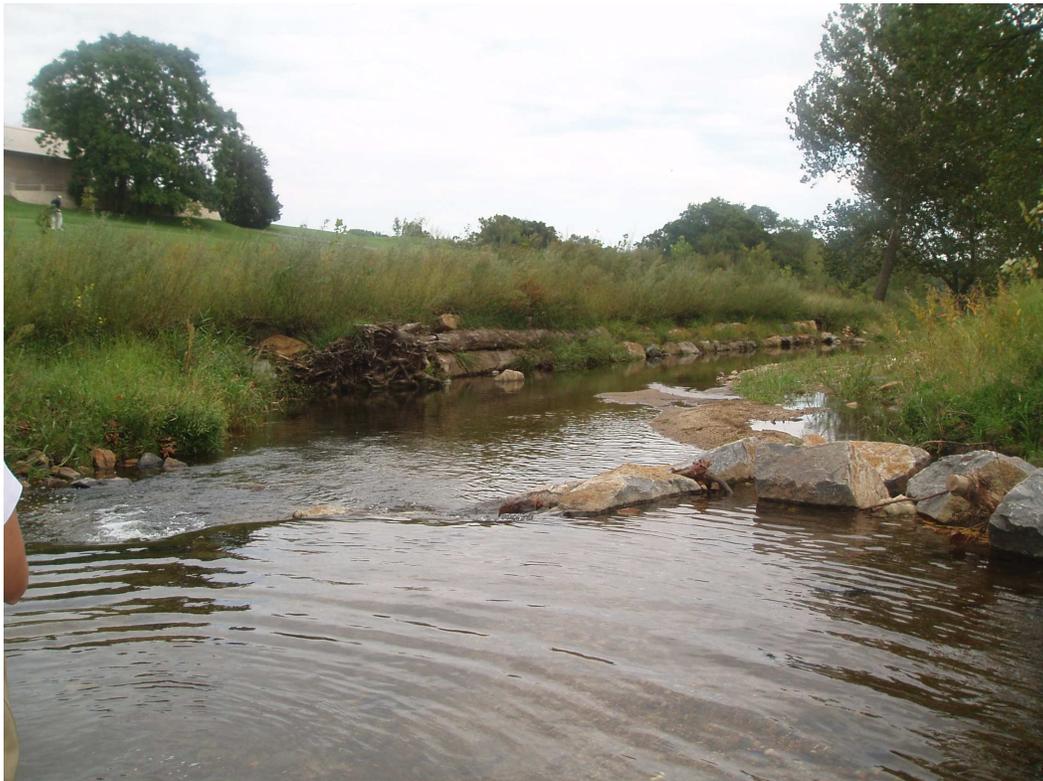
Figure 7. One year post-restoration at the Three Little Bakers Golf Course (same area depicted in Fig. 1). Log, rock and cross vanes, rootwads, and willow plantings were used to stabilize the bank, control the flow of water, and improve habitat (Source: J. Meyer 2006).

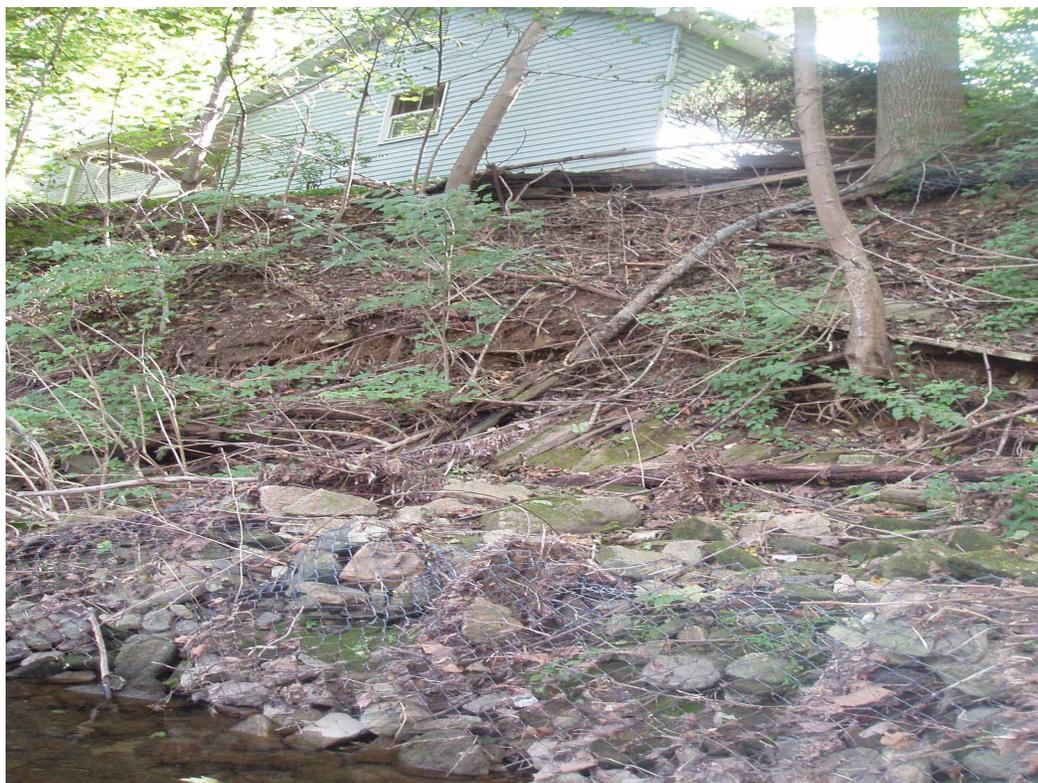
Figure 8. Pre-restoration photo: Bank erosion along the upstream, unrestored reach near the Independence School. Gabion baskets have been installed in and attempt to stabilize the banks (Source J. Meyer 2006).
