# Christina Basin

## Targeted Watershed Grant

### Final Report

# **Christina Basin Targeted Watershed Grant Final Report**

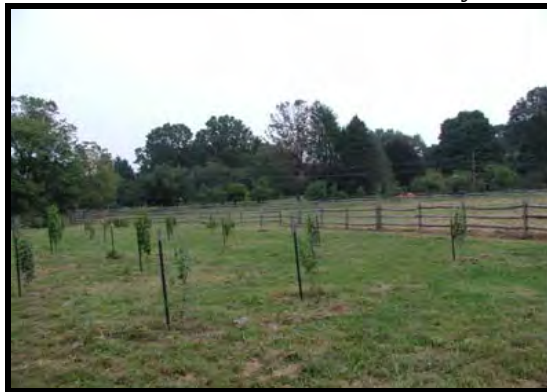
**Figure 3.3.** Floodplain forest restoration, confluence of Bucktoe and Red Clay Creeks (PA).

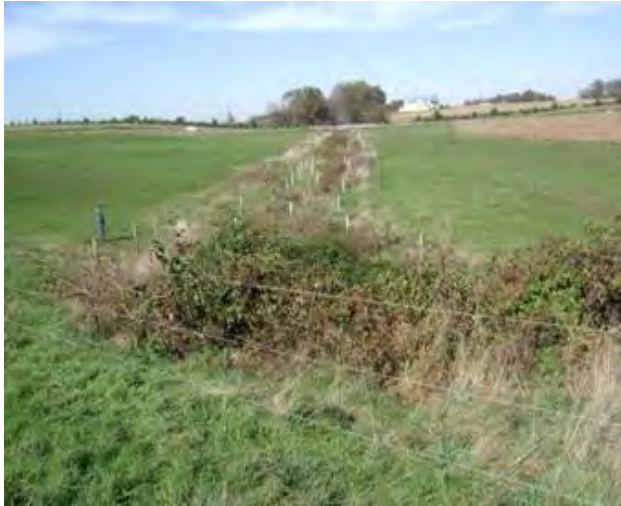
**Figure 3.8.** Stream bank fencing at Glenville Farms.

A total of 8,025 feet of stream fencing was installed on agricultural lands, almost three times the proposed 2,700 feet. The stream fencing installed will keep livestock out of the streams and therefore protect stream banks from erosion caused by animal access. The fencing will also establish buffer zones to filter pollution from stormwater runoff (Figures 3.8 and 3.9). The site locations and linear stream footage of stream fencing installed are listed below (Table 3.10).

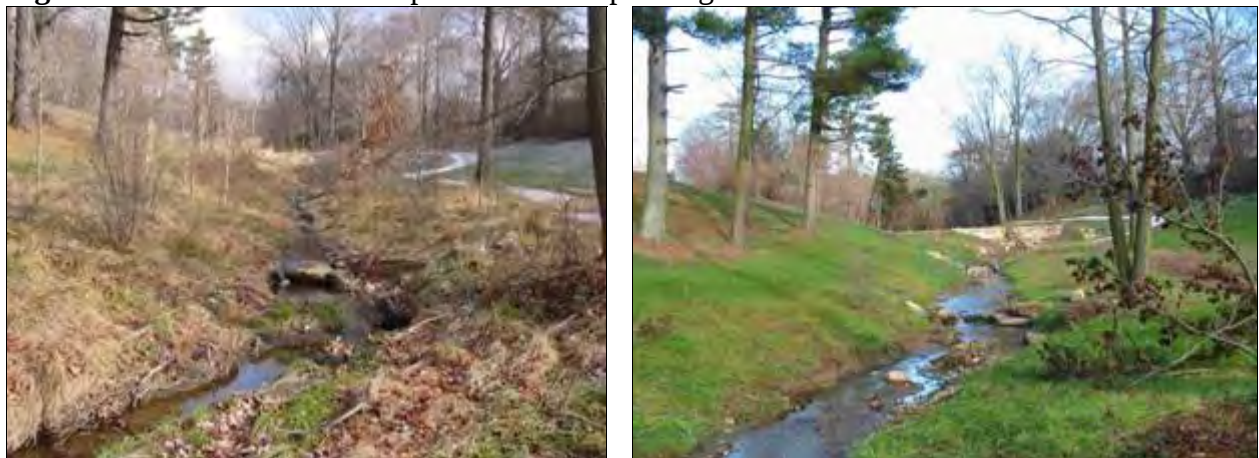
**Figure 3.13.** Sanford School riparian corridor planting.

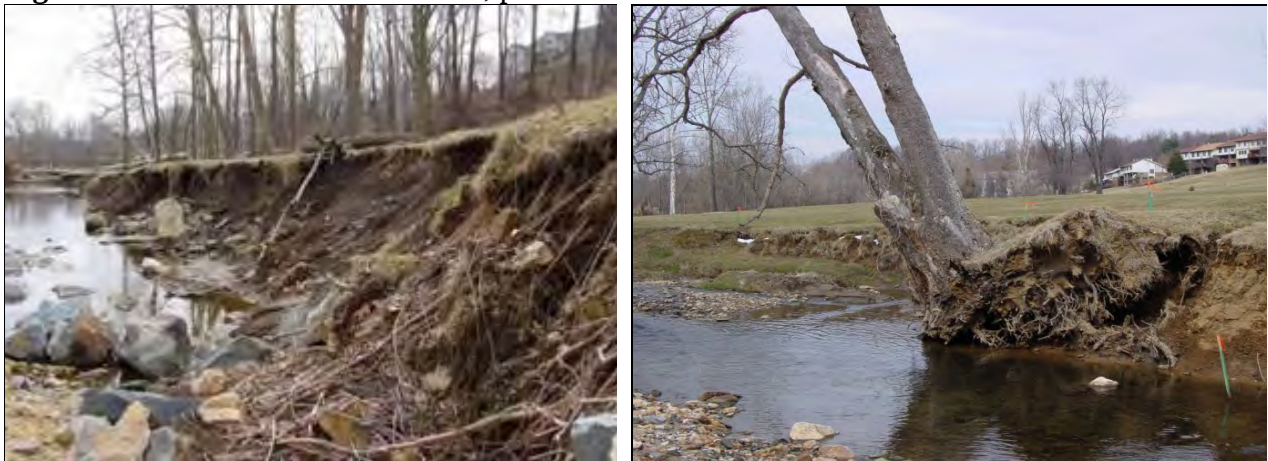
**Figure 3.15.** Three Little Bakers site, pre-restoration.

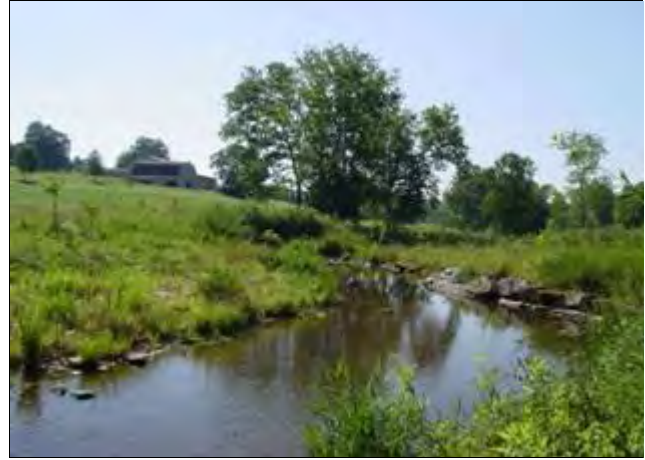
**Figure 3.19.** Three Little Bakers site, post-construction with stabilized stream banks.

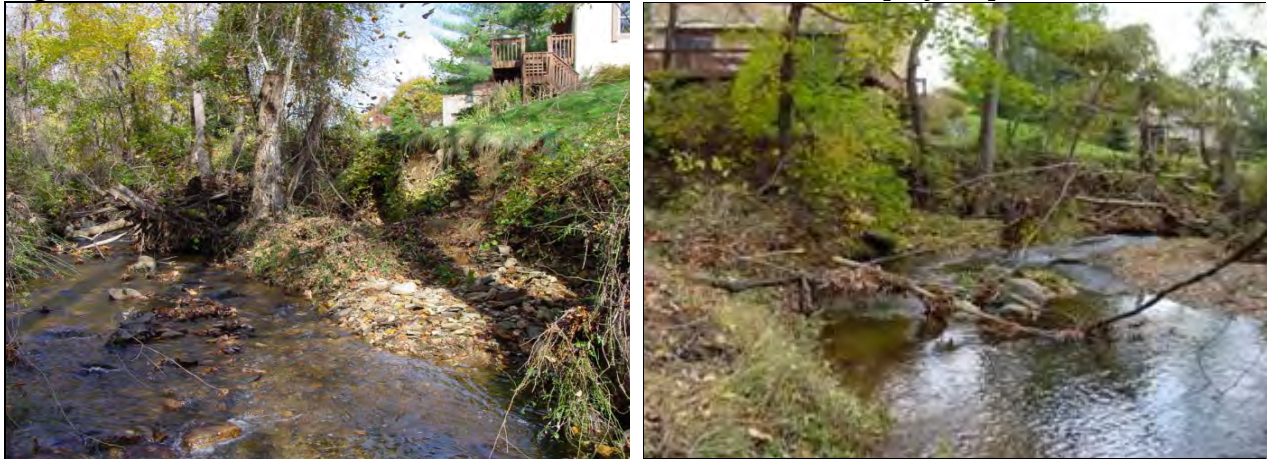
**Figure 3.20.** Meadowdale stream restoration and bank stabilization project, pre-restoration.

The Meadowdale stream restoration project, located along upper Pike Creek, was accomplished through a cooperative effort with the Meadowdale Civic Association. The Meadowdale development has an asphalt walking path that follows Pike Creek. Severe bank undercutting along the toe of the stream caused a portion of the stream bank to collapse. This bank failure destroyed a portion of the walking path. In addition to the unstable banks, the stream was blocked with several large trees that had fallen into the stream (Figure 3.20).

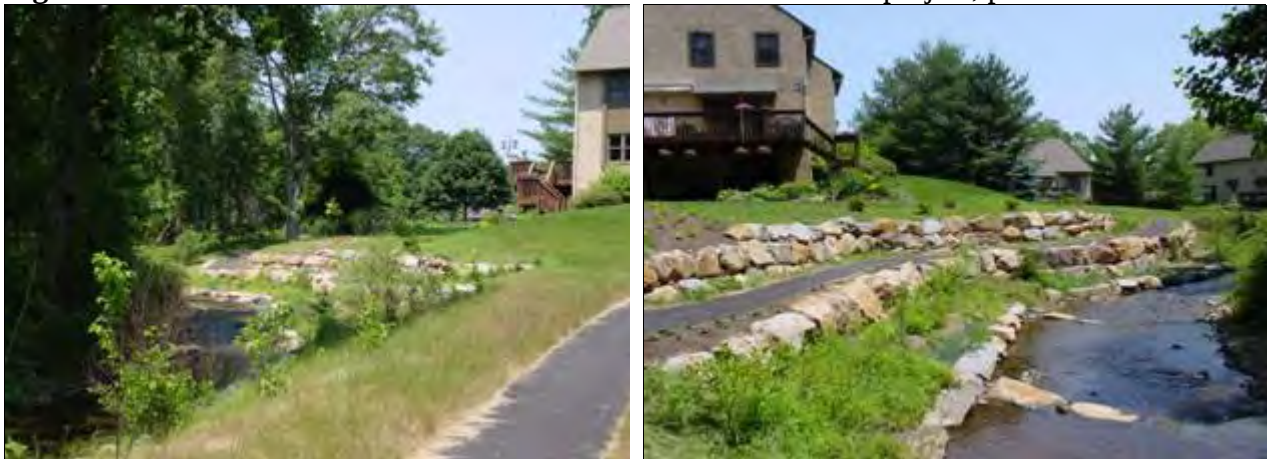
**Figure 3.21.** Meadowdale stream restoration and bank stabilization project, post-restoration.

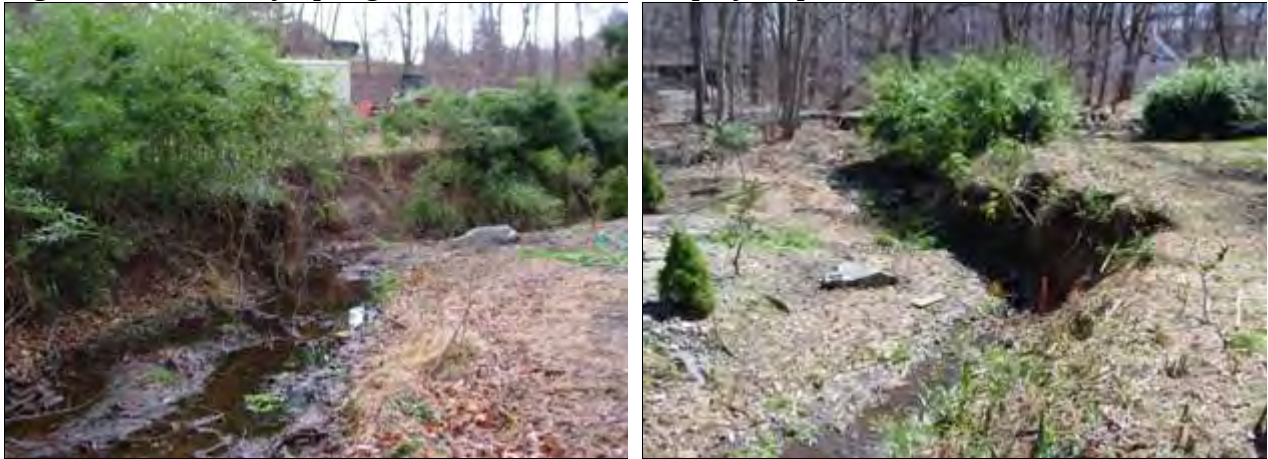
**Figure 3.22.** Hickory Spring road stream restoration project, pre-restoration.

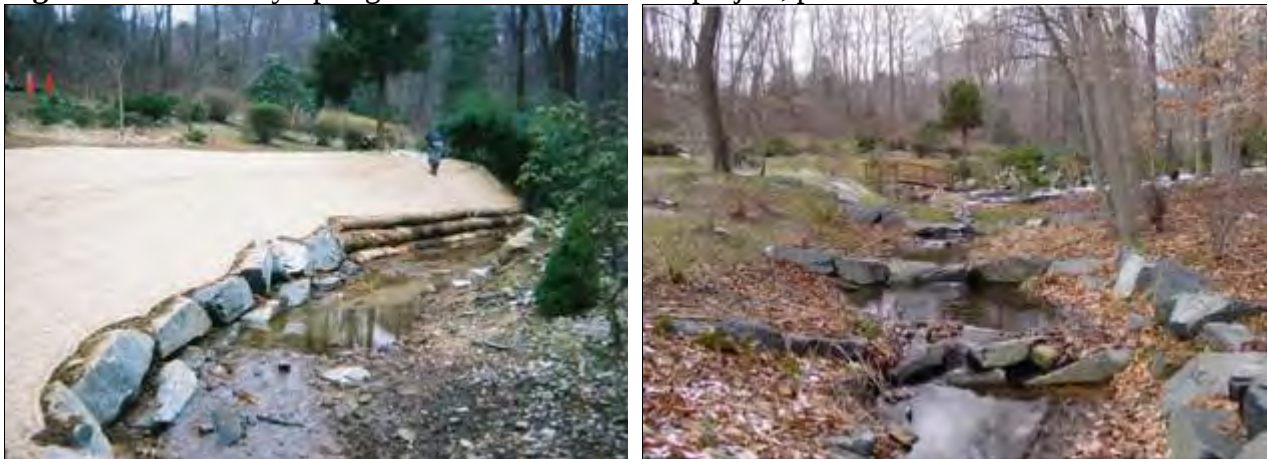
**Figure 3.23.** Hickory Spring road stream restoration project, post-restoration.

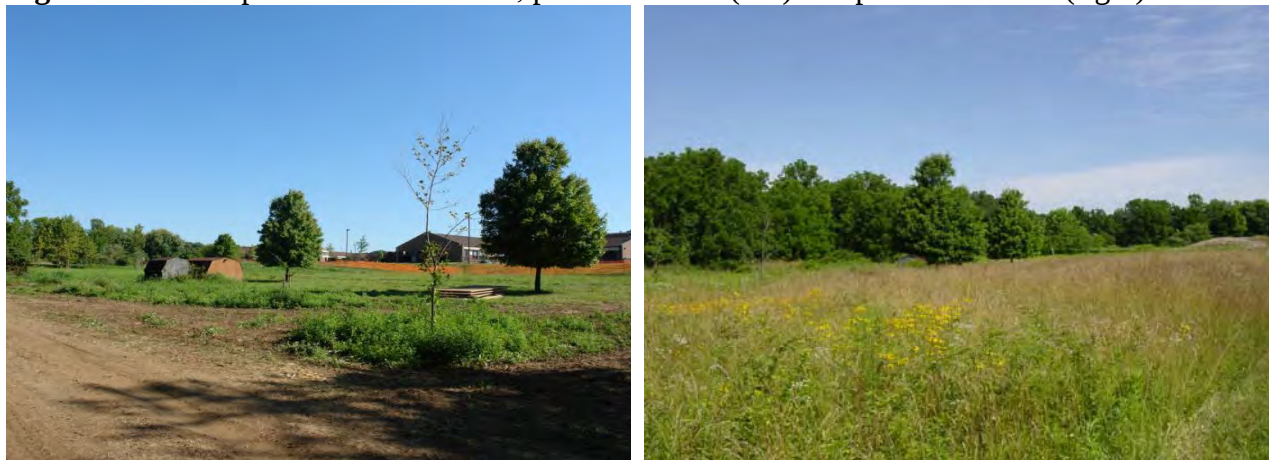
**Figure 3.24.** Independence School Site, pre-restoration (left) and post-restoration (right).

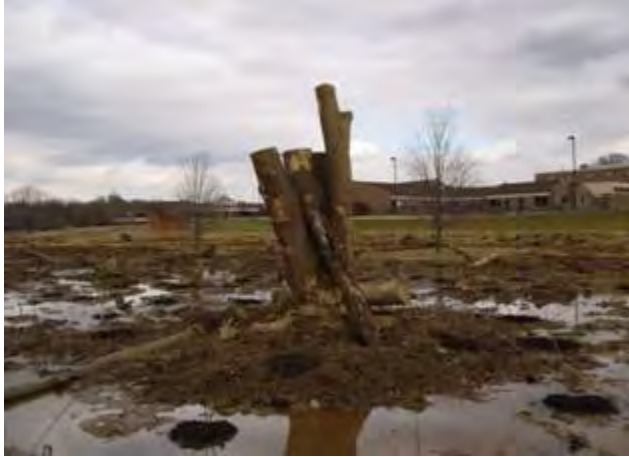
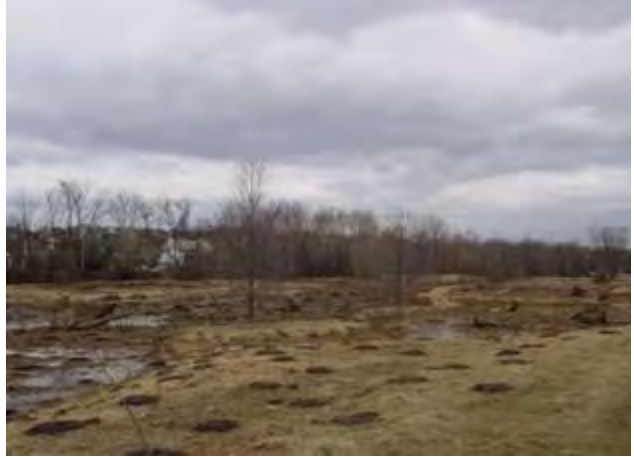
**Figure 3.25.** Independence School Site, during restoration.

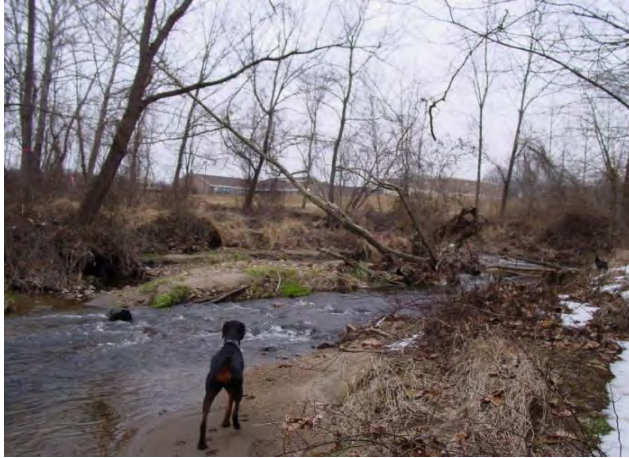
**Figure 3.26.** A degraded reach choked with debris blockage and sediment bars (before).

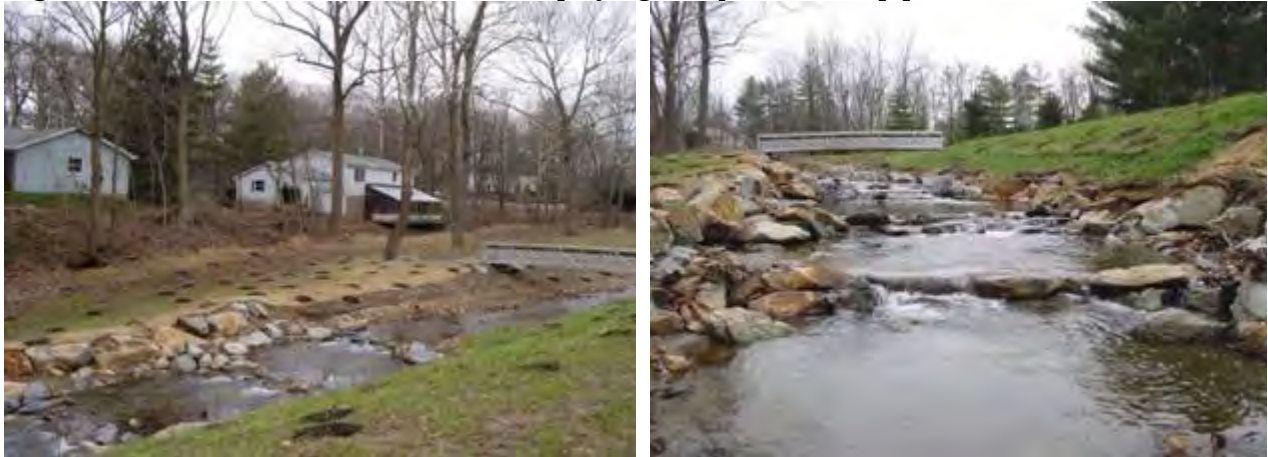
**Figure 3.30.** Relocated stream channel displaying a sequence of step pools.

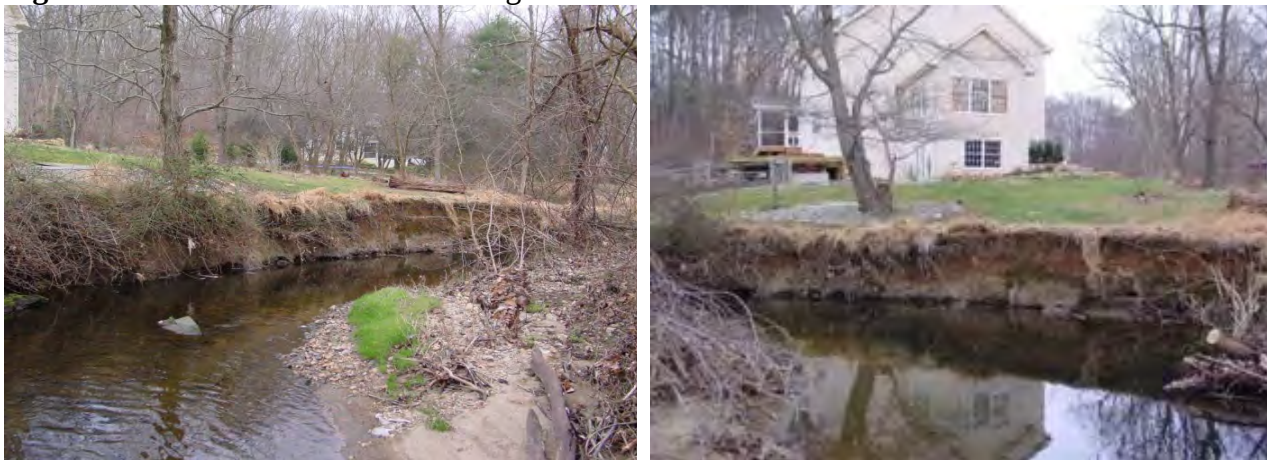
**Figure 3.31.** Severe bank erosion along Mill Creek at the Romanelli site.

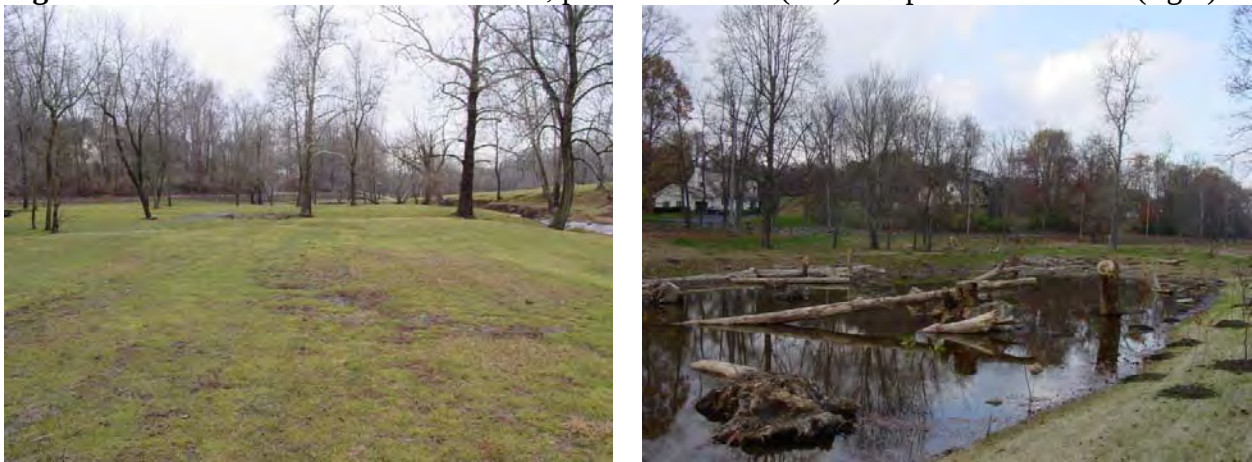
**Figure 3.32.** Pike Creek created wetlands, pre-construction (left) and post-construction (right).

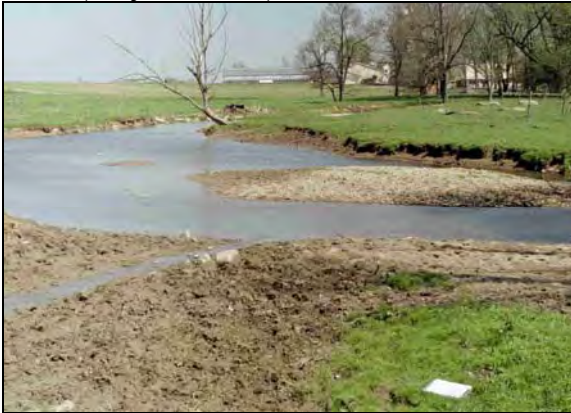
**Figure 4.3.** Lower Fisher farm pasture pre-BMP (May 18, 2004).

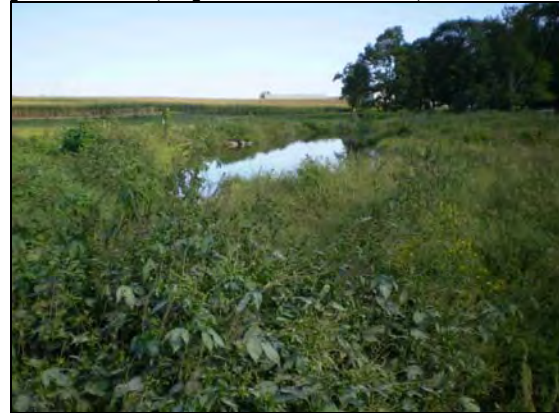
**Figure 4.4.** Lower Fisher farm pasture post-BMP (September 19, 2007).

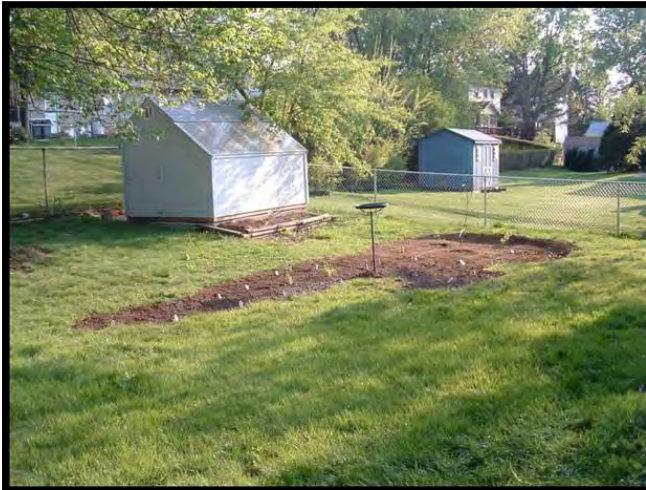
The Smartyard was strategically located to replace a portion of the lawn and to intercept the flow of water across the property, allowing it to percolate more slowly into the ground.

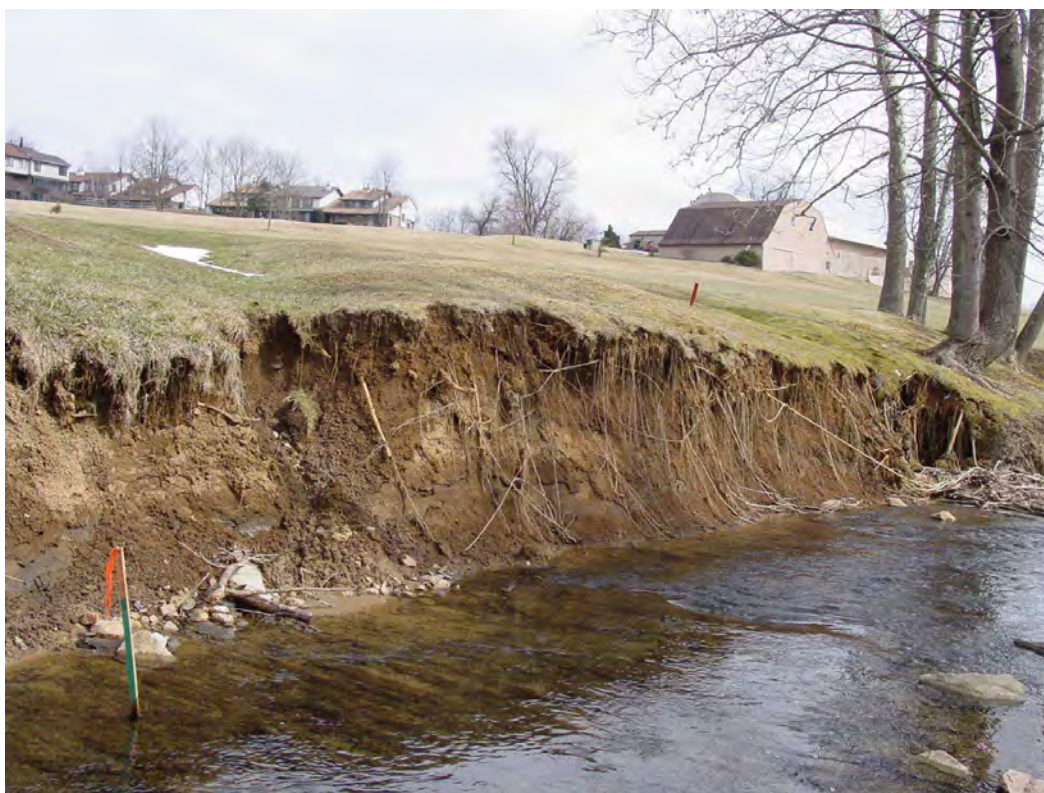
**Figure 1. Pre-restoration photo: Severe bank erosion along the Pike Creek mainstem at the Three Little Bakers Golf Course (Source: DNREC 2002)**

A Riparian Corridor Stream Inventory Study conducted by the DNREC's Whole Basin Piedmont Team in 1998-99 and a Christina River Watershed Restoration Study conducted in 1999 identified the upper Pike Creek as a segment in need of restoration. The stream was shown to have significant bank erosion that contributed to heavy sediment loads and degraded aquatic habitat. Deep entrenchment with nearly vertical eroding banks (Figs. 1 and 2) was evident in several segments and numerous mid-channel bars had formed from the heavy sedimentation (DNREC 1999).

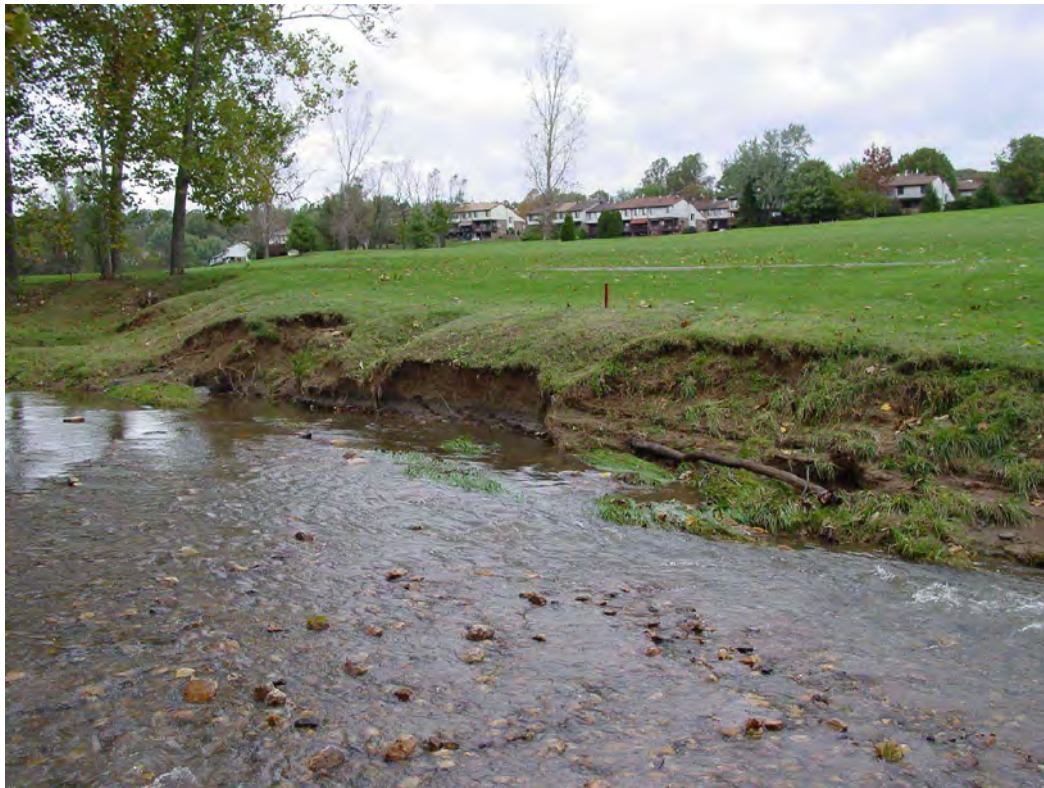
**Figure 2. Pre-restoration photo: Bank erosion and slumping along Pike Creek at the Three Little Bakers Golf Course (Source: DNREC 2002).**

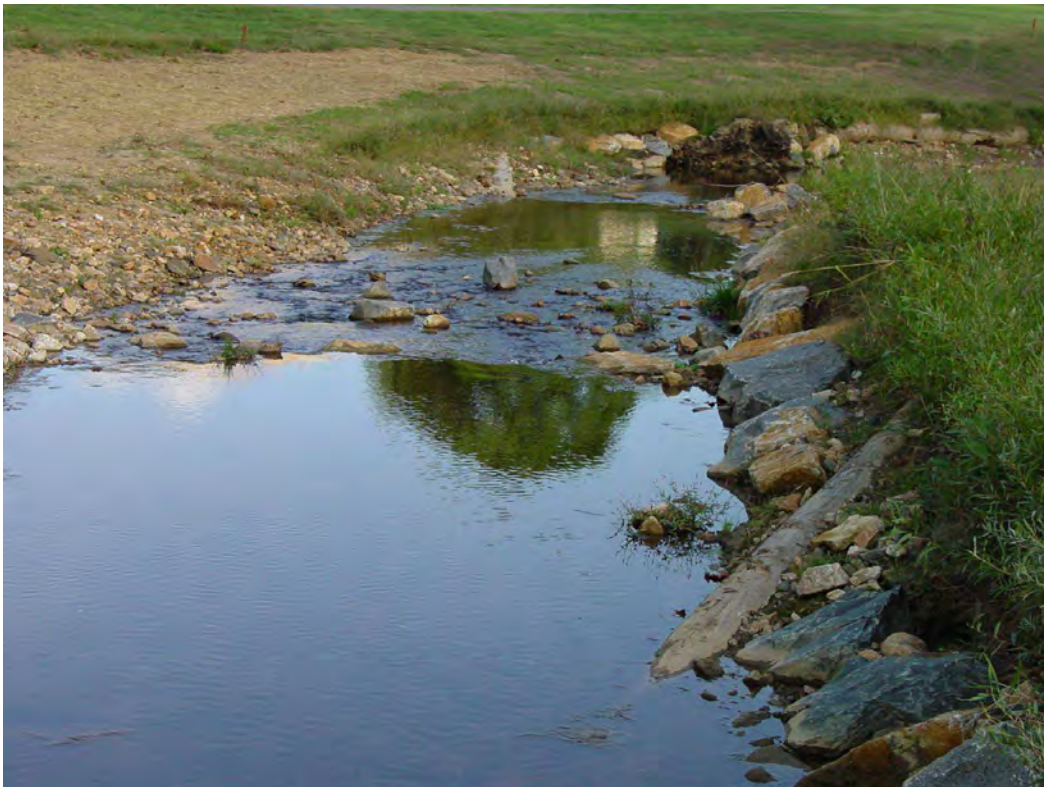
**Figure 3. Post-restoration photo: Log vane (lower right corner) installed for hydrologic directional control and bank stabilization (Source: DNREC 2005).**

DNREC implemented the Pike Creek restoration project at Three Little Bakers Golf Course in 2002. This phase of restoration was completed in the summer of 2005 (Table 1). The goal of this project was to stabilize 5000 linear feet of stream channel using natural channel design geomorphologic techniques (DNREC 1999, Rosgen 1996). These techniques attempt to return a stream or stream reach to morphological equilibrium by reducing bank erosion and restoring sediment transport and turbidity levels to those that would occur under stable stream conditions comparable to pre-urbanization conditions. Reduction in sediment loads to the stream will serve to reduce suspended solids in the stream, thereby improving water quality and aquatic habitat, and controlling aggradation and degradation. The project also attempted to stabilize the streambed and bank, by introducing rock, log and cross vanes, meandering bends, and creating riffle-pool sequences (Figs. 3 and 4). Streamside wetlands and riparian wetland and upland plantings (Figs. 5, 6 and 7) were also included to further stabilize the banks, improve and maintain water quality, provide shade, riparian habitat and organic matter for ecological processes.

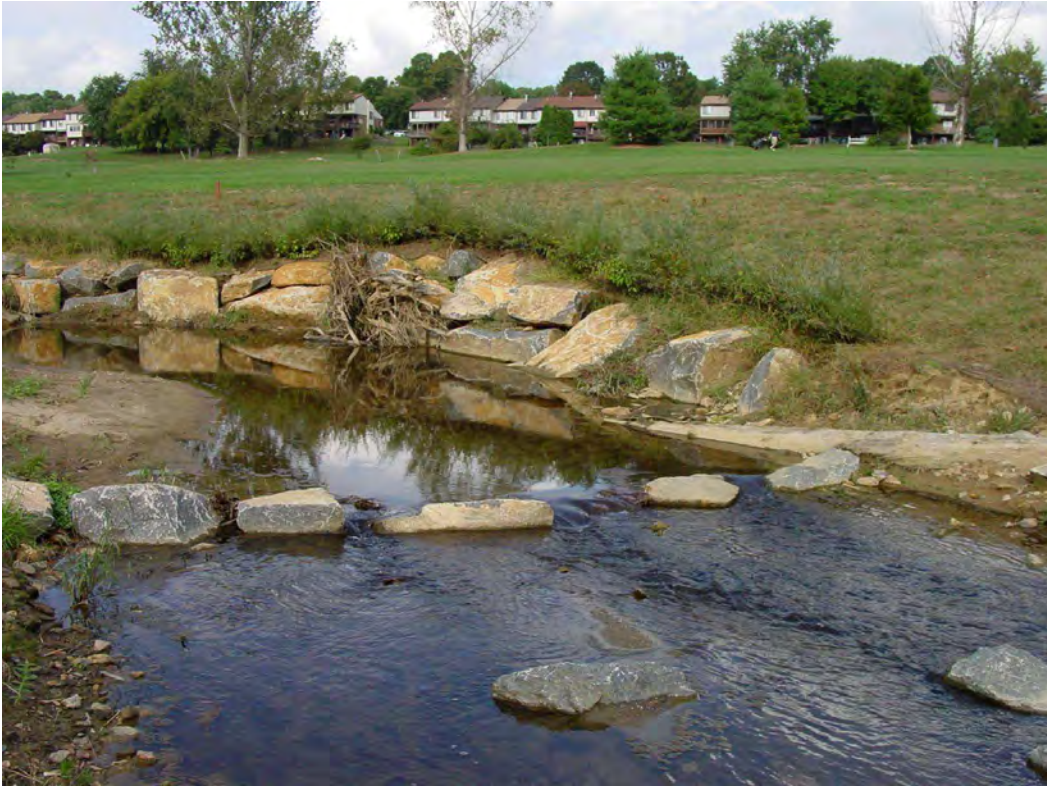
Figure 4. Post-restoration photo: Rock toe and vane, cross vane, and rootwad installed for bank stabilization, and hydrologic direction and grade control (Source: DNREC 2005).

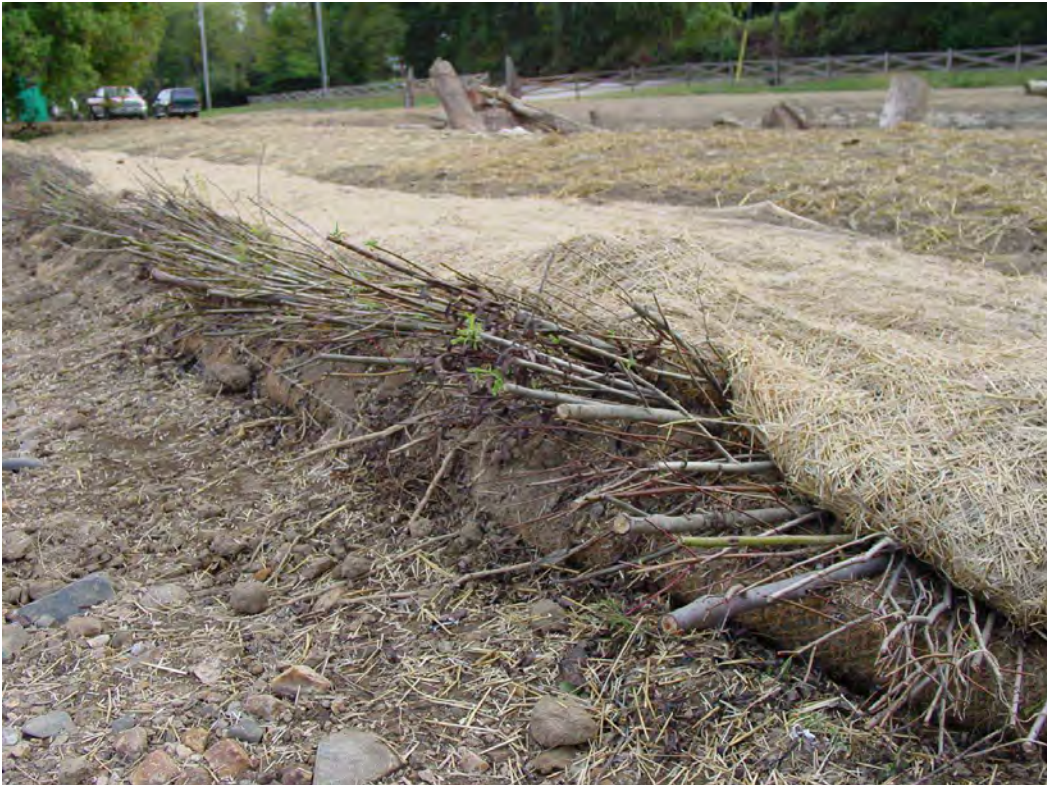
Figure 5. Post-restoration photo: Live riparian willow sprigs (*Salix sp.*) and coir matting installed for bank stabilization and to establish a riparian buffer (Source: DNREC 2005).

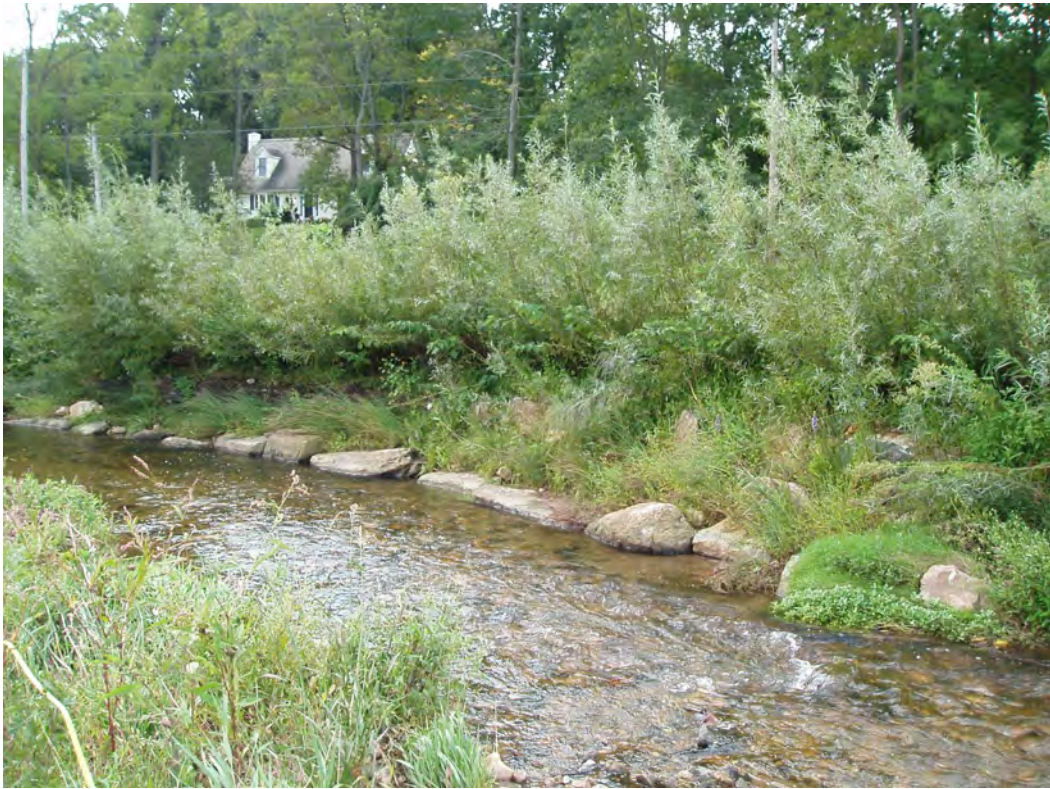
Figure 6. Post - restoration: Willow plantings one year post-restoration (same area pictured in Fig. 5 above)(Source: J. Meyer 2006).

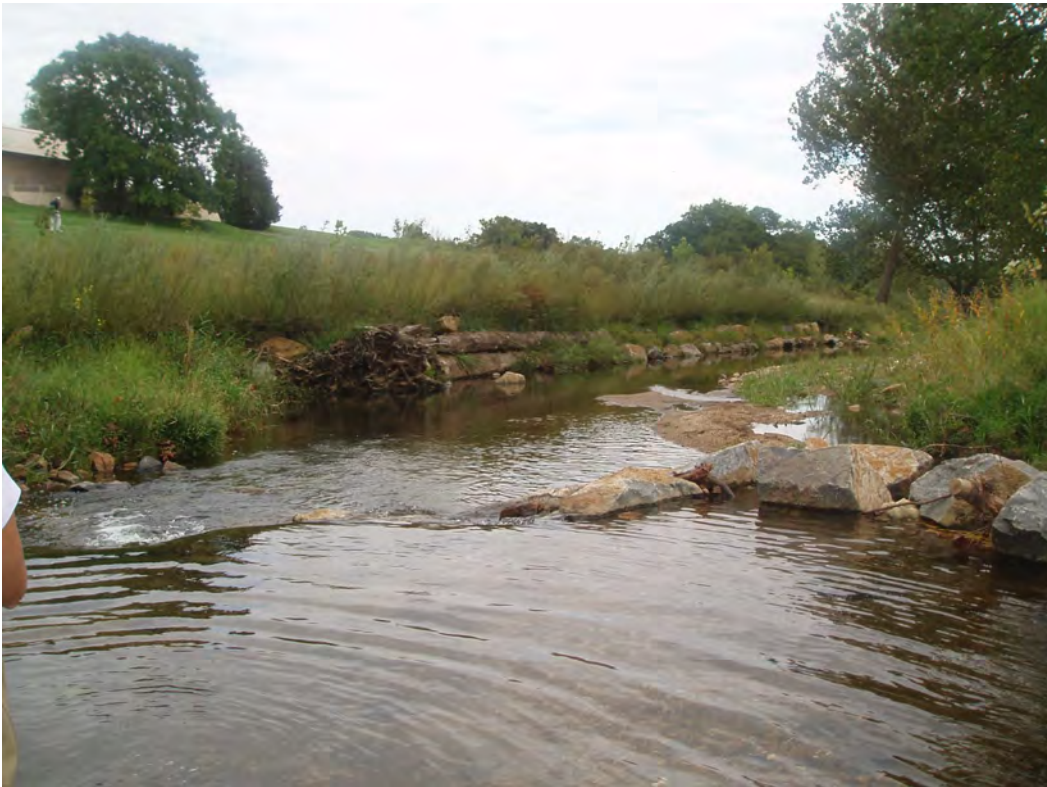
Figure 7. One year post-restoration at the Three Little Bakers Golf Course (same area depicted in Fig. 1). Log, rock and cross vanes, rootwads, and willow plantings were used to stabilize the bank, control the flow of water, and improve habitat (Source: J. Meyer 2006).

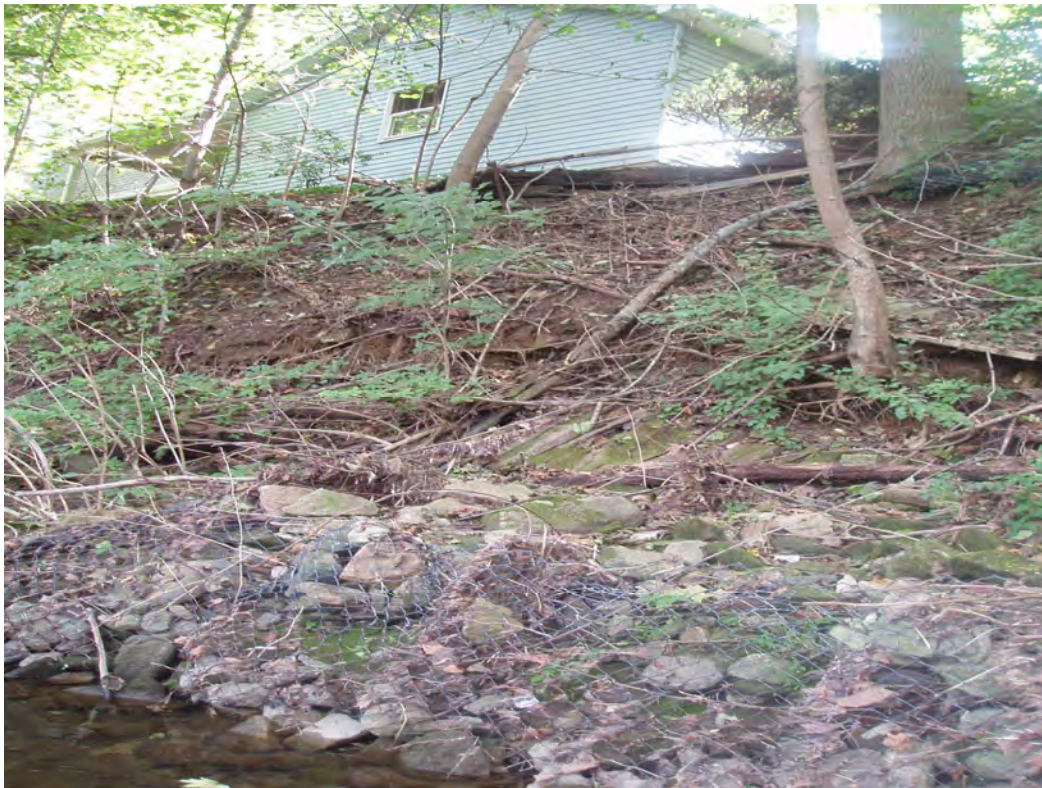
**Figure 8. Pre-restoration photo: Bank erosion along the upstream, unrestored reach near the Independence School. Gabion baskets have been installed by homeowners in an attempt to stabilize the banks (Source J. Meyer 2006).**
