Back River Action Group

BRAG About It

Back River Action Group (BRAG) About It

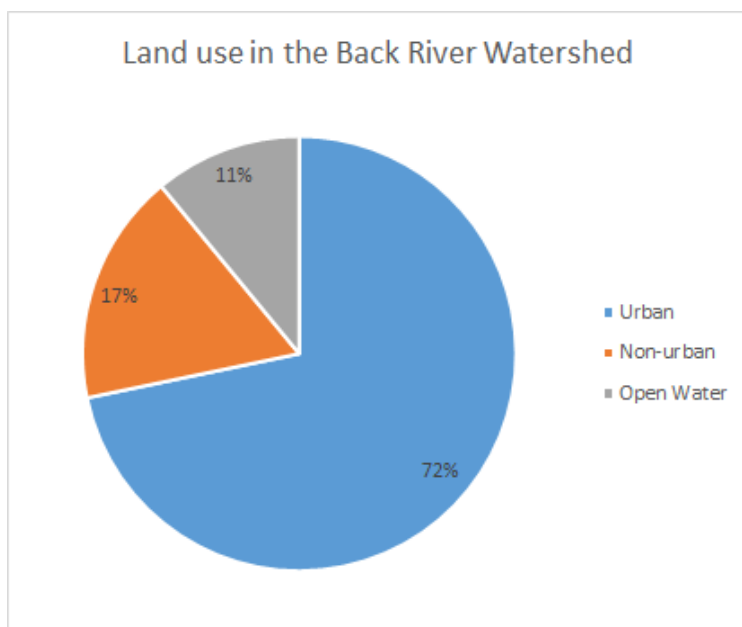
Figure 2. Land Use in the Back River Watershed graph

“The dominant land uses in the watershed are urban (28,037 acres or 71.7%) and non-urban which is comprised of mixed agriculture and forest and other herbaceous (6,753 acres or 17.7%) and open water (4,295 acres or 11%) (United States EPA Region 3 Office of Standards, Assessment And TMDL's, 2005).
