# SiDE

## Silver Brook Daylighting Efforts

Sara Albrecht  
Ally Adams  
Gemma Antoniewicz  
Norma Brasure

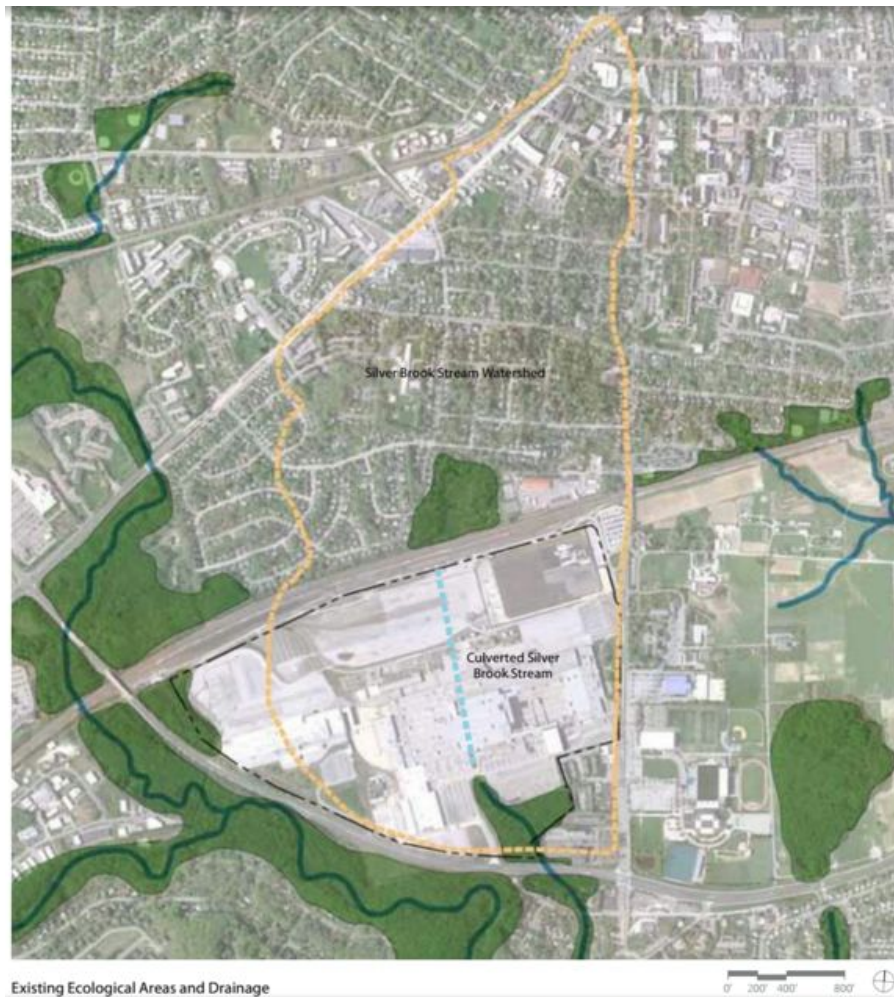
Figure 1. Silver Brook Watershed and Culvert

This proposal focuses on an underground segment of Silver Brook. The site in need of restoration was the location of a Chrysler Plant from 1951 to 2008. When the Chrysler plant was built, Silver Brook was relocated underground in an 84” culvert. In 2009, the University of Delaware purchased the site and began redeveloping it as the Science and Technology Campus (STAR Campus). The portion of STAR that was formerly the Chrysler plant is currently owned by 1743 Holdings LLC, a wholly-owned subsidiary of the University of Delaware. The Silver Brook drains areas of the University’s main campus, the STAR Campus, residential neighborhoods, and over 100 acres of industrial impervious surfaces from the former Chrysler plant site. Figure 1 shows the Silver Brook Watershed and underground Silver Brook culvert.

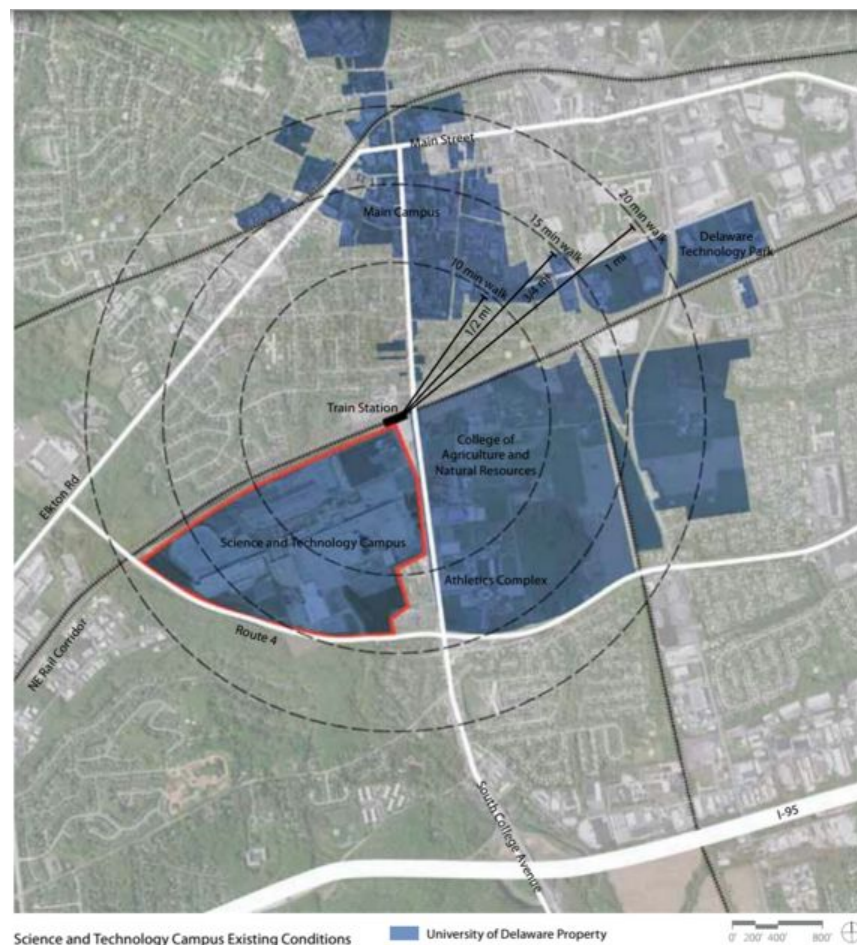
Figure 2. Location of the Silver Brook Restoration Site

The Silver Brook currently runs underneath the STAR campus in an underground culvert. The stream enters the culvert on the north side of the railway and continues south toward Route 4, where it is resurfaces. STAR campus is directly to the west of the University of Delaware College of Agriculture and Natural Resources. The site is bounded to the north by the Norfolk Southern and Amtrak train lines, to the east by South College Avenue and the south by Route 4. The western end of the site is a point where Route 4 and the train lines come together. Figure 2 shows the location of the Silver Brook in relation to University of Delaware campuses.

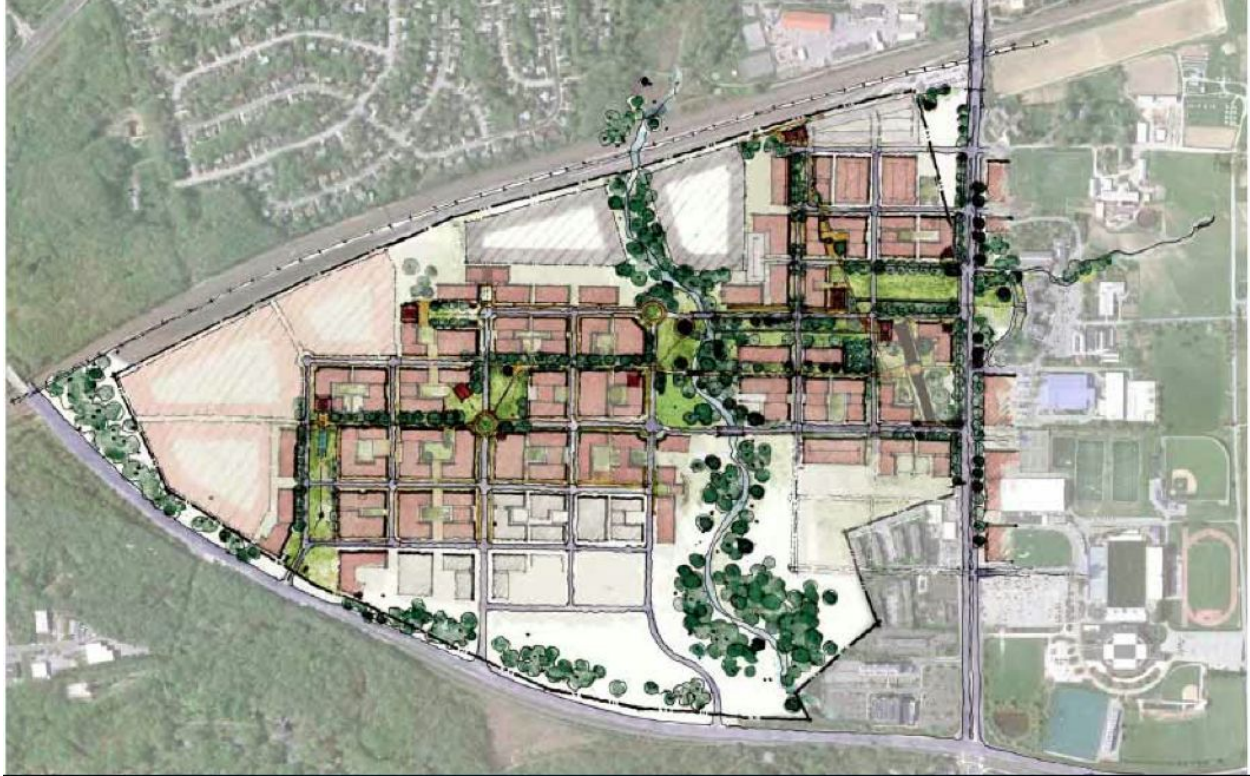
Figure 3. Proposal of Green Space

If the pipe is removed to daylight the Silver Brook, there will be runoff that was diverted by the pipe. Also, the likelihood of contamination getting into the Christiana River is increased by the amount of impervious surfaces for Silver Brook watershed, nearing 40% coverage. Impervious cover contributes to flash floods during storms, and decreases infiltration to recharge groundwater. This environmental problem can be solved by adding more green space such as a Riparian buffer consisting of native plant species, which slow erosion and support local wildlife. STAR campus can turn areas that were pavement into green space to decrease runoff. For example, a stormwater strategy could be to add green corridors that are greenways that combine pedestrian and bicycle pathways. A solution to removing the pipe could be to create a new stormwater plan to deal with the extra runoff.
