Guánica Bay/Rio Loco Agenda to Neutralize Detrimental Inputs (GRAND)

By: Justin Leary, Rebecca Schurr, Polly Ni, and Luke Stirparo

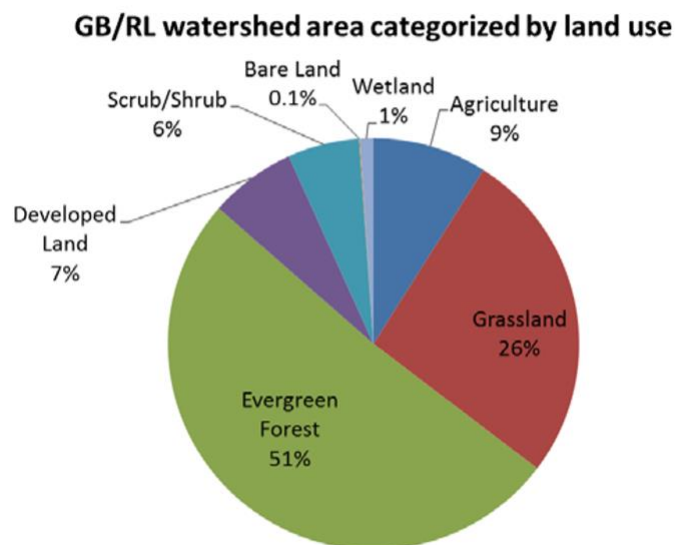
Once re-founded, Guánica first became a part of the municipality of Yauco until March 13, 1914 when it was established as a separate municipality. Located near the town of Guánica is a body of water known as Guánica Bay. Guánica Bay, located in the southwestern corner of Puerto Rico, approximately 20 miles west of the city of Ponce and 100 miles southwest of San Juan, is the discharge site of the Guánica Bay/Rio Loco (GB/RL) watershed (Rodriguez). The GB/RL watershed differs from typical island land use due to its extensive mountainous forest cover in the north and the extensive Guánica Dry Forest in the southeast portion of the watershed. The current land use in GB/RL watershed specifically (based on natural hydrology) is 48% forested, 43% agriculture (Lajas Valley) and 9% urban (Yauco) (CWP). The watershed is approximately 151 square miles due to human alteration.

One major form of human alteration was done in an effort to increase the drainage area of the watershed (Rodriguez). This alteration was done by a series of inter basin or inter-watershed water transfers, five reservoirs and two hydroelectric plants. In addition to an increase in drainage area, another hope for the alteration was to increase and regulate potable water from the high elevation watersheds of the central cordillera (mountain region) for use by the local populations in Yauco, Guánica, and the Lajas Valley for irrigation of crops and flood control. Guánica Bay only receives water directly from the Rio Loco (“Crazy River”), but the actual total drainage area encompasses much more. Included in the total drainage area are the five smaller basins and associated reservoirs: Yahuecas Lake, Guayo Lake, Prieto Lake, Lucchetti Dam, and Loco Dam. Guánica Bay is essentially drained by both the Rio Loco, which receives flow from the four reservoirs north and upstream of it, as well as by historic Guánica lagoon.

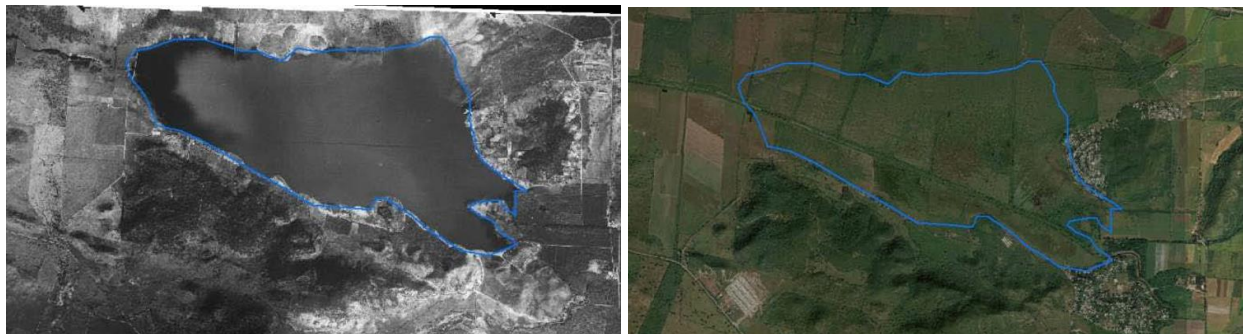
The ditching and draining of Guánica Lagoon, a large historical lagoon and adjacent wetland system, in the 1950s had a profound effect on the filtering capacity in the watershed because the lagoon acted as a huge sponge and filter before Rio Loco passed into the Guánica Bay. In the photos below, the picture on the left represents the lagoon before the draining and the photo on the right shows the area where the lagoon once was as outlined by the blue line.

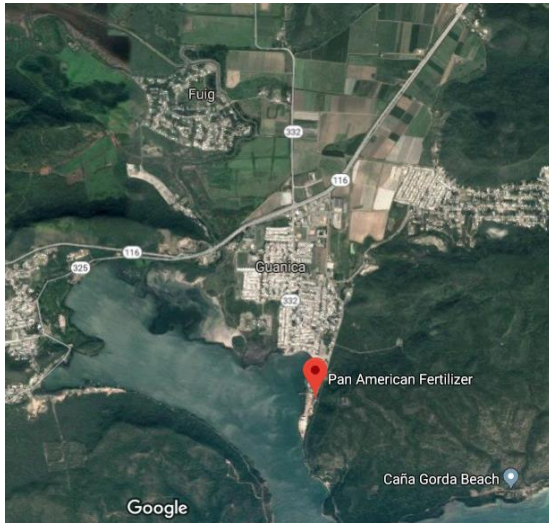
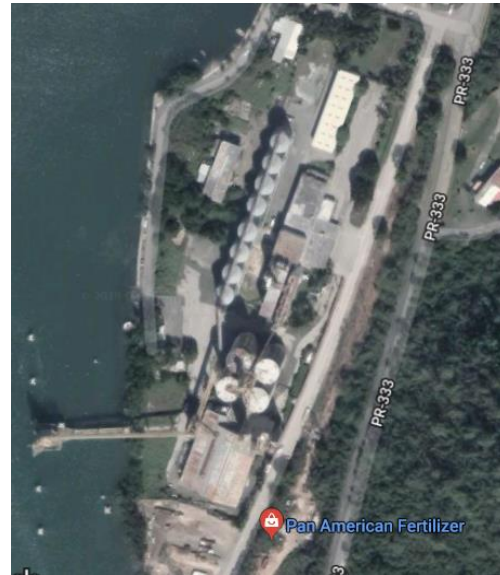
Sources of nitrogen in Guanica Bay stem from nearby farms where cattle are raised for meat and dairy, and where rice is grown on a large scale. The rice industry accounts for a large portion of fertilizer use, while cattle production yields natural fertilizer (manure) which also contaminates the watershed (Rios, “Lajas Valley...”). Guanica Bay has a local fertilizer plant located right on the bay, shown below. The image on the left shows the plant located south of local farms, and the image of the right is a close up.
