Plan to Aid Turtle Creek's Health (PATCH)

By: Lindsay Johston, Zach Burcham, and Aidan Kedzierski

The goal of PATCH is to reduce flooding conditions and to reach state standard concentrations in the Turtle Creek Watershed in Southwestern Pennsylvania by the year 2040.

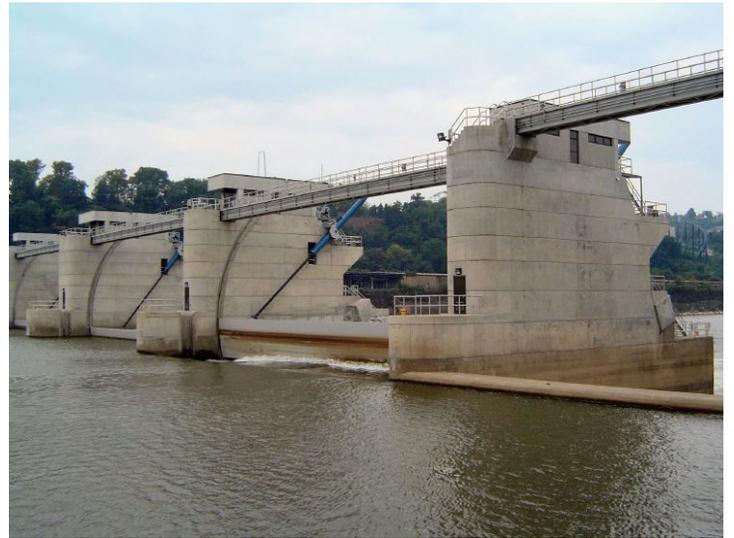
Lock and Dam No. 2 is located shortly downstream of the mouth of Turtle Creek in the Monongahela River. The dam was constructed in 1902 by the US Army Corps of Engineers in order to control the flow of the Monongahela River and make it more navigable for boats. Lock and Dam No. 2 is one of nine navigational structures built in the Monongahela River from its starting point in West Virginia until its confluence with the Allegheny in downtown Pittsburgh. The dam operates by holding back a certain height of river water and allowing any excess to continue flowing downstream. As the dam disrupts normal river flow, it poses a great concern during heavy rainfall events. When there is an excess of river water, it cannot flow quickly downstream and causes a backup to occur at the mouth of the Turtle Creek. This backup has created flooding concerns in and around the areas of the Lower Turtle Creek
