FY19-20 DWRC Undergraduate/Graduate Water Research Students

Optimization of Hydrogen Peroxide Analysis to Quantify Enzyme Activity within Bioreactors

Discriminating between Mill Dam and Flood Deposits
along the White Clay Creek
Research Advisor: James Pizzuto
Research Student: Zhendong Ji

Wilson Run Watershed Field Surveying at Winterthur

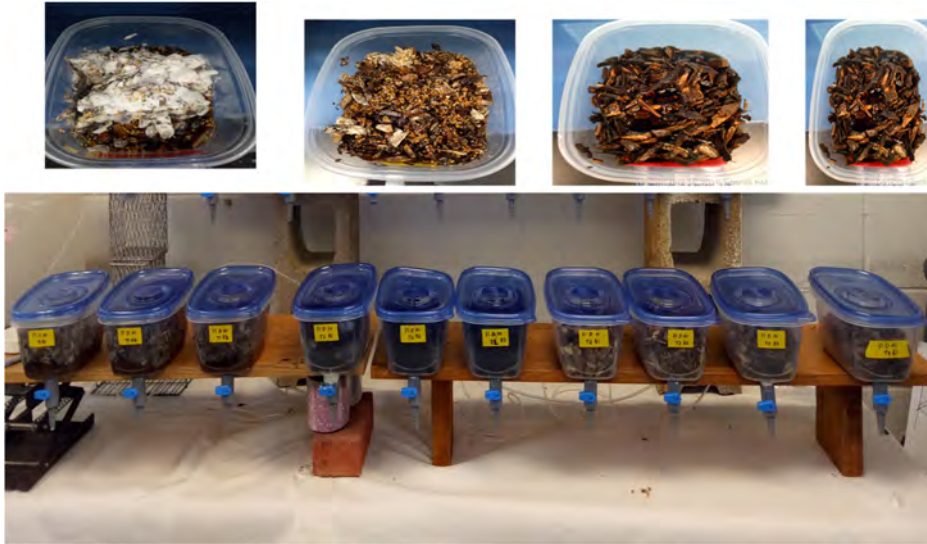
Figure 1. Experimental set up with treatments 1 through 4 shown on the top from left to right.

10 bioreactors were set up and each one contained woodchips, live fungi, and manure spiked with *E. coli* (Figure 1). The first three were set up with Treatment 1, which contained live fungus and manure spiked with *E. coli*. The next three were set up with Treatment 2, which contained autoclave fungus on the support media and manure spiked with *E. coli*. The last three were set up with Treatment 3, which contained autoclaved support media and manure spiked with *E. coli*. The last bioreactor was used as the negative control and contained autoclaved support media and uninoculated manure. The experiment lasted 10 days. Liquid samples were collected from each bioreactor on day 0, 1, 3, 5, 7, and 10. The samples were then diluted with water 50:1 milliliter and stored for hydrogen peroxide and enzyme analysis.

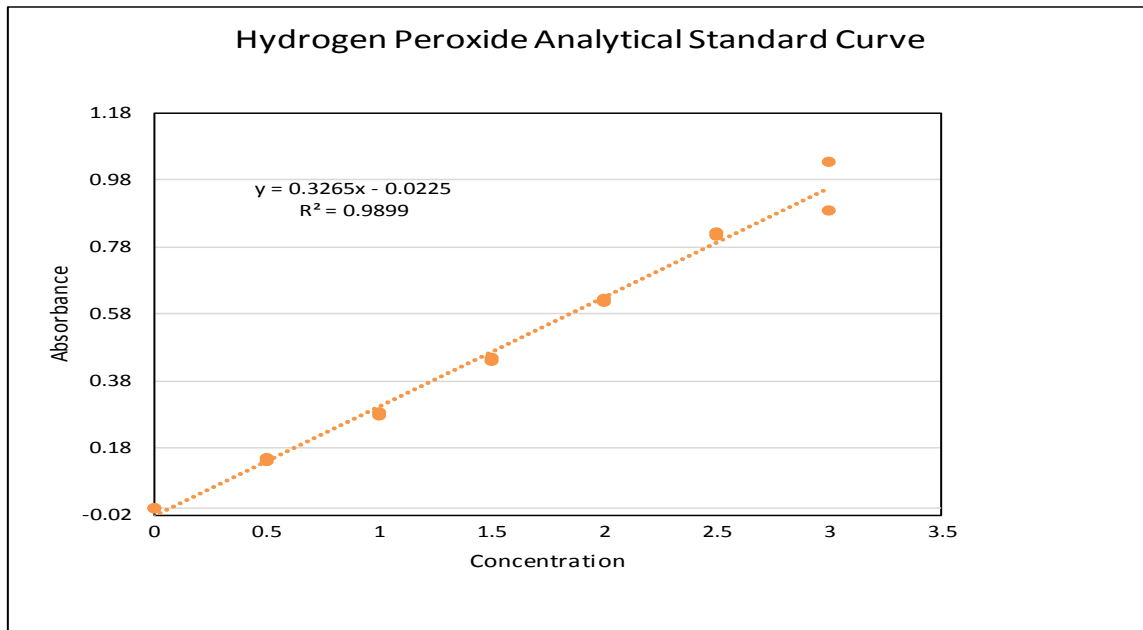
Figure 2. Standard curve for hydrogen peroxide colorimetric analysis.

For hydrogen peroxide analysis, a reagent solution was made consisting of 1 ml of ferrous ammonium sulfate in 0.25 M sulfuric acid and 99 ml of xylenol orange solution. Four milliliters of the reagent were added to a spectrophotometer tube containing two milliliters of diluted liquid sample. After a time period of thirty minutes for the reagent to react, the samples were read on a visible spectrophotometer at a wavelength of 580 nanometers and the absorbance was recorded. The results were compared to a standard curve of hydrogen peroxide concentration versus absorbance. Figure 2 is a standard curve used for the hydrogen peroxide measurement, where H₂O₂ concentration versus absorbance at 580 nm is plotted and the resulting regression curve is used to determine H₂O₂ concentration of the unknown samples. The regression equation is as follows: $y = 0.3265x - 0.0225$ where y is the absorbance measurement and x is the concentration of H₂O₂, and the R² value is 0.9899.

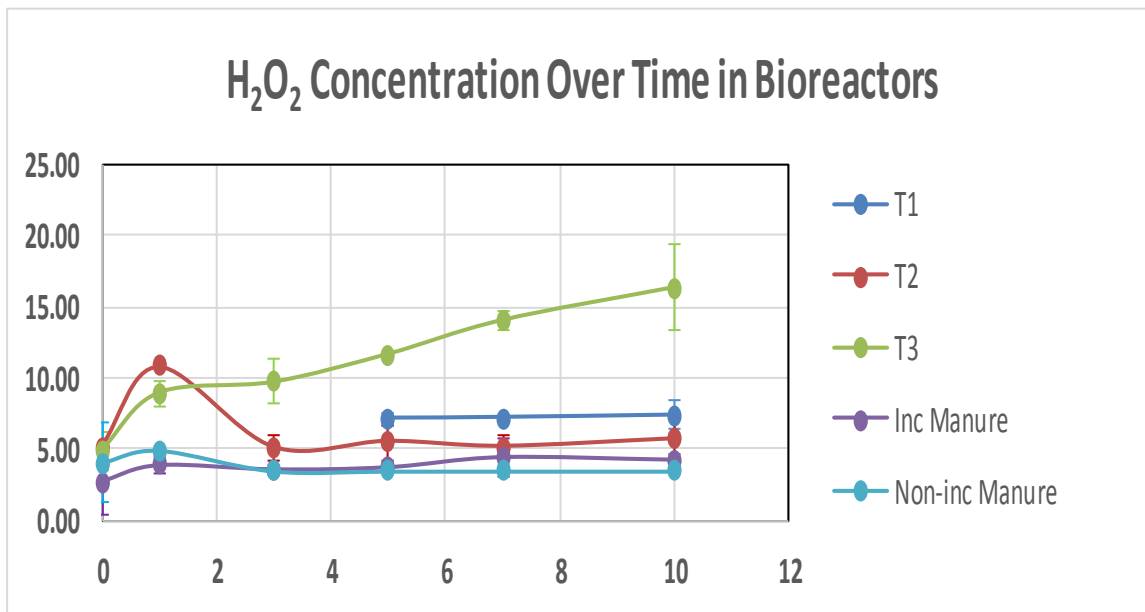
Figure 3. Production of Hydrogen Peroxide over time in bioreactors.

After measuring the absorbance, I found that over the ten-day period there was an increase of hydrogen peroxide in the samples for Treatment 3, which did not contain the fungus (Figure 3). The concentration of H₂O₂ remained constant in the inoculate and non-inoculated manure influents.

Due to the pandemic, I was not able to complete the analyses and some data is missing for Treatment 1, which is the treatment with the live fungus. The concentration of H₂O₂ remained steady from day 5 to 10 for Treatment 1, while the concentration increased over time for Treatment 3 containing no fungus. This may be due to interferences in the manure affecting the analysis. The live treatment showed a decrease in the concentration of organic compounds (data not shown) indicating that the fungus was degrading these materials and the H₂O₂ produced was utilized to activate the ligninolytic enzymes. Treatment 3 had the biggest increase in hydrogen peroxide over the time period of ten days. Due to COVID-19, I was not able to run more trials or test the collected effluent from the bioreactors for enzymes, therefore we can't correlate the H₂O₂ concentration to the enzyme activity.

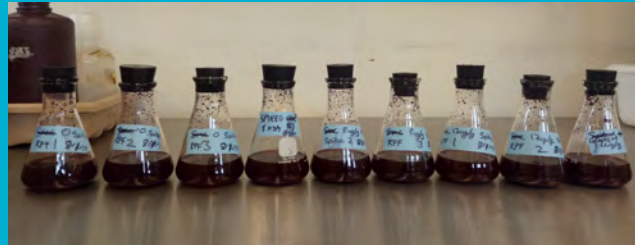
Pictured: Extraction process of P.C. from growth on an inert media

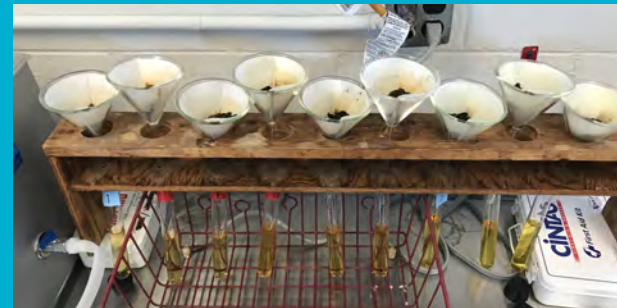
Pictured: Filtering process of samples for extraction

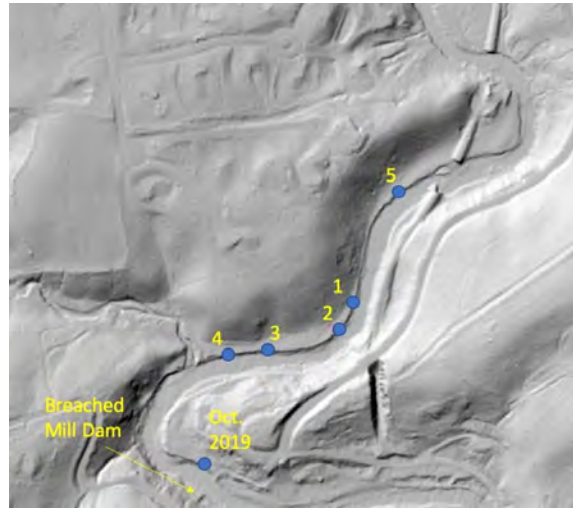
Figure 2: Six sample sites within the research location

Each sample have different distance from the mill dam. This helps to find out the change of deposit composition when it moves further from the mill dam.

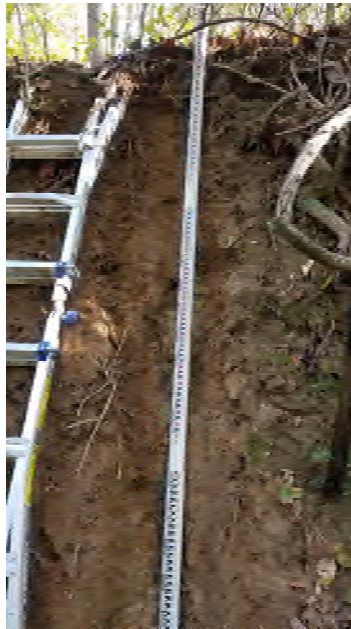
Figure 3: Cross section photo from one of the sites that has been sampled

When we look closely at the cross section, different layers of soil can be determined. From the bottom to the top, we take a small chunk of each layer. Color, soil type, what presents in the soil are recorded for the description. The distance of each layer and soil samples has been taken for measurement later in the lab. We repeat the same method for all six sites. The next step is to use lab equipment to find out what is the composition of those soil samples through more accurate measurement. These measurements will help to define those soils are either flooding deposits or mill dam deposits.

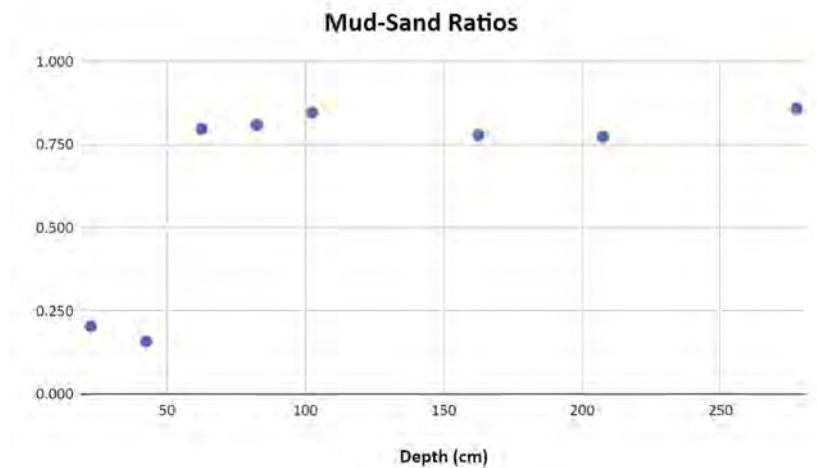
Figure 4: Mud-Sand ratio graph of samples collected in Oct. 2019

Table 1: This table shows the lab results of sand-mud ratio and other measurements of samples collected in Oct. 2019. Through the lab work, sand-mud ratio has been tested from the table above. The numbers help us to understand what type of deposits each layer contain and how does the layer changes.

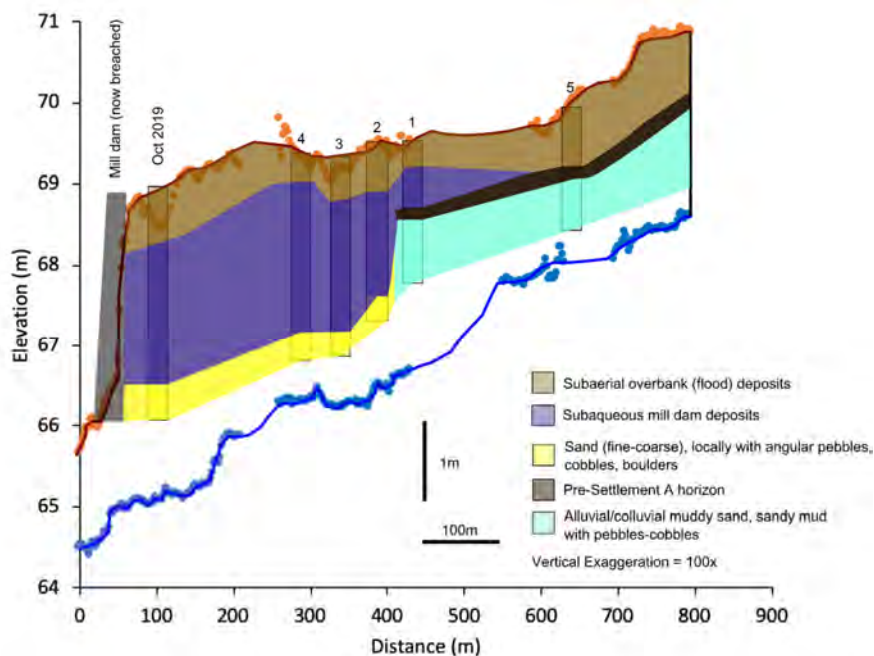
Figure 5: Cross section graph for all six sample sites.

Mill dam deposit truly have influence to the existing river banks. But based on figure 5, the result is somehow different with Walter and Merritts concluded in their paper. The mill dam only has influences to a certain range. Closer to the mill dam,

the river bank is being more affected. When we move further downstream, the influence from mill dam starts to reduce and even disappear when reaching a certain distance. The results also suggest that the findings from Jacobson and Coleman is partially correct, not also not very accurate. Flood deposits appears in all six samples, but it is not the only factor of deposits accumulation. Mill dam deposits and flood deposits are both big elements for the buildup of thick river banks.

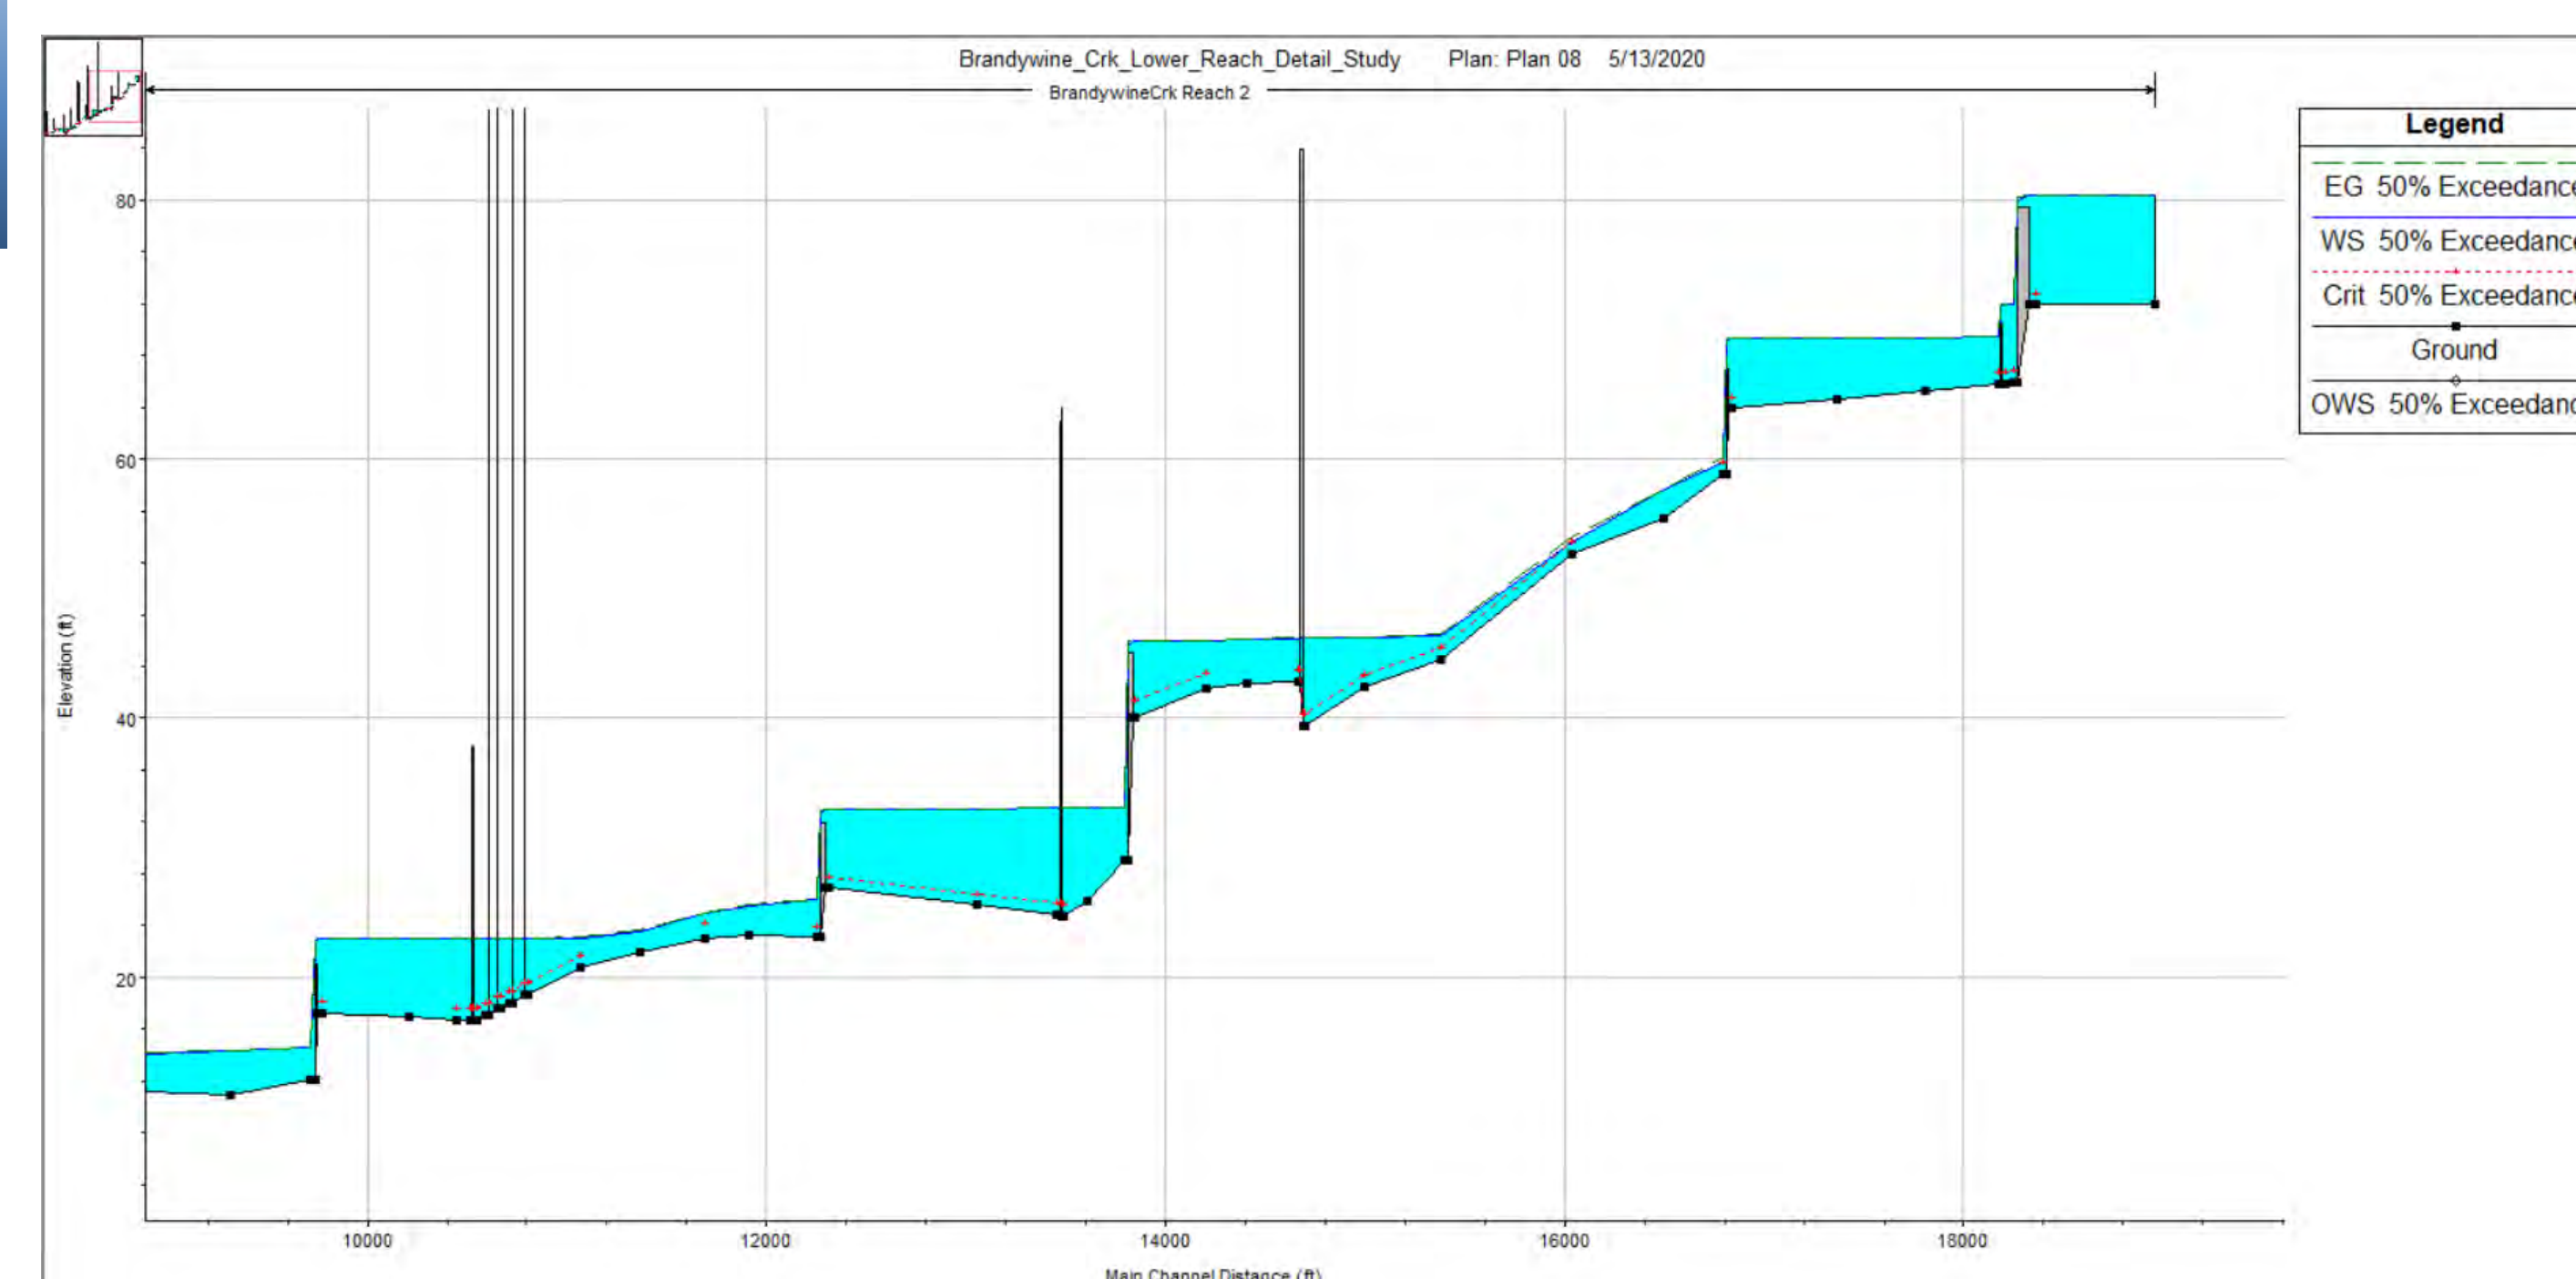
Figure 1. Profile of lower DE Dams

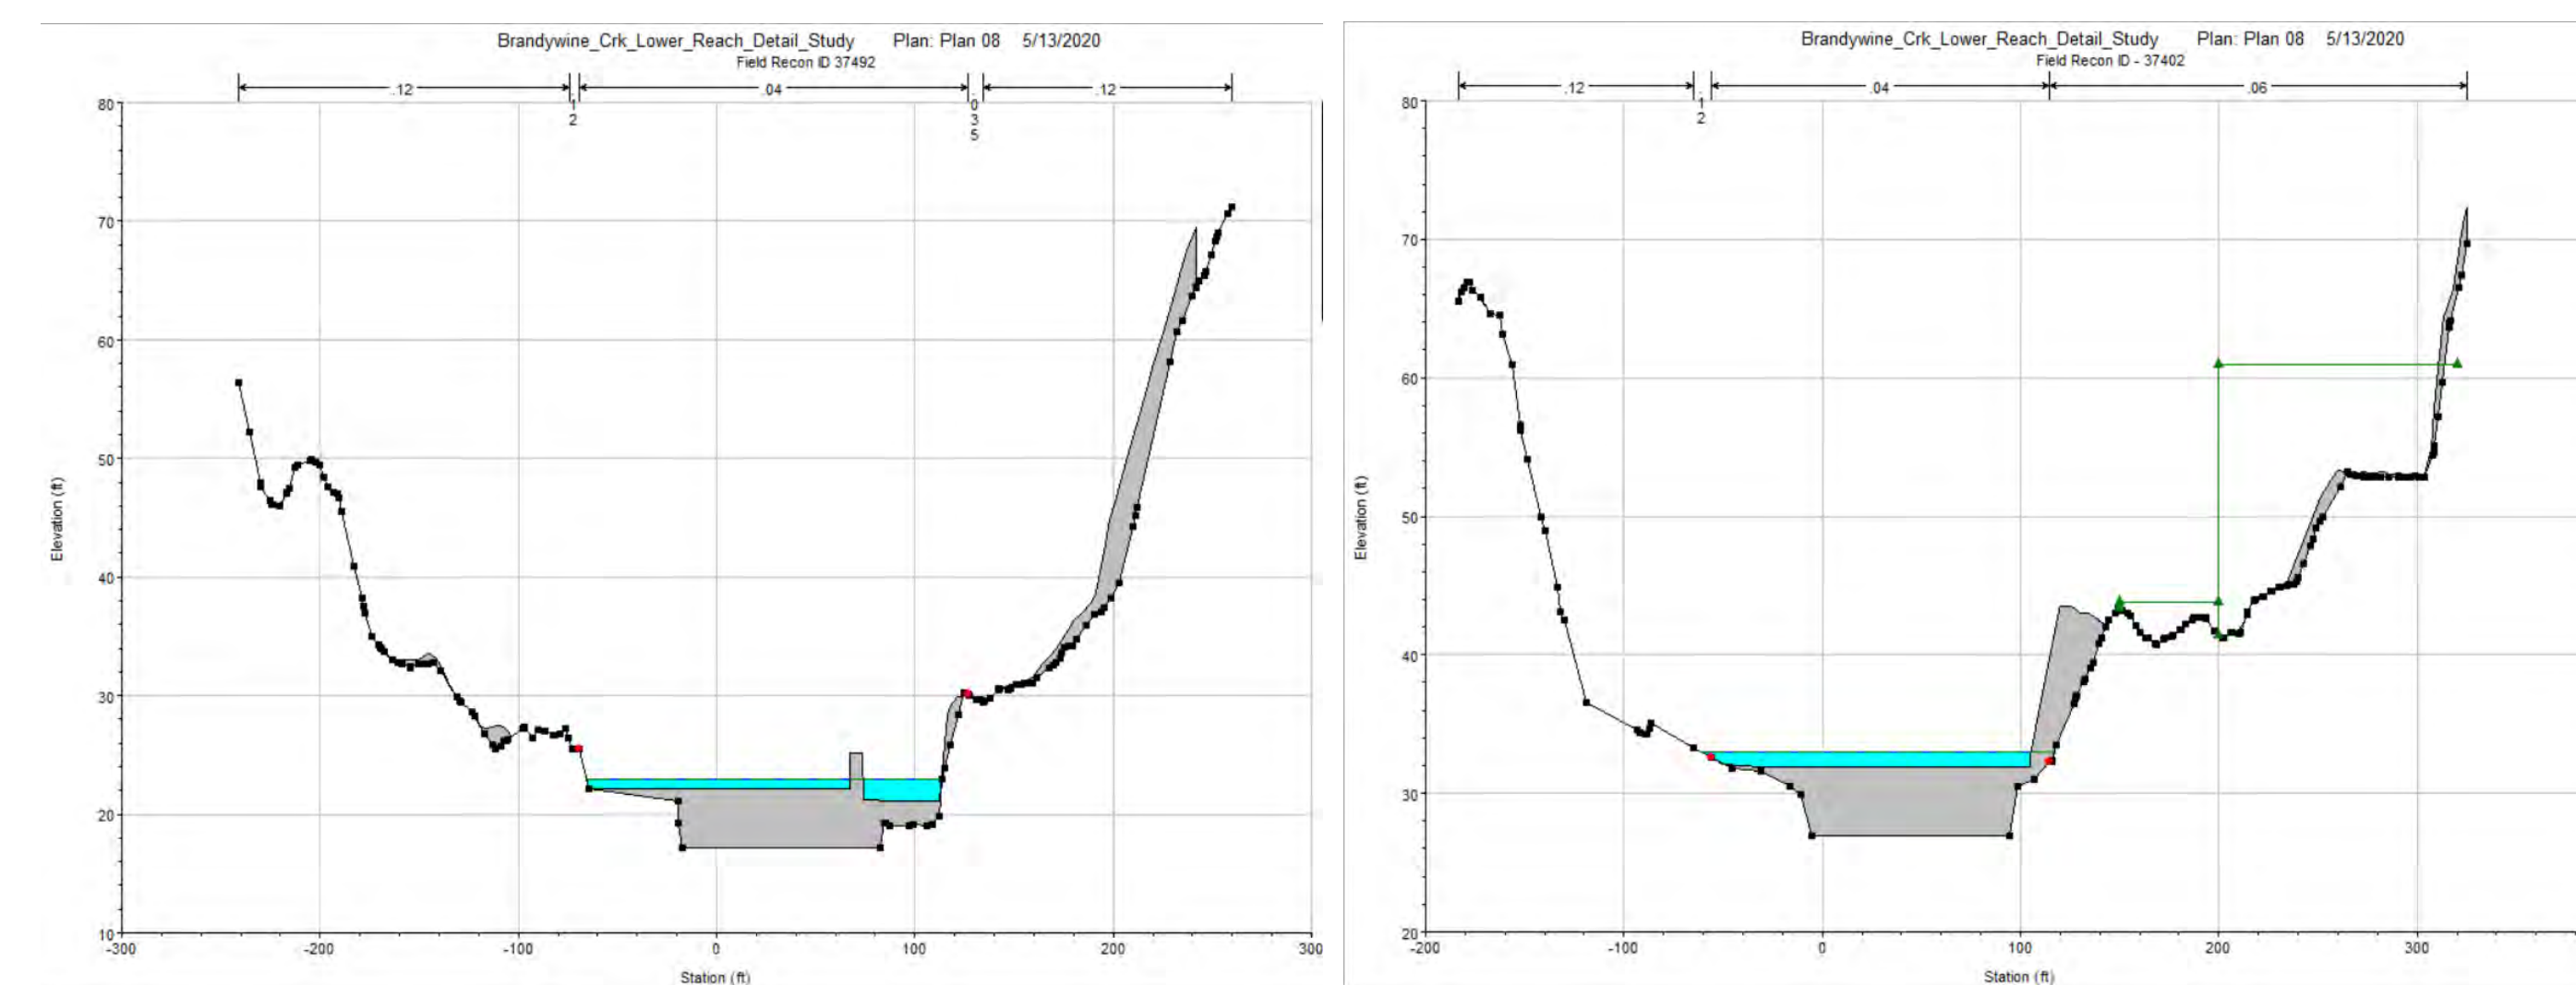
Figure 2. Cross Section Dam 2

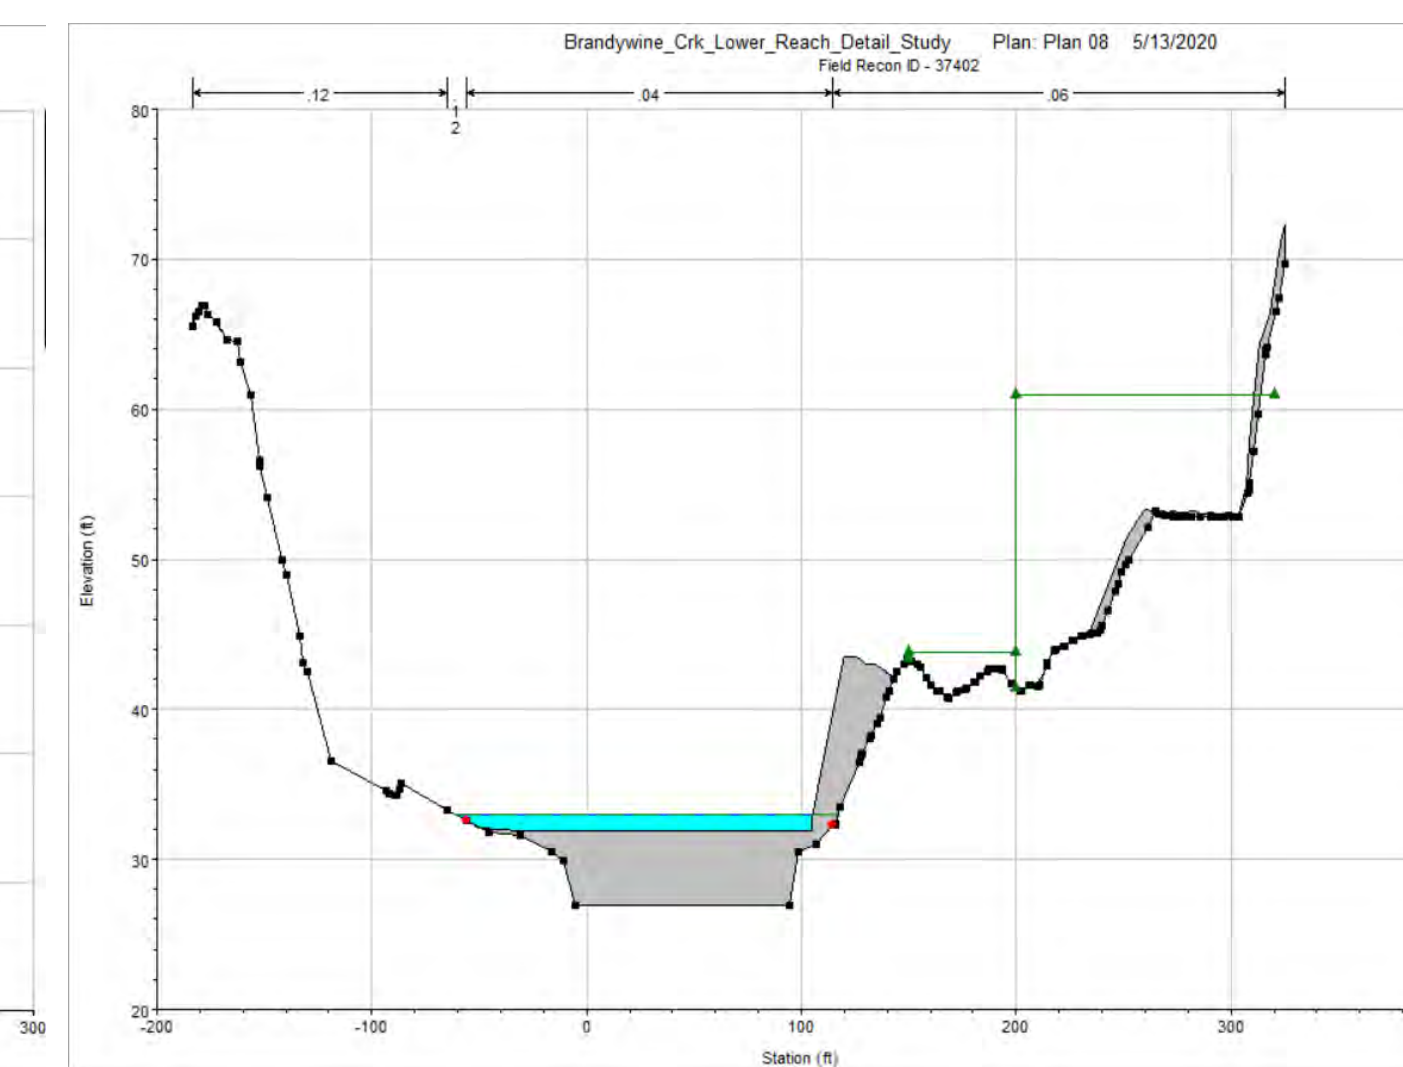
Figure 3. Cross Section Dam 3

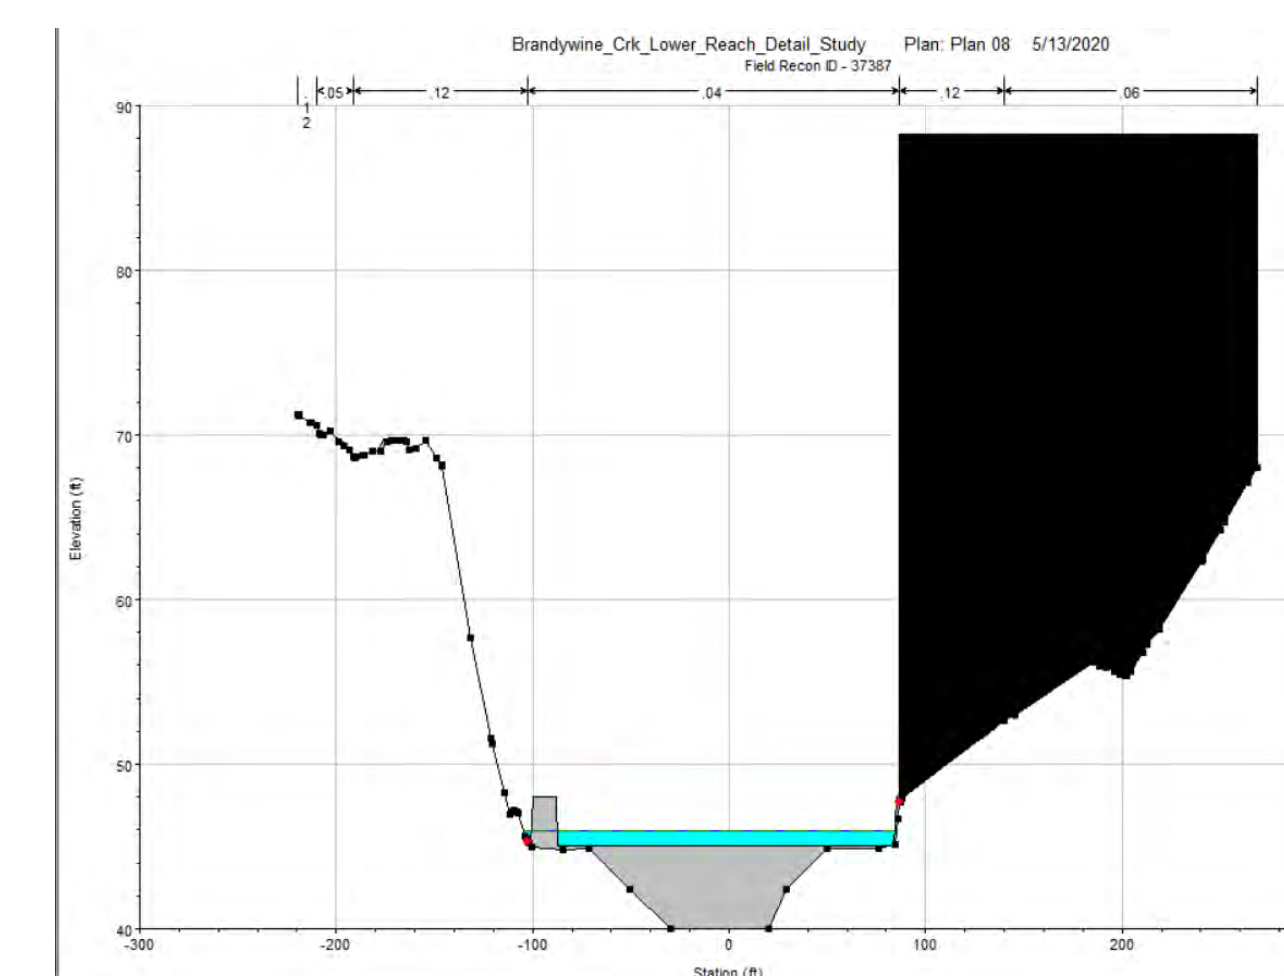
Figure 4. Cross Section Dam 4

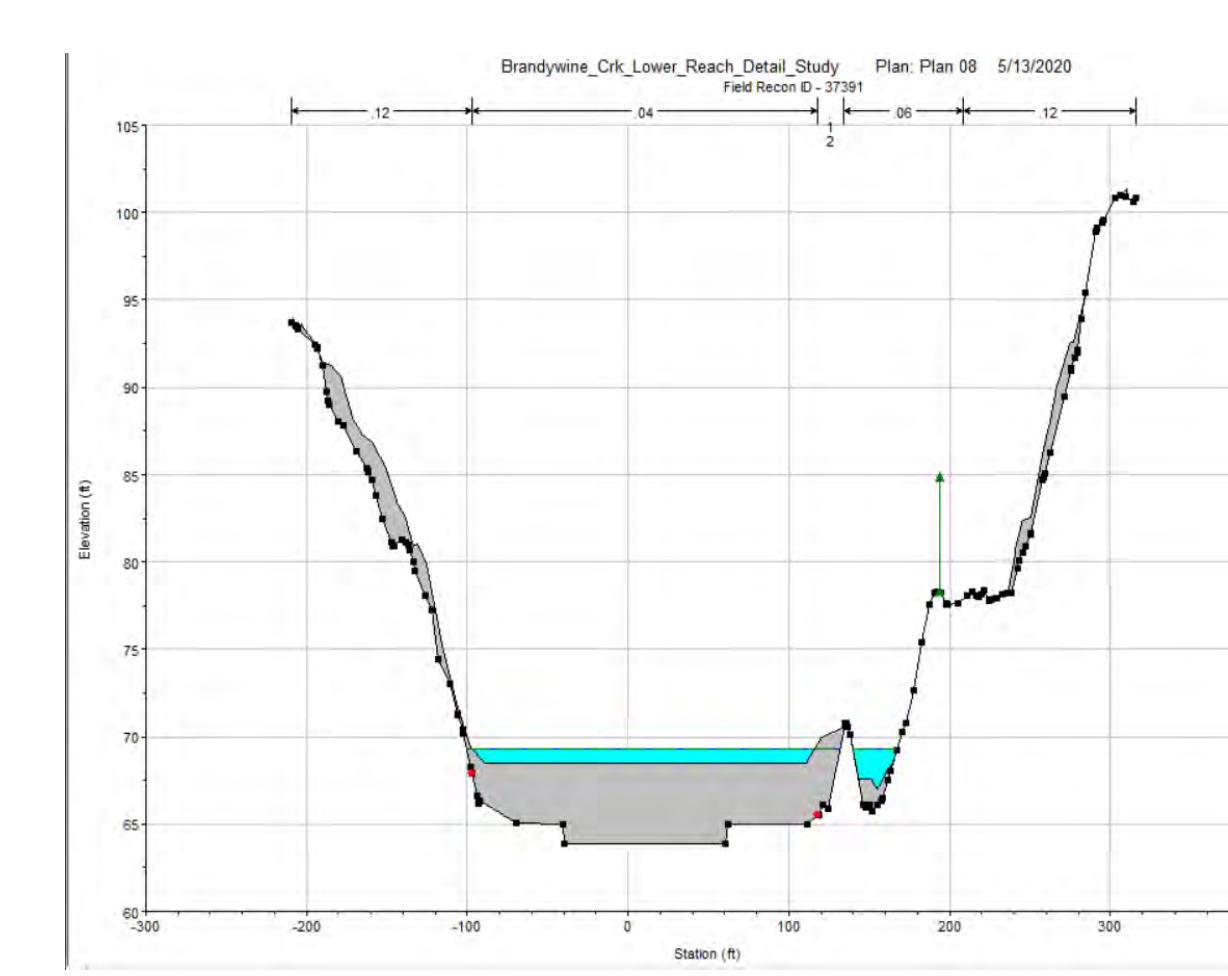
Figure 5. Cross Section Dam 5

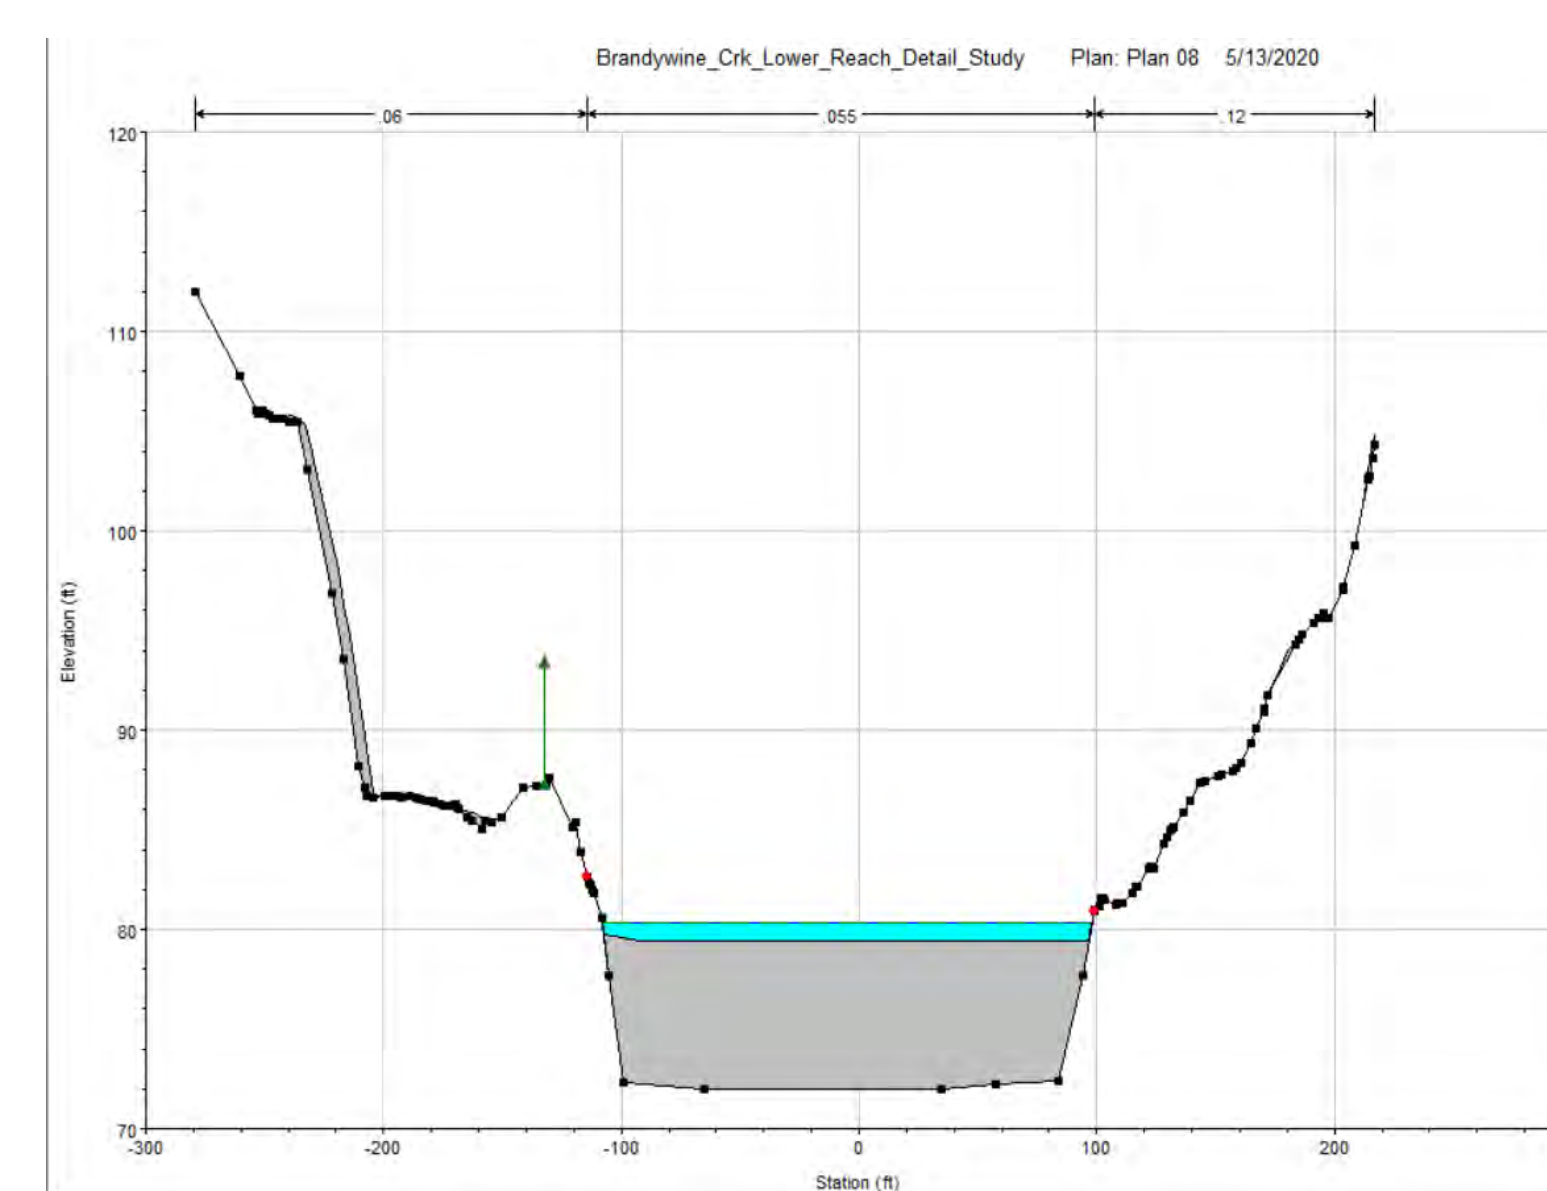
Figure 6. Cross Section Dam 6

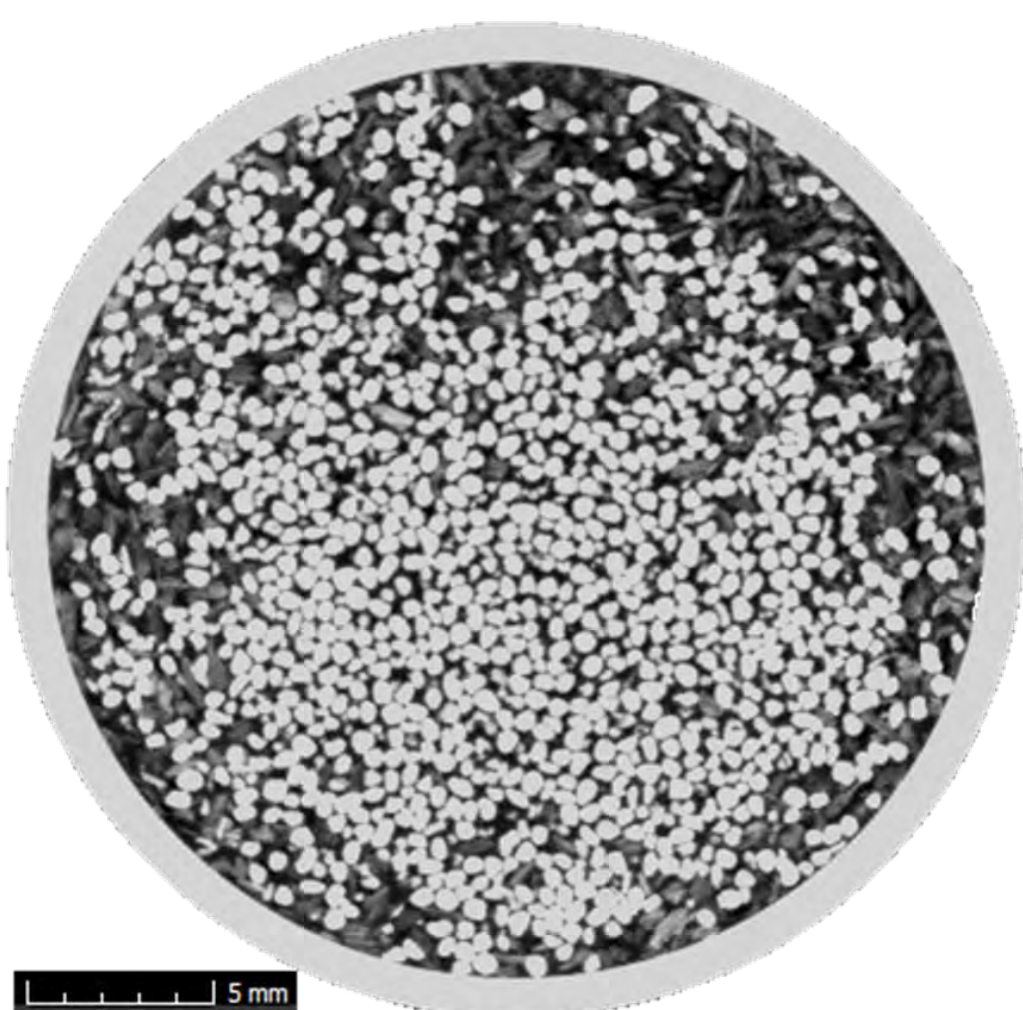
Microstructural Images for Dry Packed Biochar-Soil Mixture by Kalehiwot Nega Manahiloh

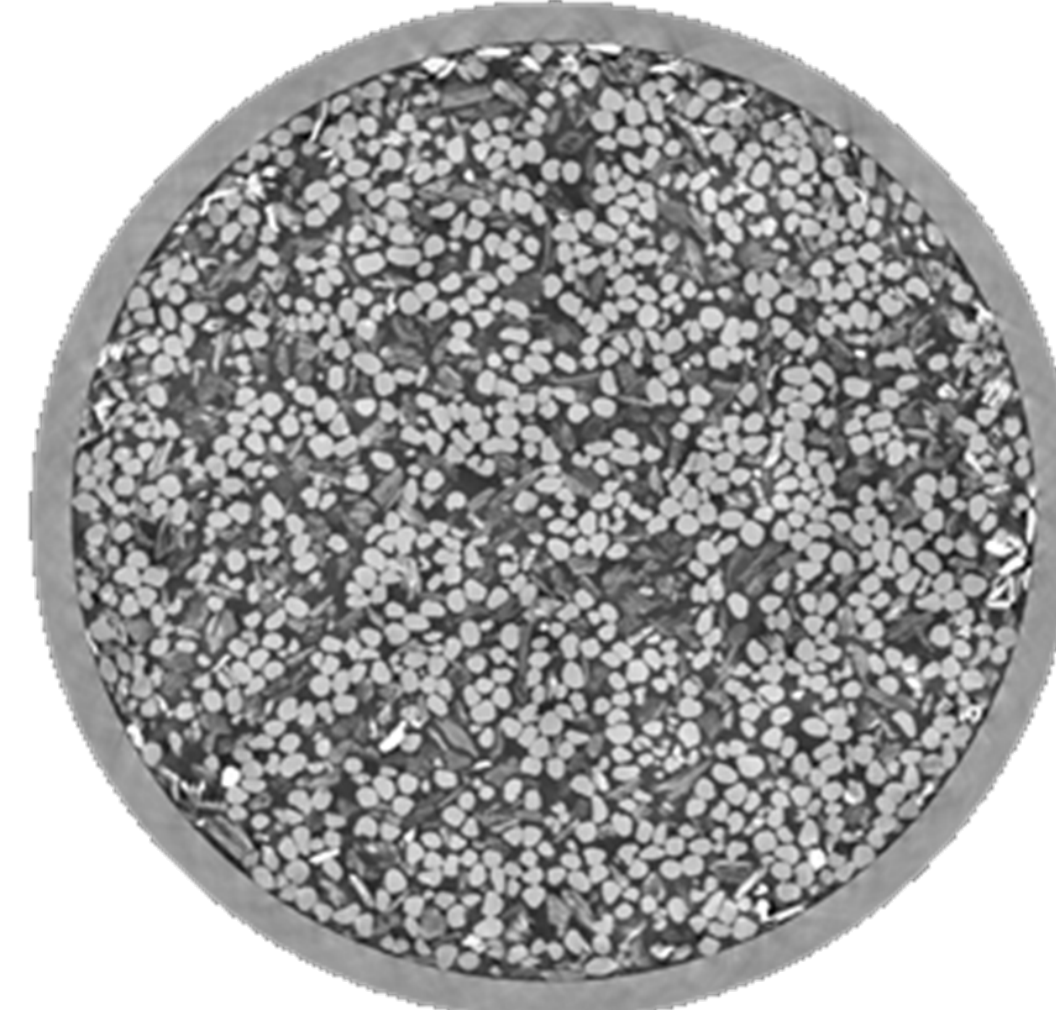
Microstructural Images for Wet Packed Biochar-Soil Mixture by Kalehiwot Nega Manahiloh
