FY19-20 DWRC Undergraduate/Graduate Water Research Students

Optimization of Hydrogen Peroxide Analysis to Quantify Enzyme Activity within Bioreactors

Discriminating between Mill Dam and Flood Deposits
along the White Clay Creek
Research Advisor: James Pizzuto
Research Student: Zhendong Ji

Wilson Run Watershed Field Surveying at Winterthur

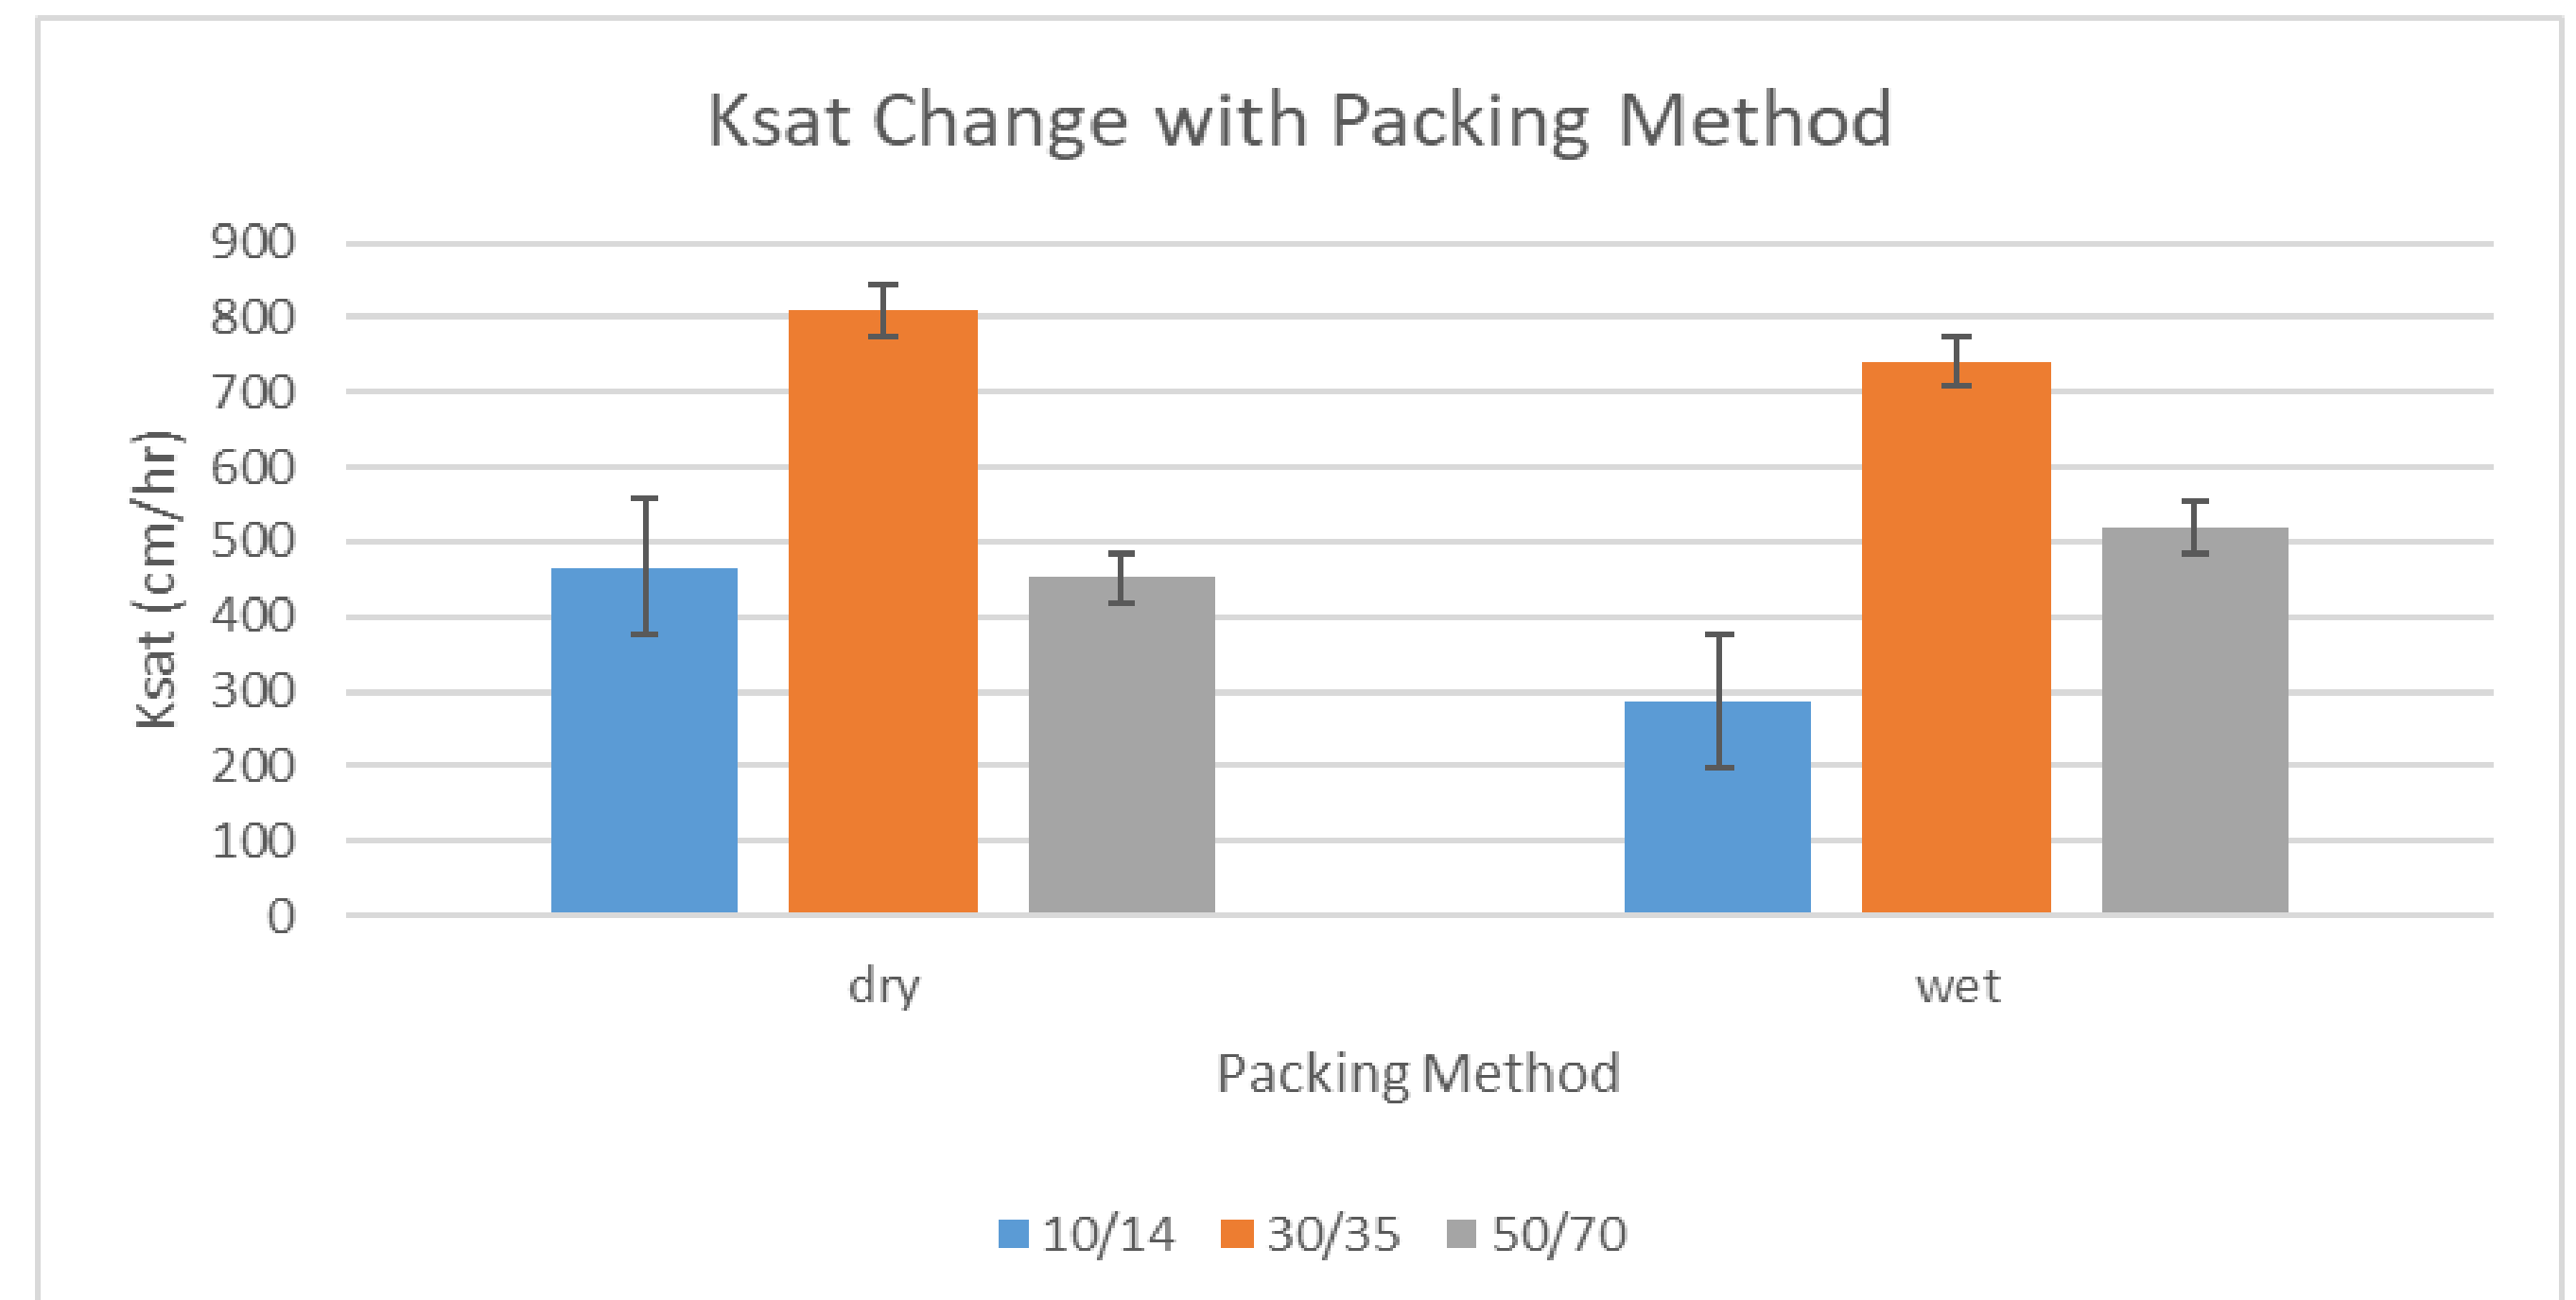
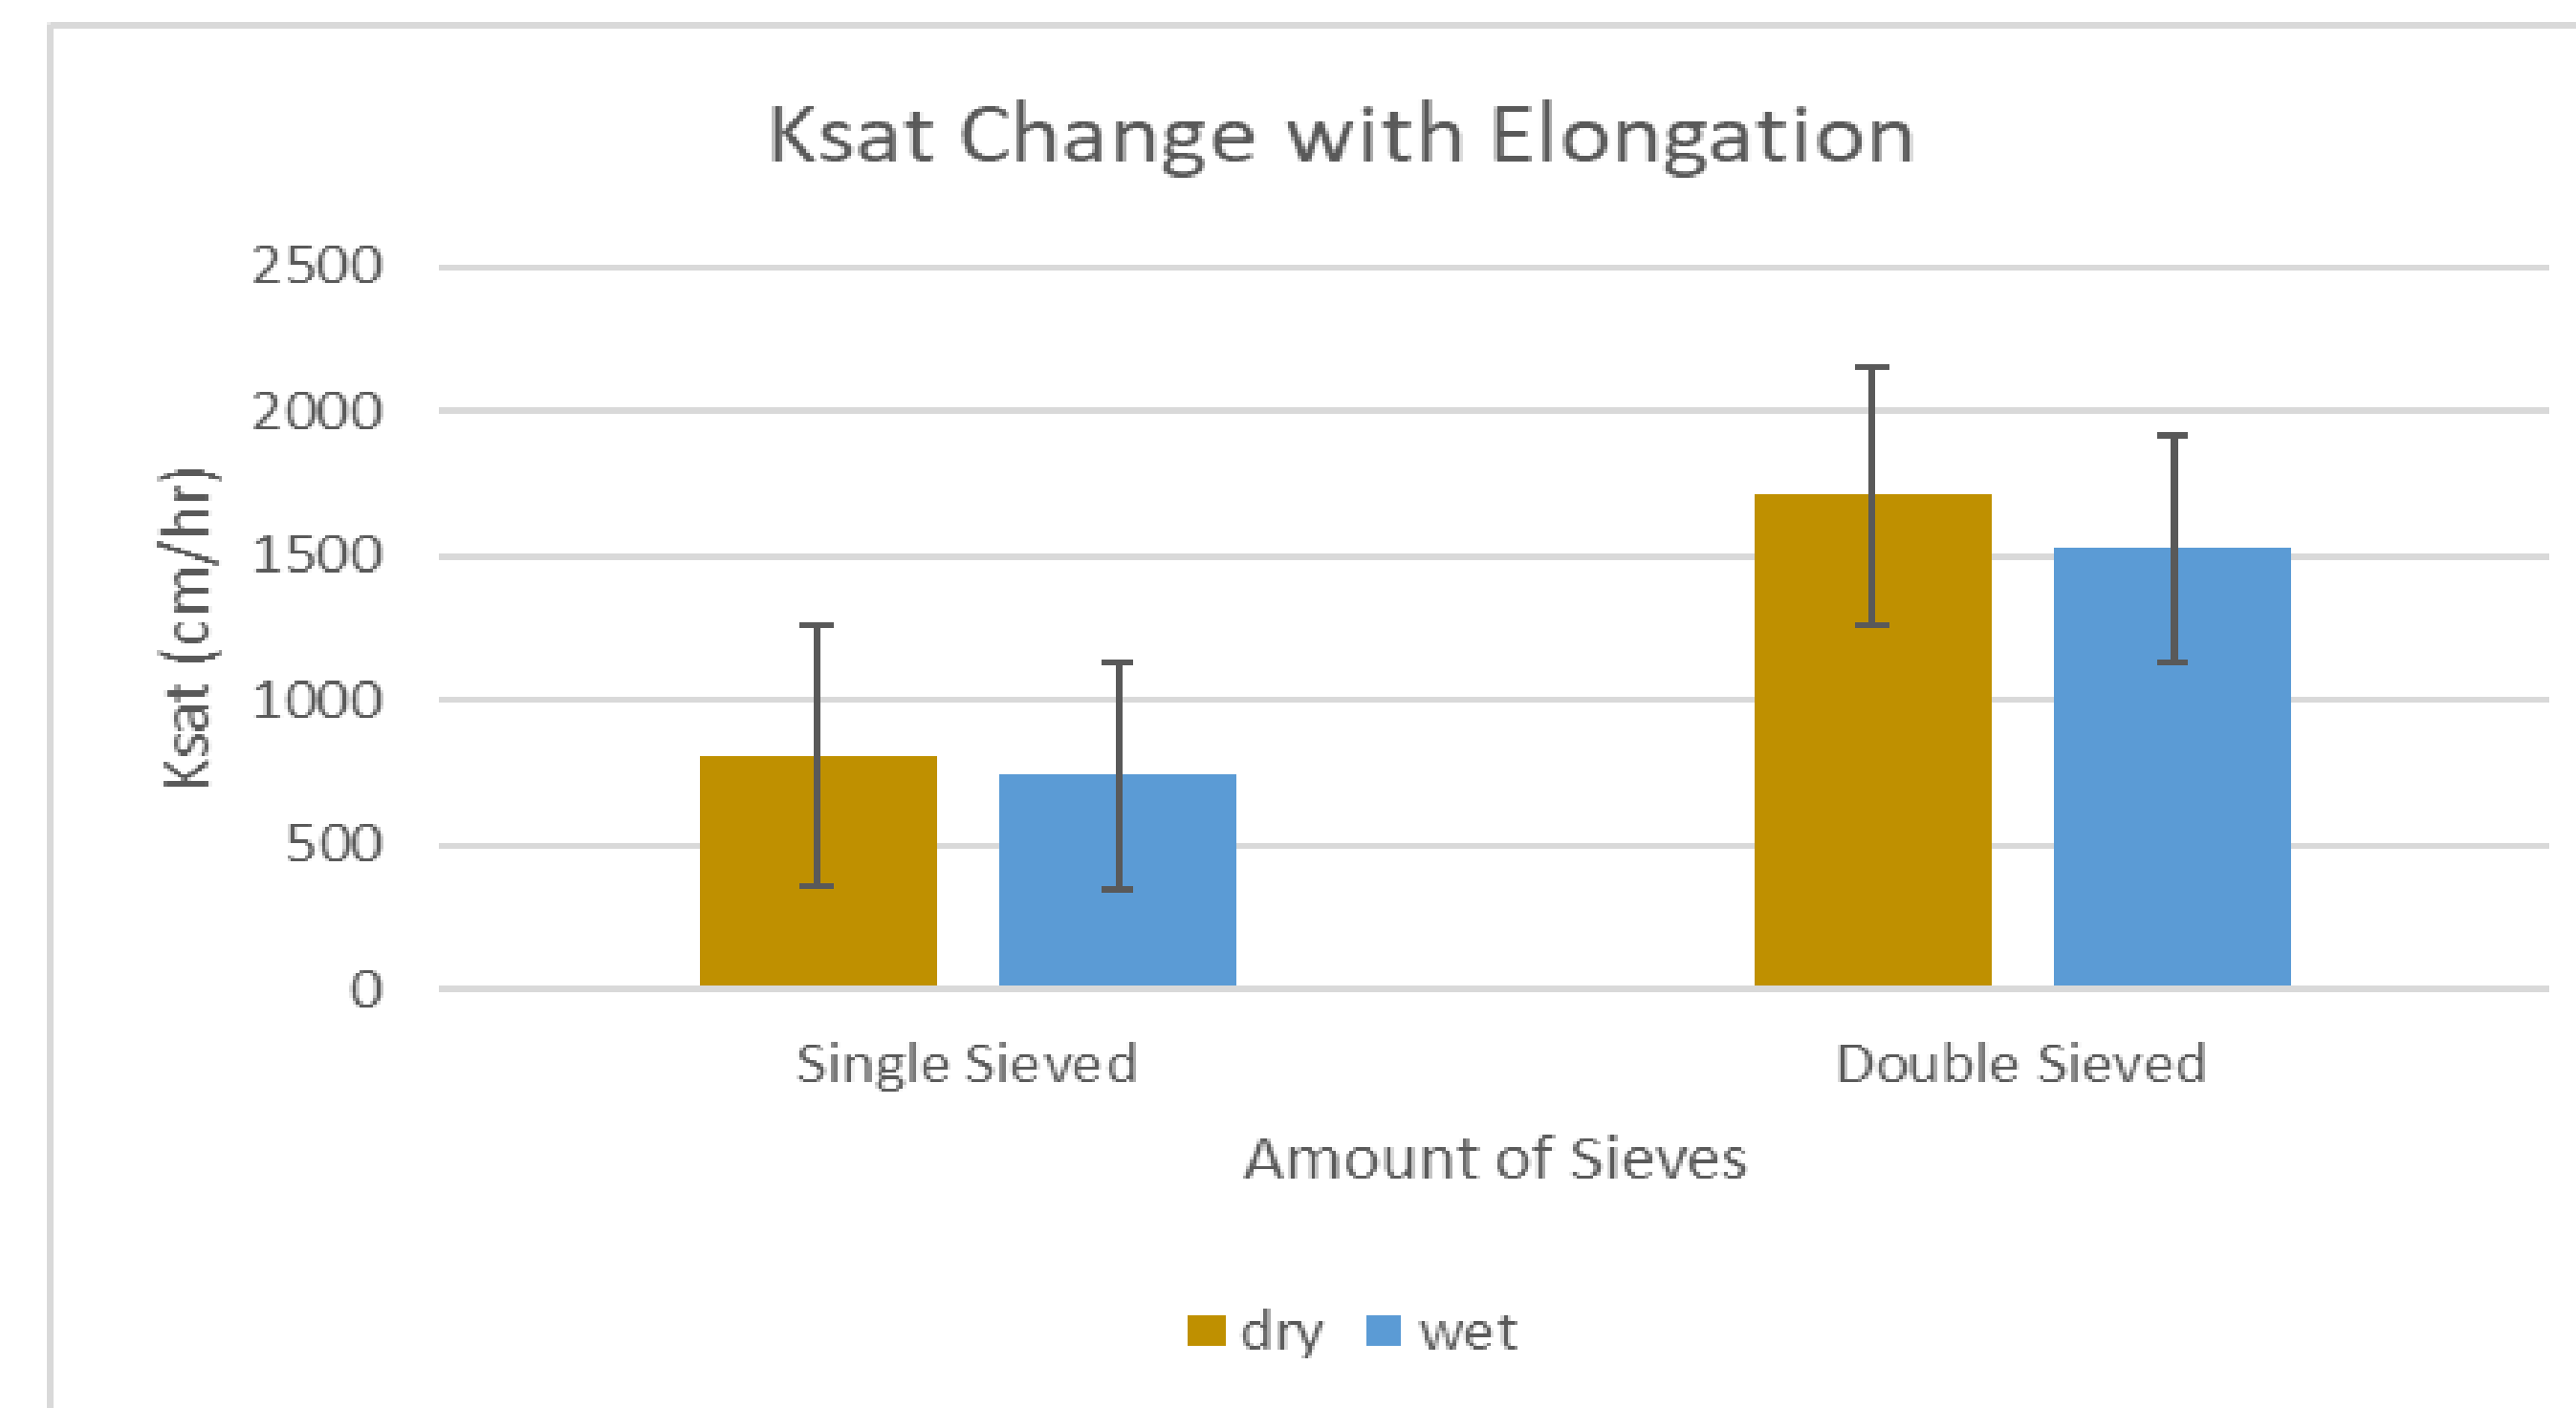
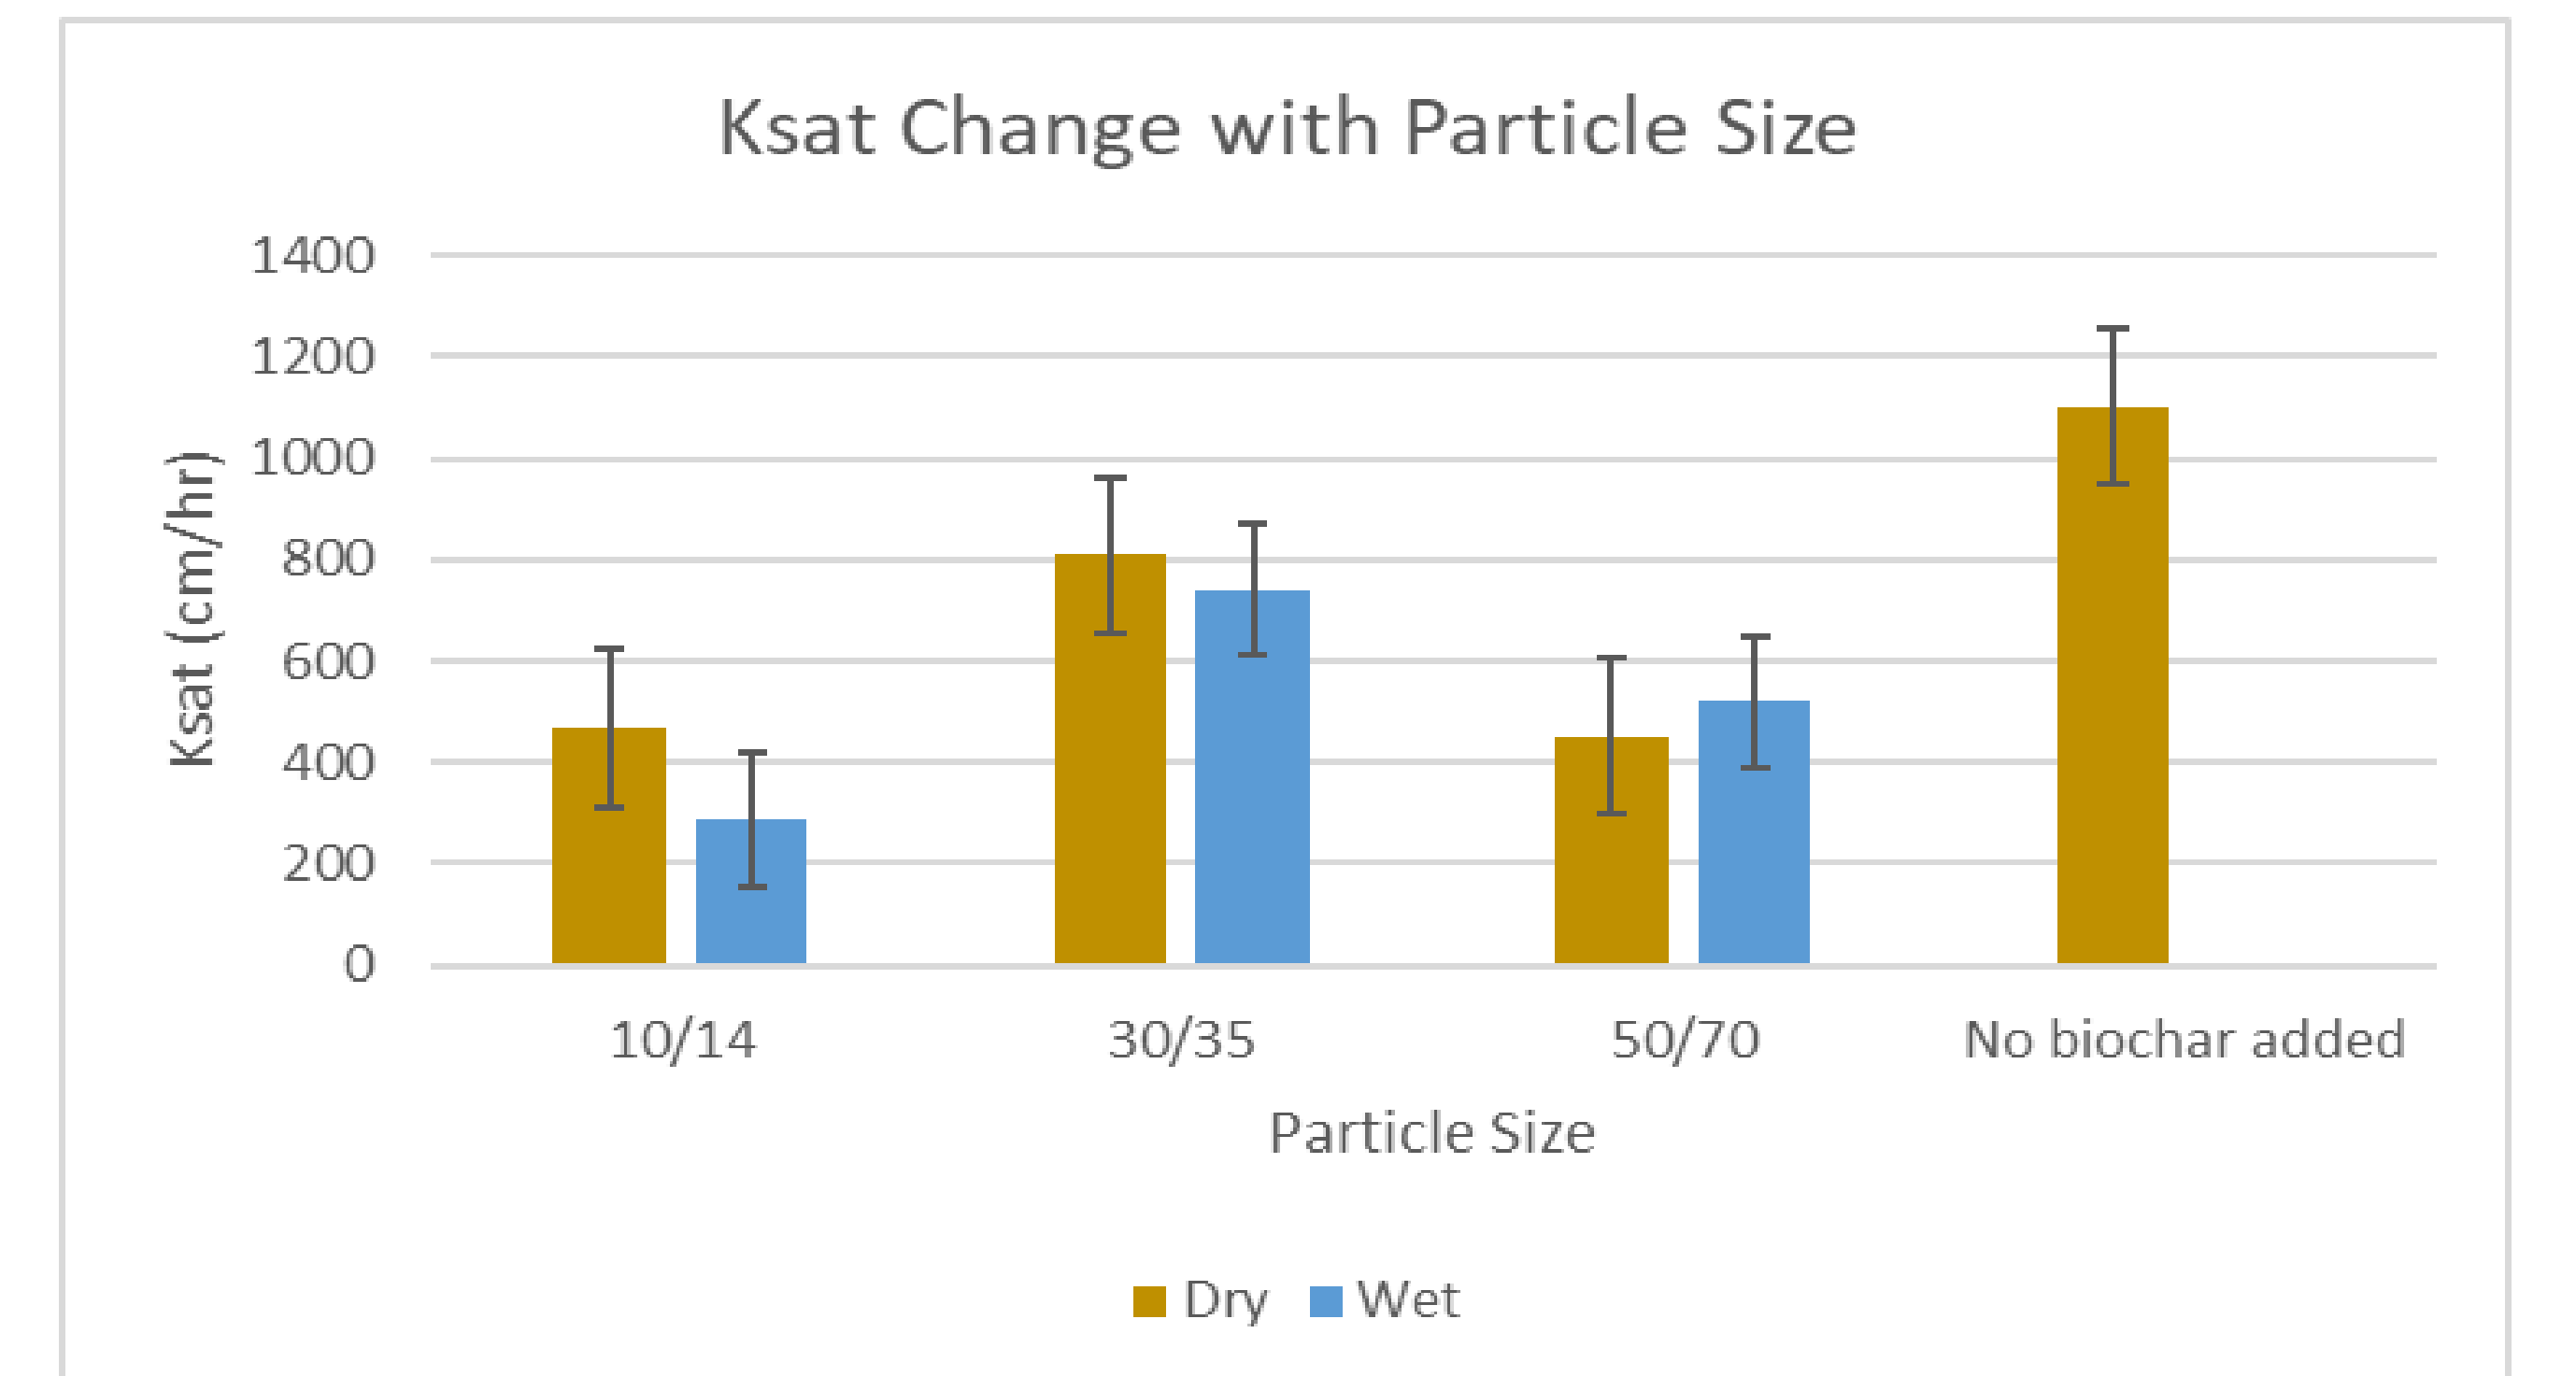
Note: All Results in the graphs above are the mean value from triplicate data, and all error bars represent standard error.

- The total porosity of the medium size biochar is the largest, due to the properties of biochar
- The larger porosity of the medium biochar causes it to have the highest Ksat compared to small and large.
- The particle Elongation had the greatest effect out of any variable, nearly doubling the Ksat compared to single sieved.
- The elongated particles were the only biochar particles to increase Ksat
- The fully segregated particles only slightly decreased the Ksat, with the Ksat of the smaller particles actually increasing.
