UDWRC Research Interns

FY19 Student Support

FY19 Delaware Water Resources Center Undergraduate/Graduate Internships

FY20 Delaware Water Resources Center Water Research Internships

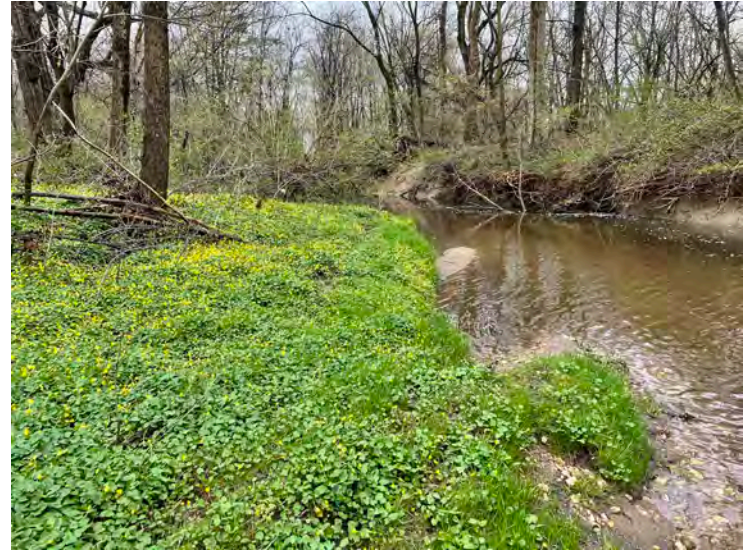
Fig. 9. Sensor station in Hockessin, Delaware

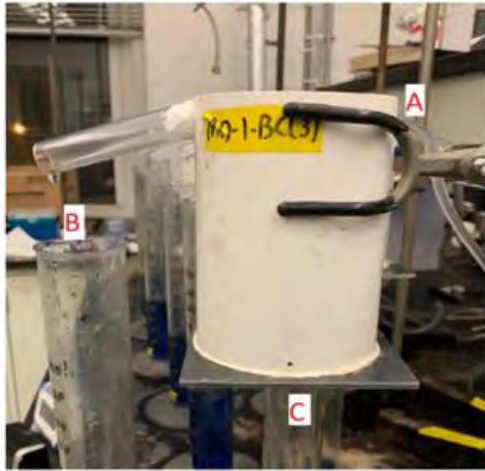
Figure 2: Infiltration test setup.

The study seeks to simulate biweekly artificial storm events to evaluate the response of laboratory soil columns with and without the presence of biochar. The samples are examined in order to measure steady-state runoff and percolation rates that result from each storm event as well as the cracking and swelling of each soil column before and after each storm event. The overall goal of the project is to determine, based on these factors, what the differences are between soil samples where biochar is present and samples where there is no biochar present.

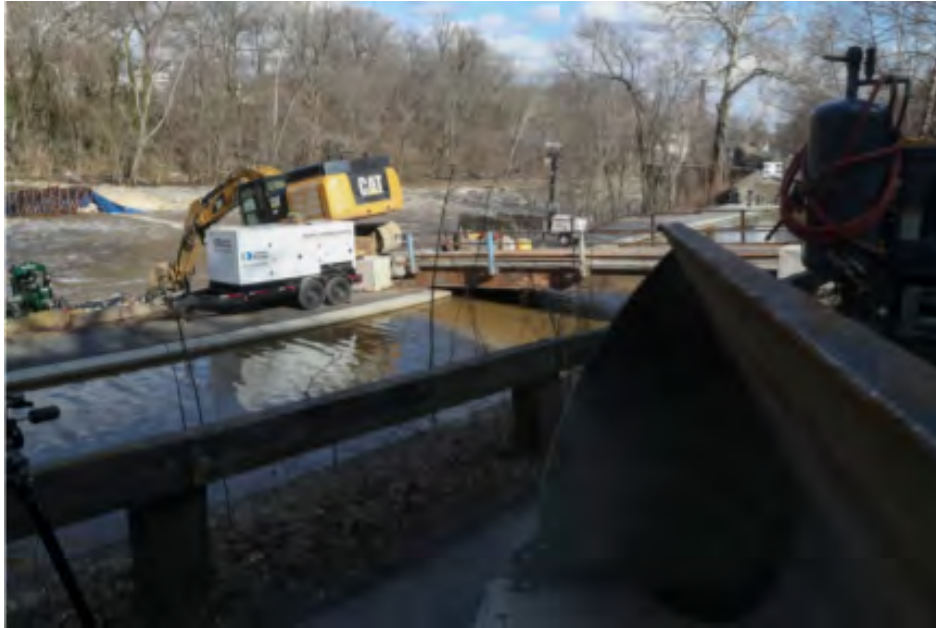
Demolition continues on the dam and replacement of a water main across the Brandywine in Wilmington. *WILLIAM BRETZGER, The News Journal*
