Tropical Storm Ida Remnants Brandywine River at Chadds Ford, Penna. Sep 1-2, 2021

The UDWRC utilized the HECRAS hydraulic model developed by FEMA and LIDAR mapping to examine the effects of Tropical Storm Ida remnants along the Brandywine River in Chadds Ford, Penna. on Sep 1-2, 2021.

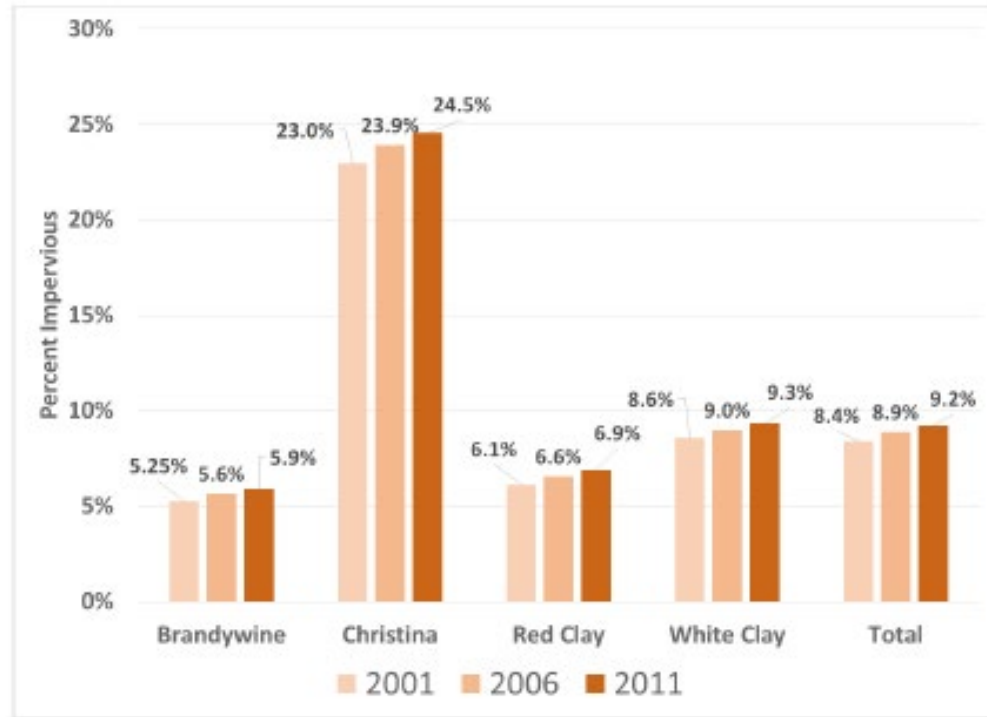
FIGURE 5-21 Imperviousness by year and watershed, 2001, 2006, and 2011. (USGS NLCD)

While developed land and population in the Brandywine watershed has increased, an associated rise in impervious cover has not been observed. Impervious cover has increased from just 5.25% in 2001 to 5.9% in 2011. This impervious cover of about 6% is quite low in the watershed field the deleterious effects of impervious cover on flooding are usually observed when watershed impervious cover exceeds 15% to 20%.

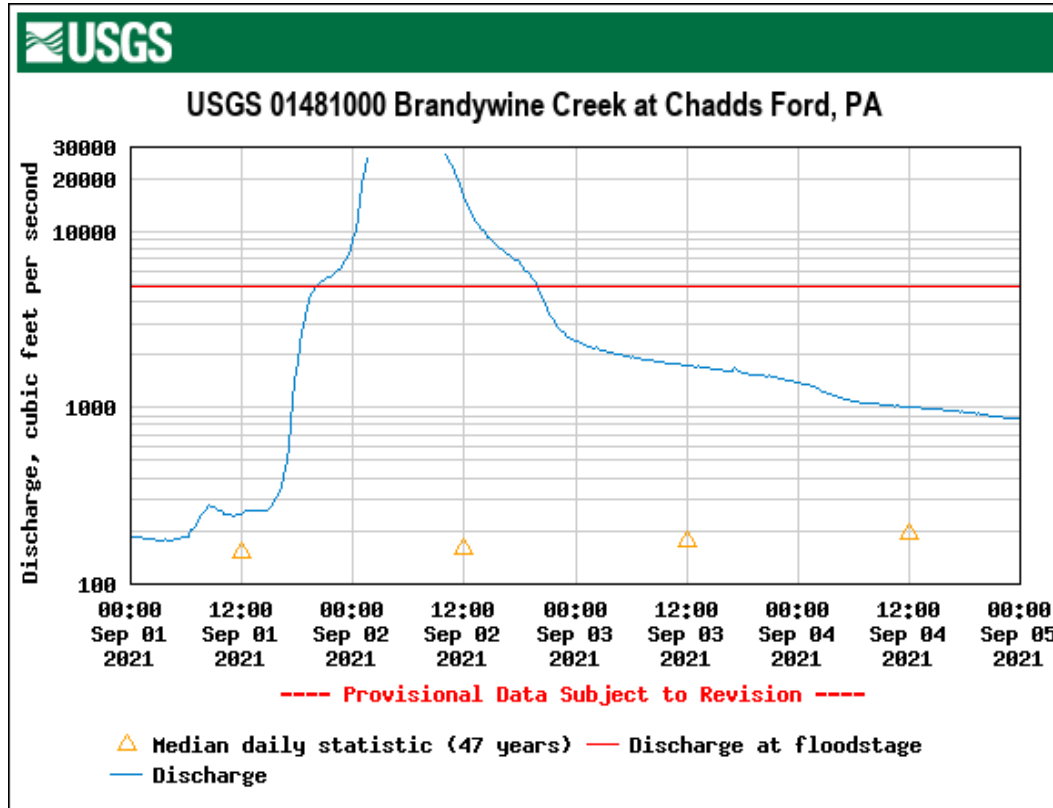
Ida peak discharge recorded at Brandywine Creek at Chadds Ford, PA > 33,000 cfs (>100-yr) at 2 am on Sep 2, 2021.

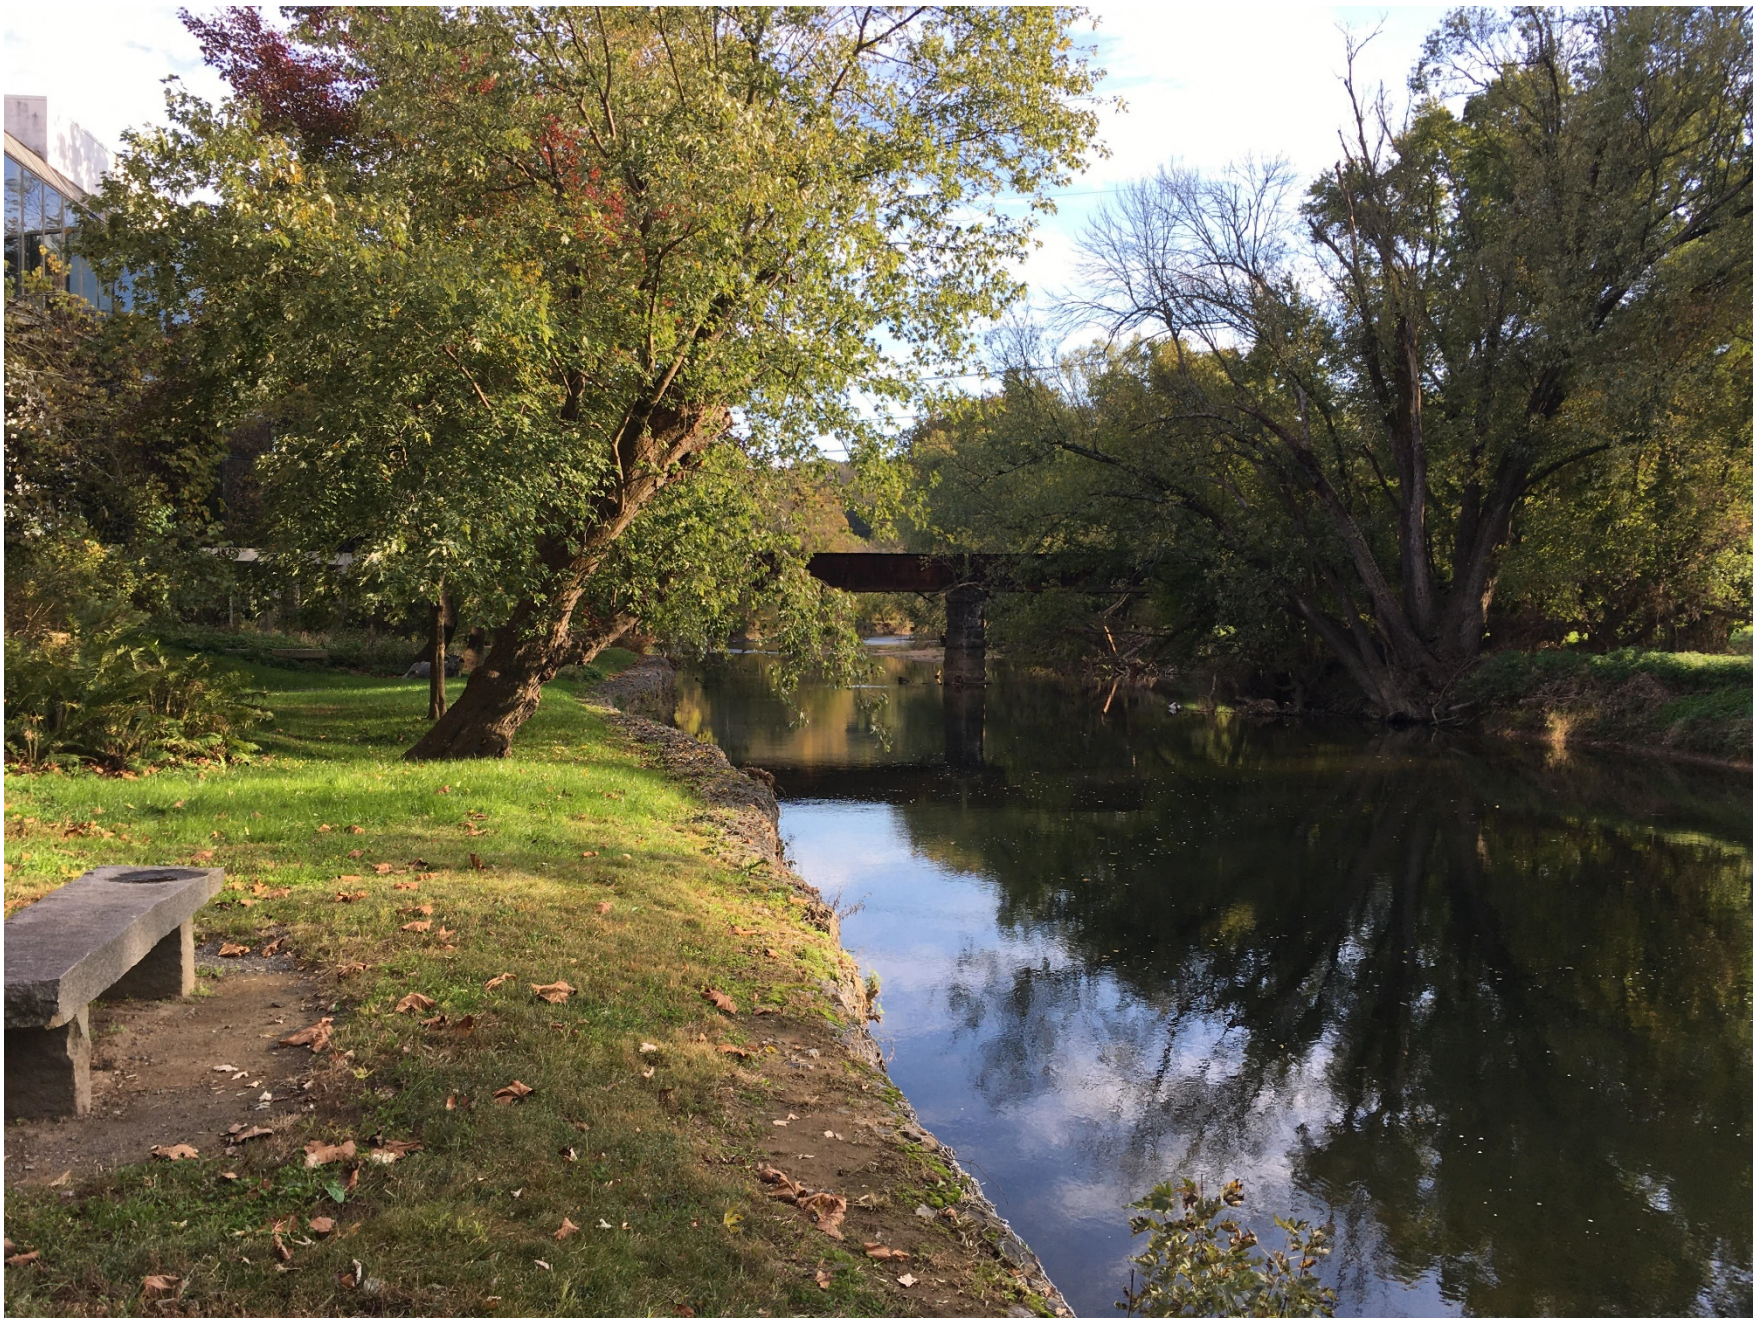
RR trestle looking downstream embankment to east and trestle to west note debris from Ida.

At some point in the 19th century, a decision was made to "channelize" the Brandywine's banks from Route 1, near the current site of the museum, for several hundred yards eastward to make way for a railroad bridge, he said. Shrinking the banks provided land for planting the trestle supports.

"I think that's the choke point," he said.

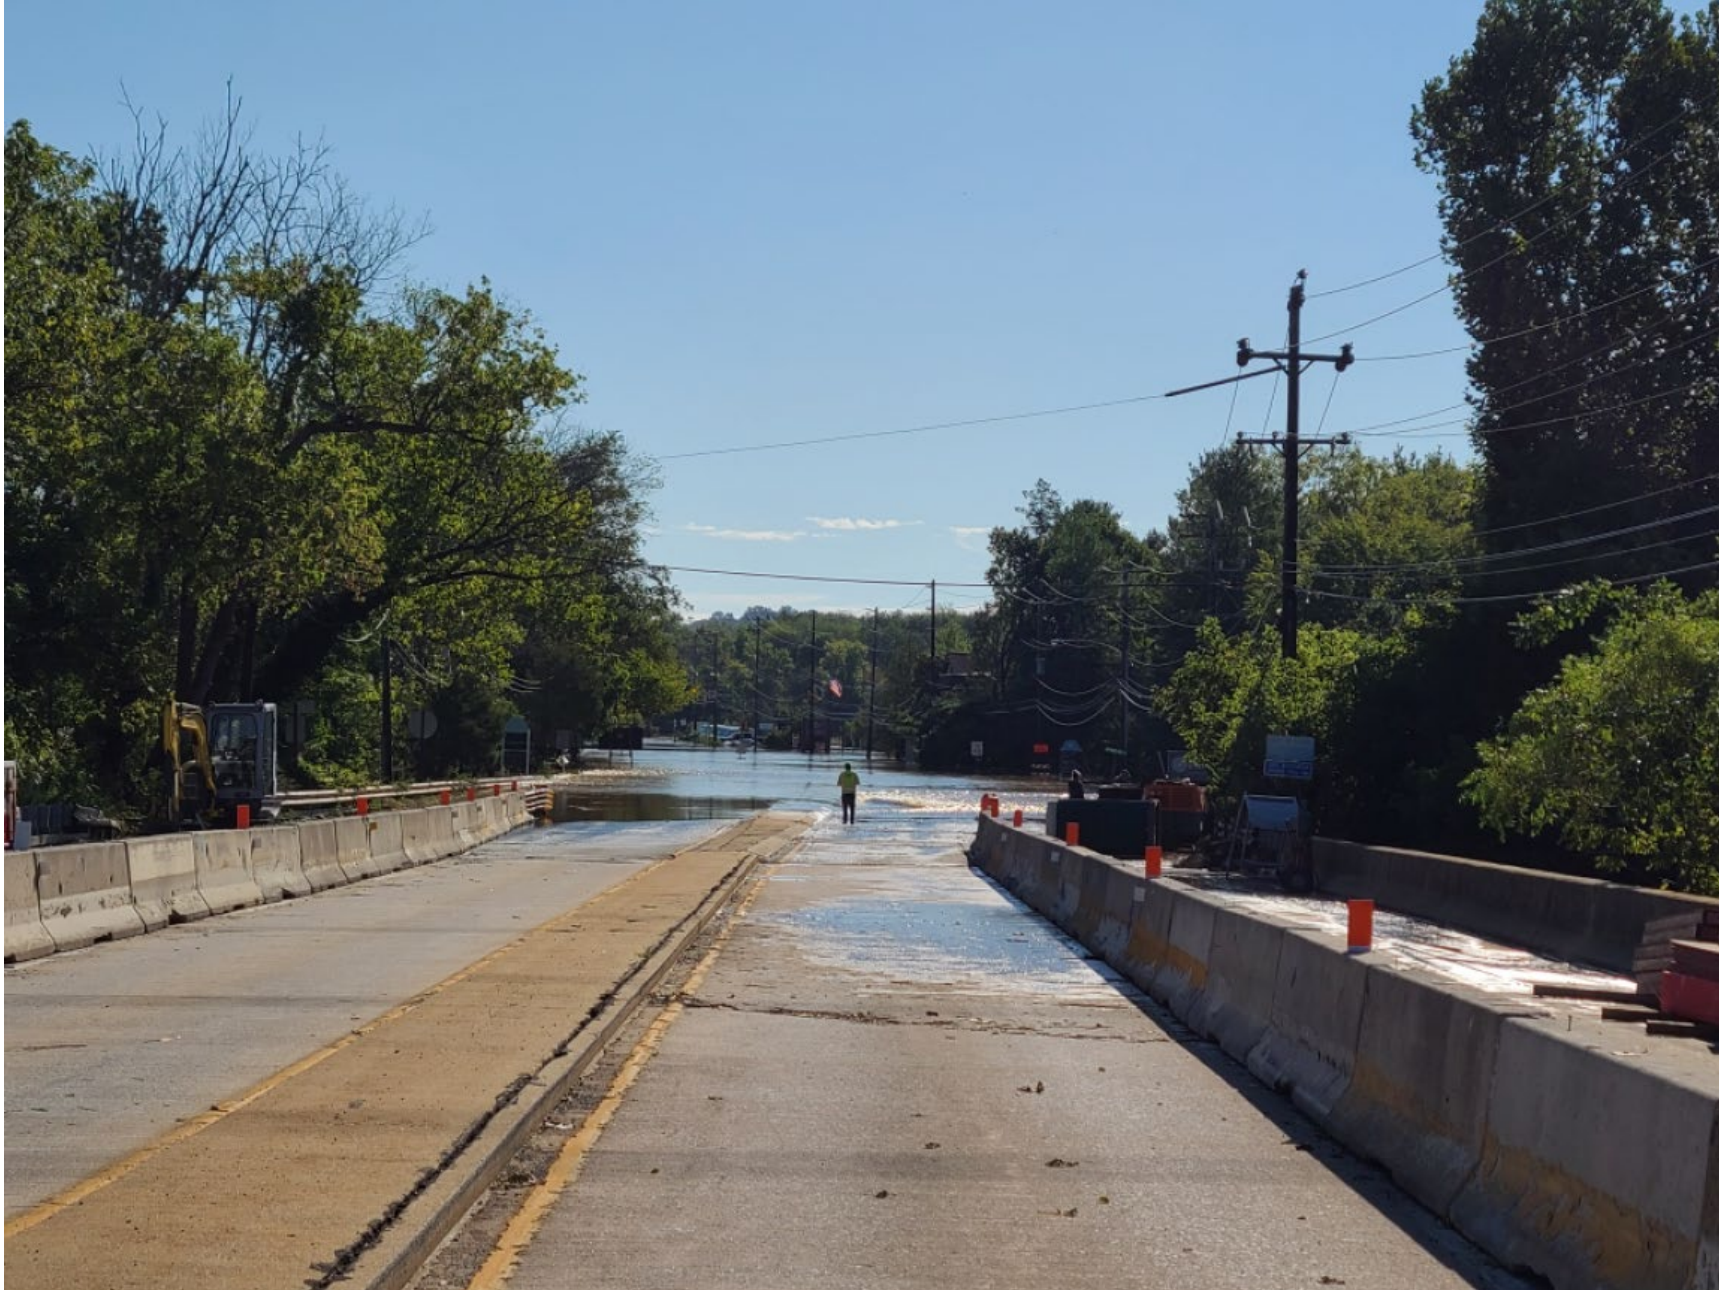
Ida highwater mark (elev. 172 ft) at Rte 1 bridge looking east at 8 am Sep 2, 2021 (BCMA).

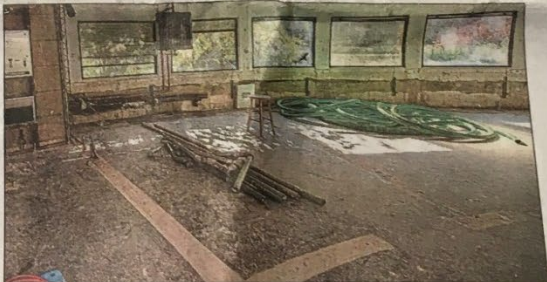
Floodwaters filled the lower level to the ceiling and damaged all 10 buildings. Above, the ground-floor museum offices. JOSE F. MORENO / Staff
