Floods along the Brannvin

UDWRC Water Policy Seminar No. 1

Dec 10, 2021

University of Delaware
Water Resources Center

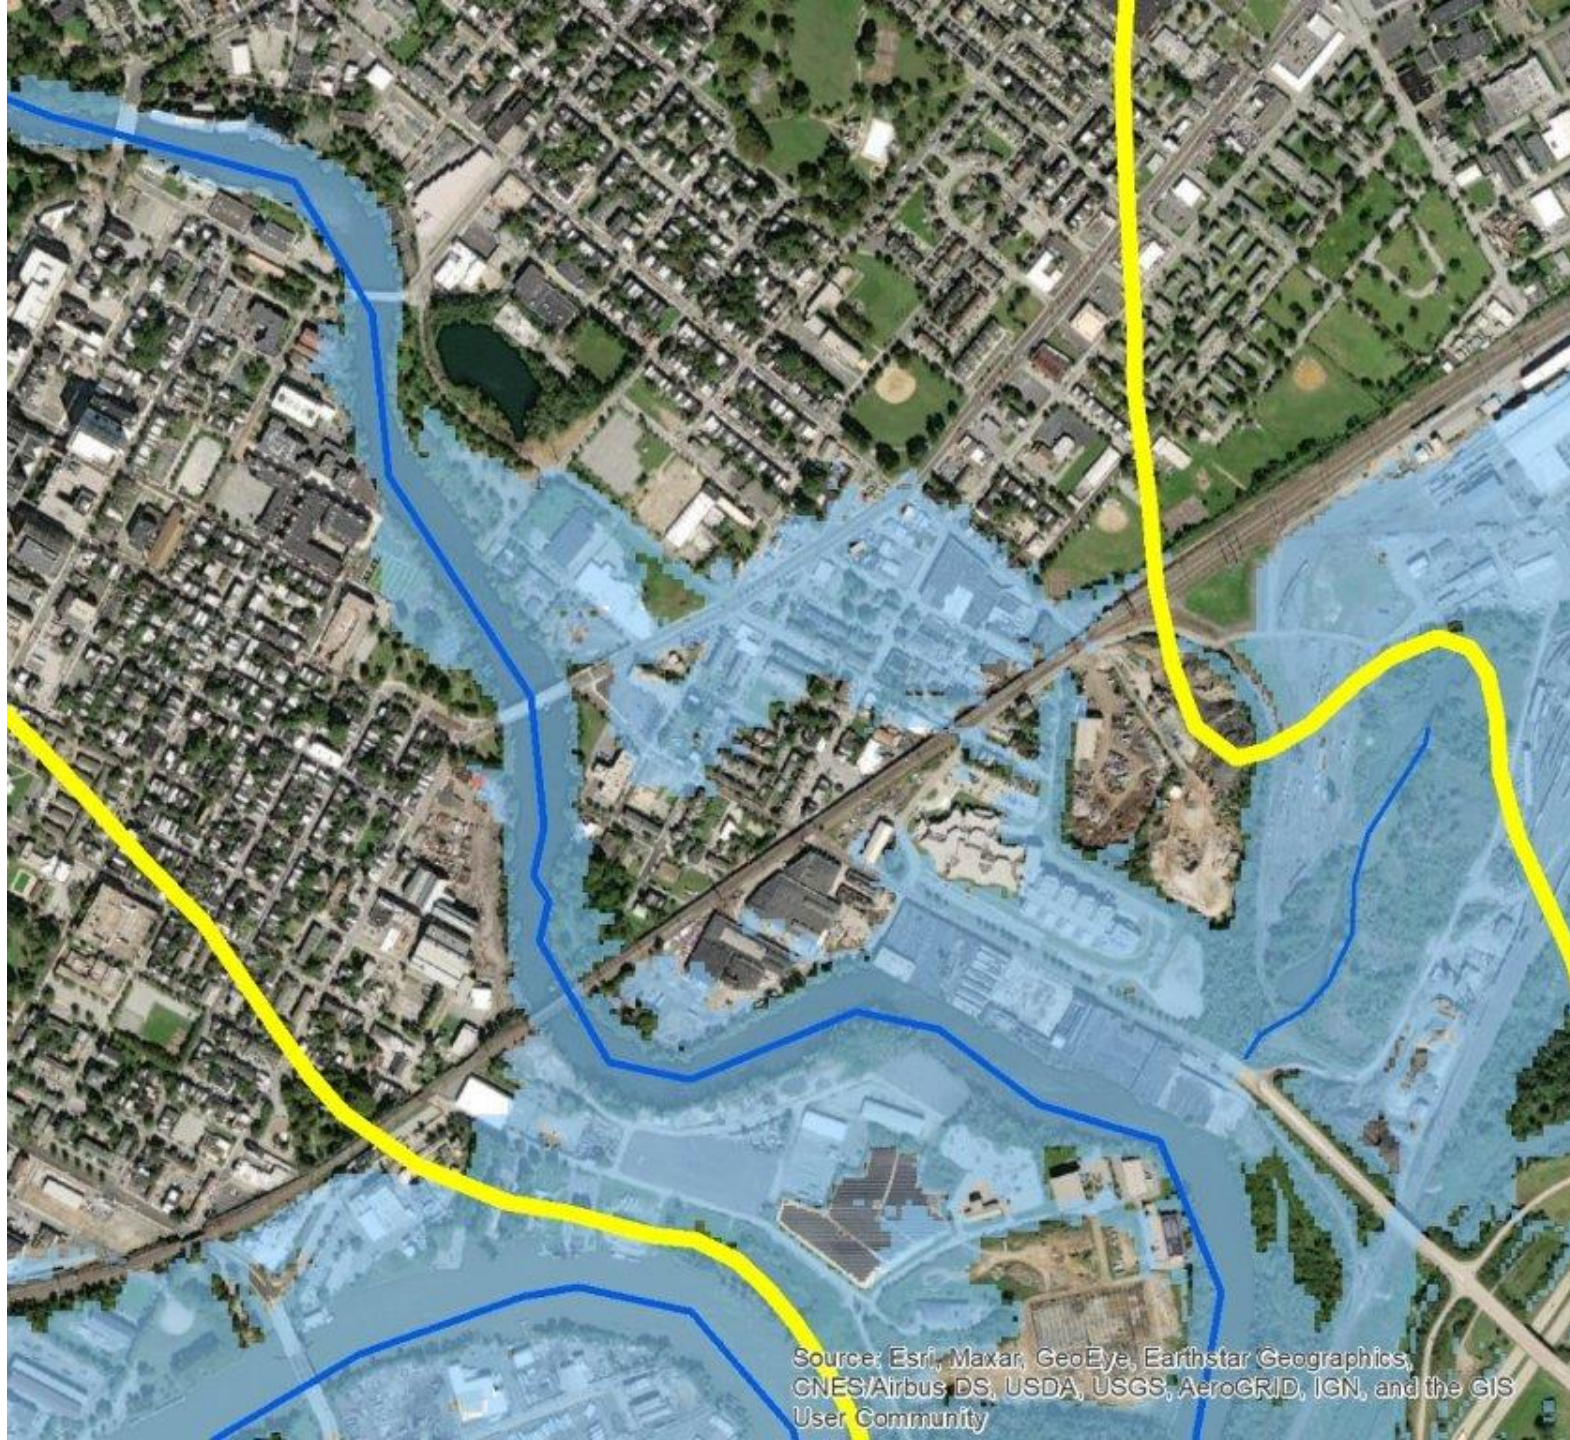
GIS topo map illustrates in blue the ground at El. 10 msl and less and depicts the overflow point upstream from the Northeast Blvd. Bridge this is the area where a low berm or dike would prevent overflow of the river.

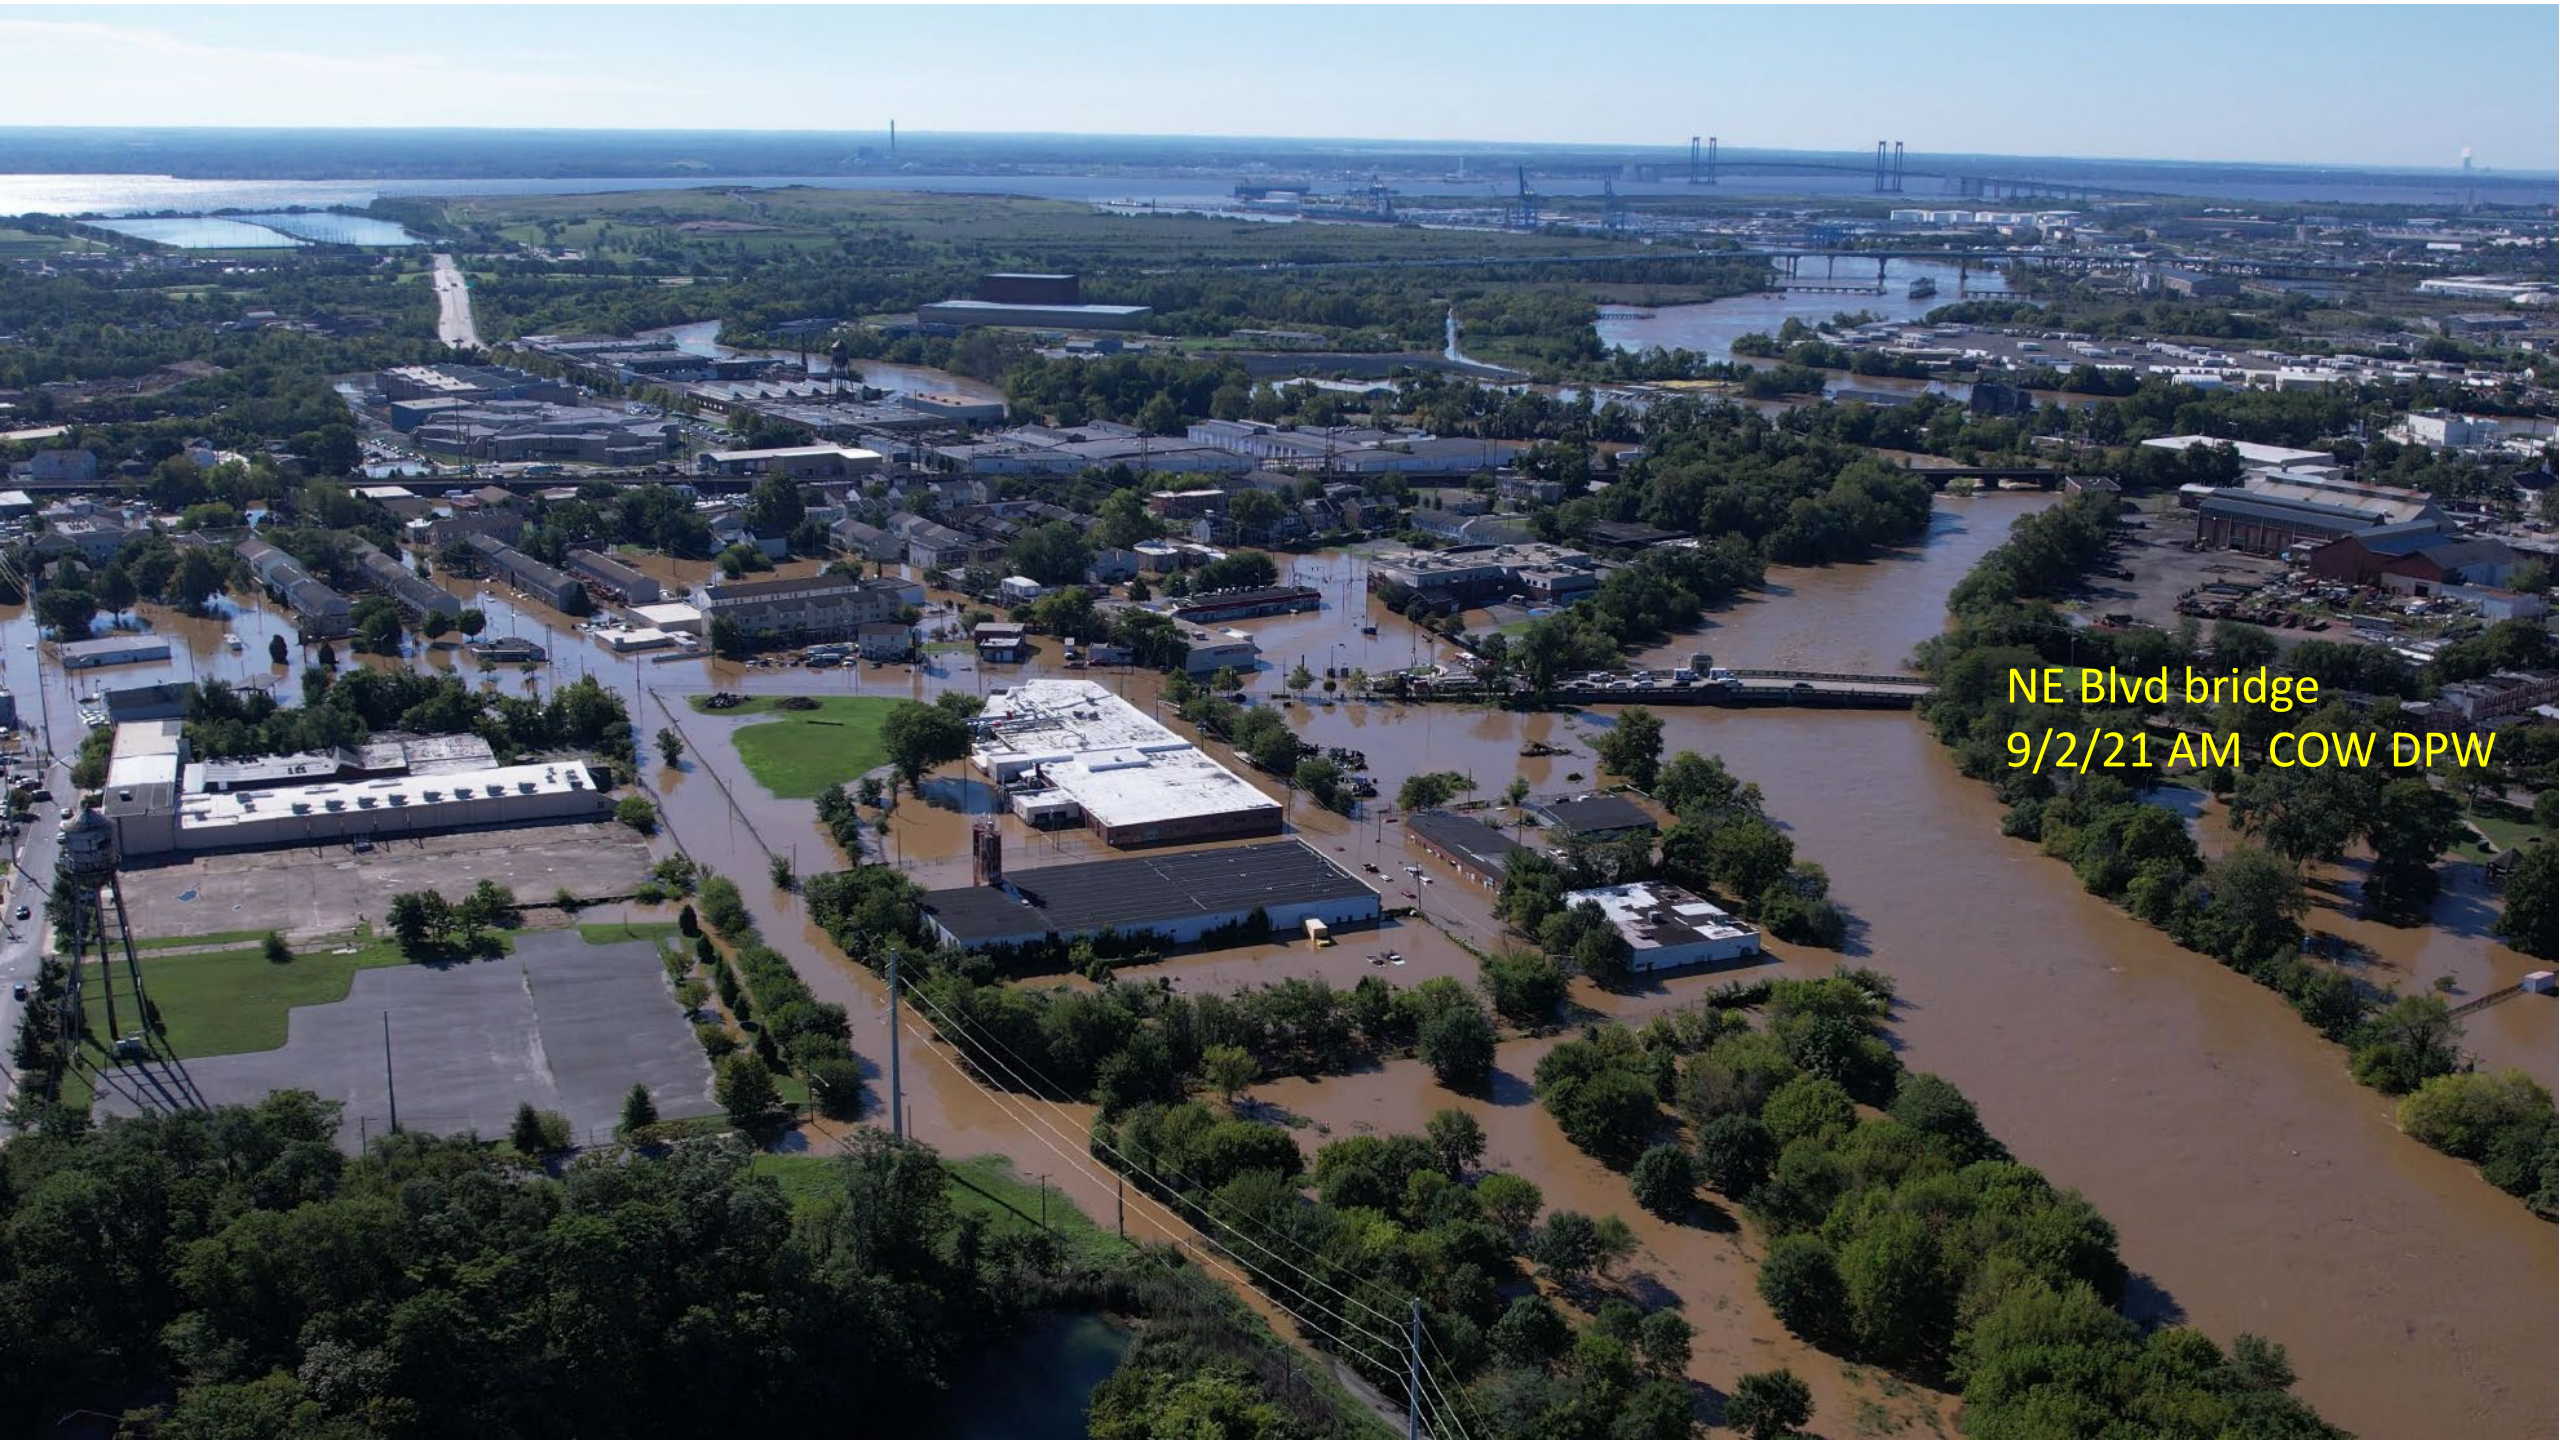
NE Blvd bridge
9/2/21 AM COW DPW

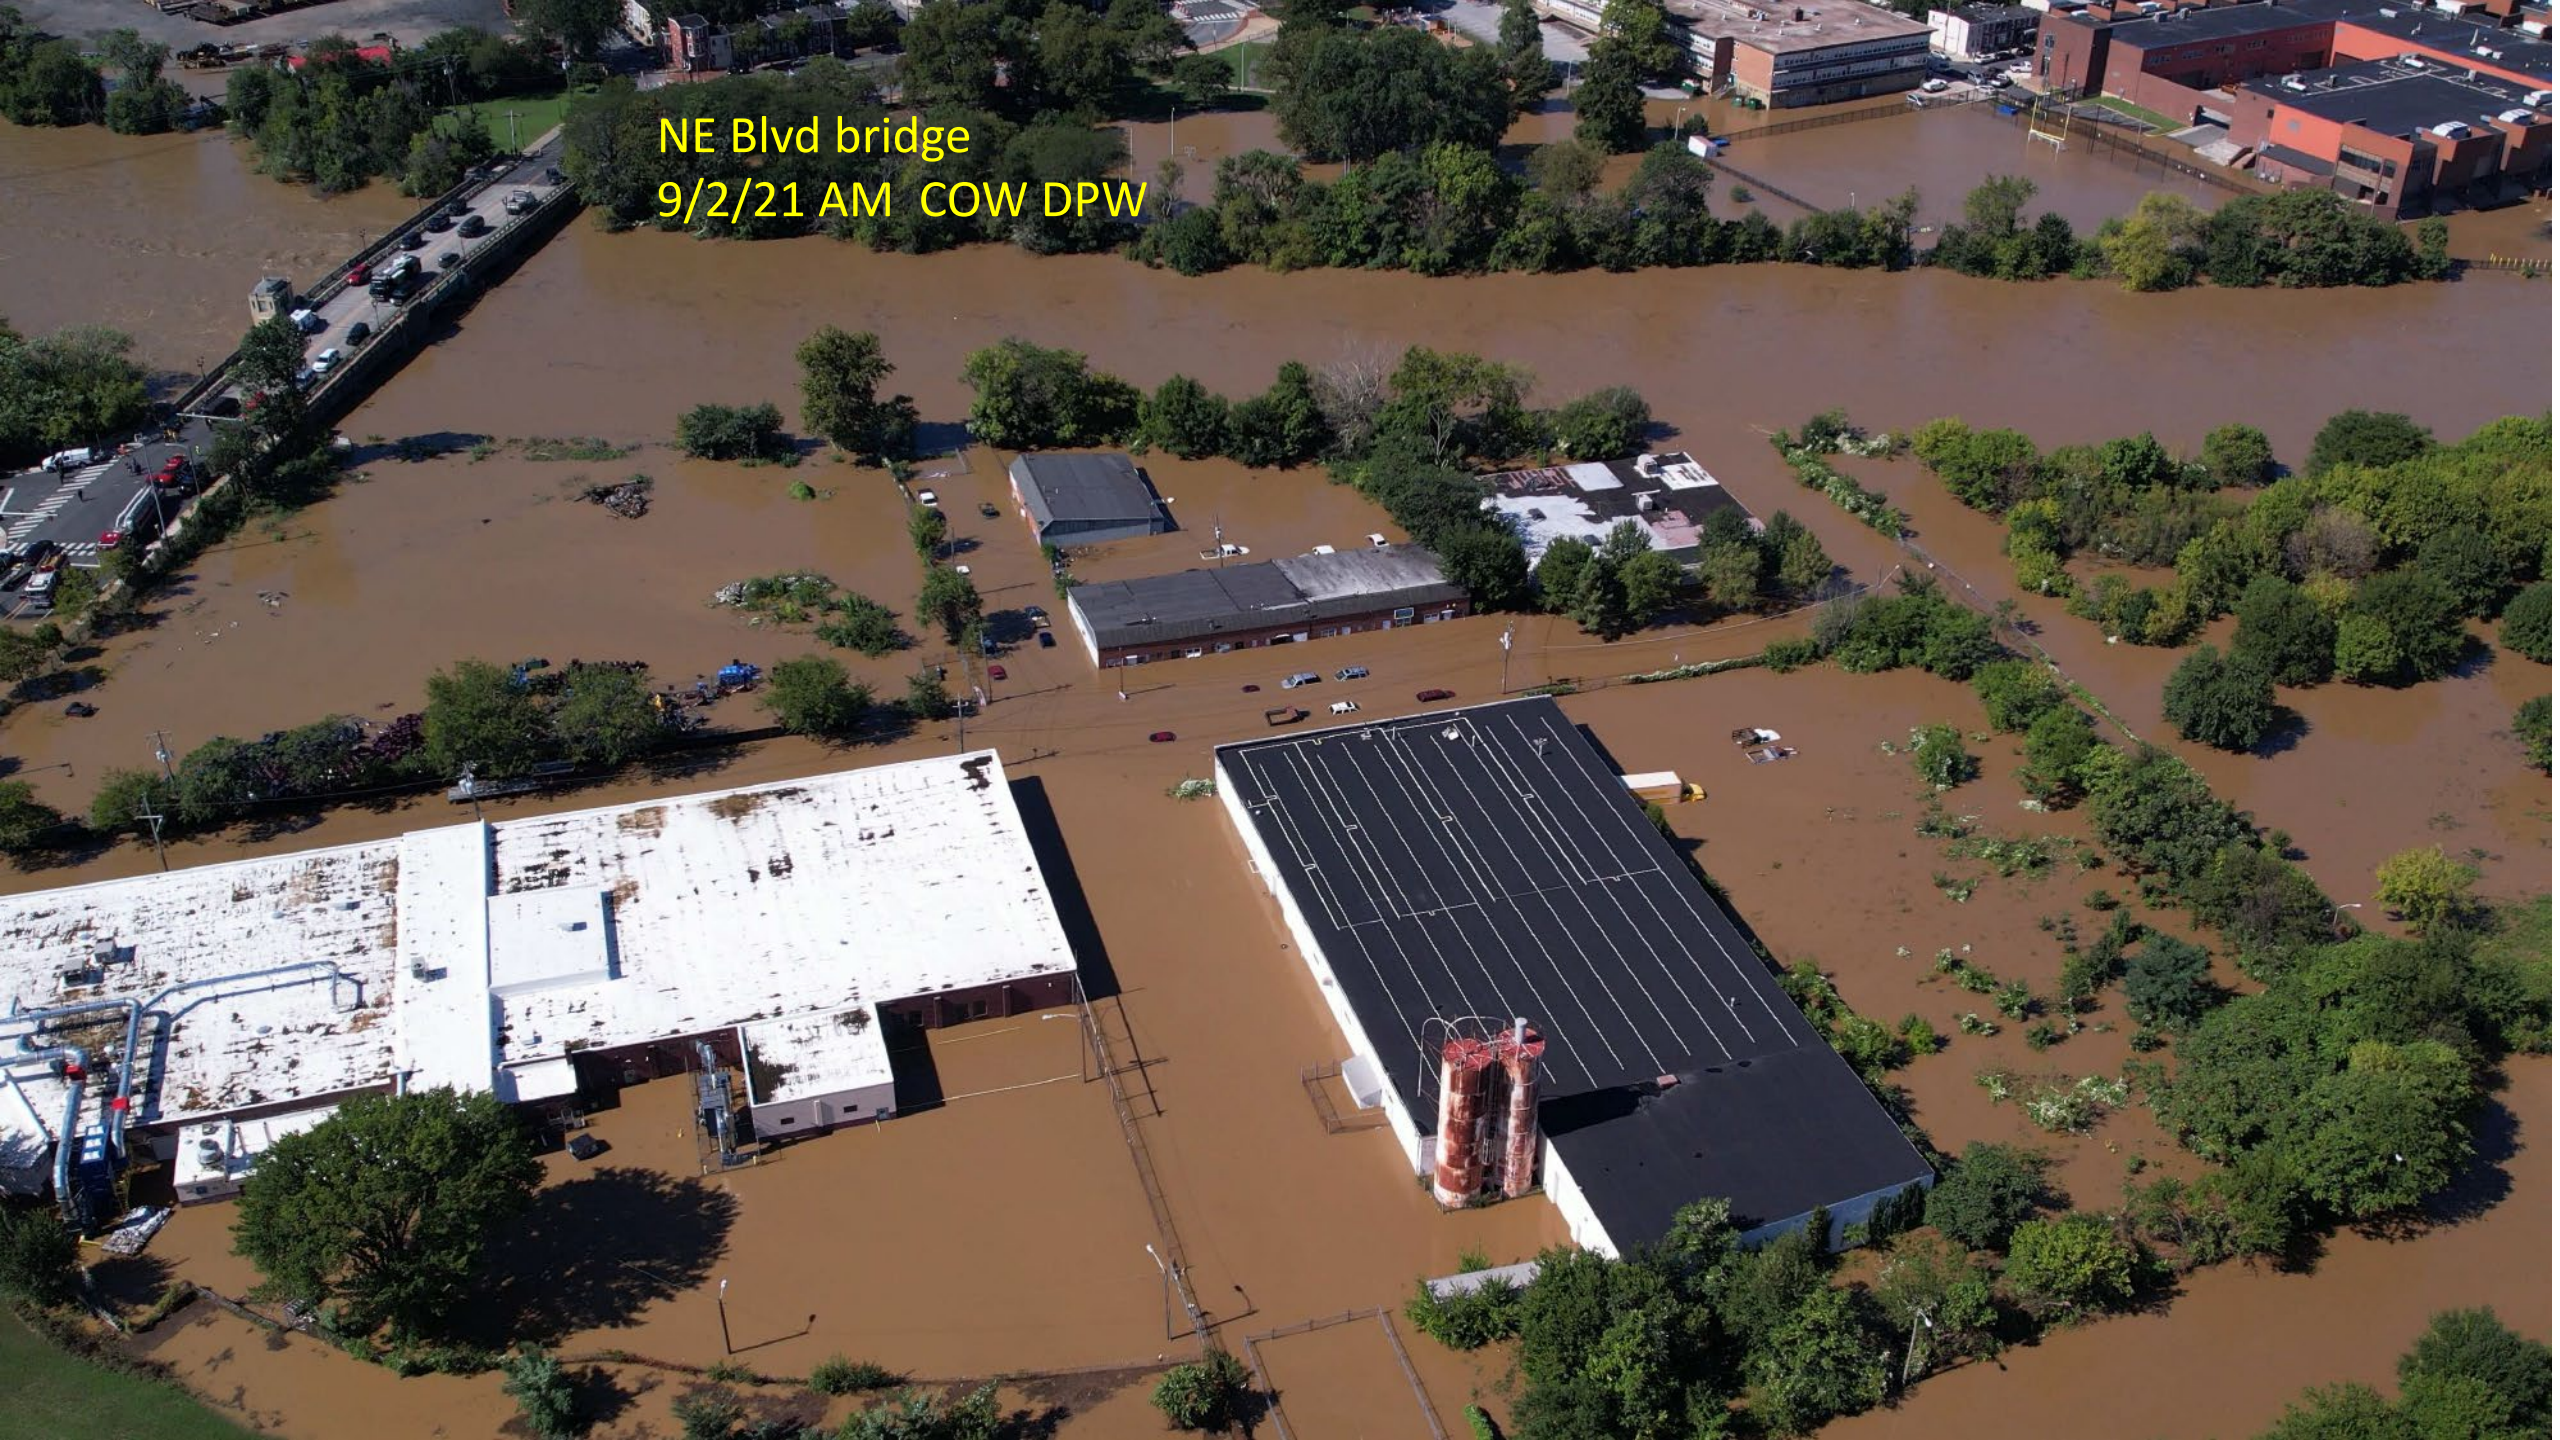
NE Blvd bridge
9/2/21 AM COW DPW

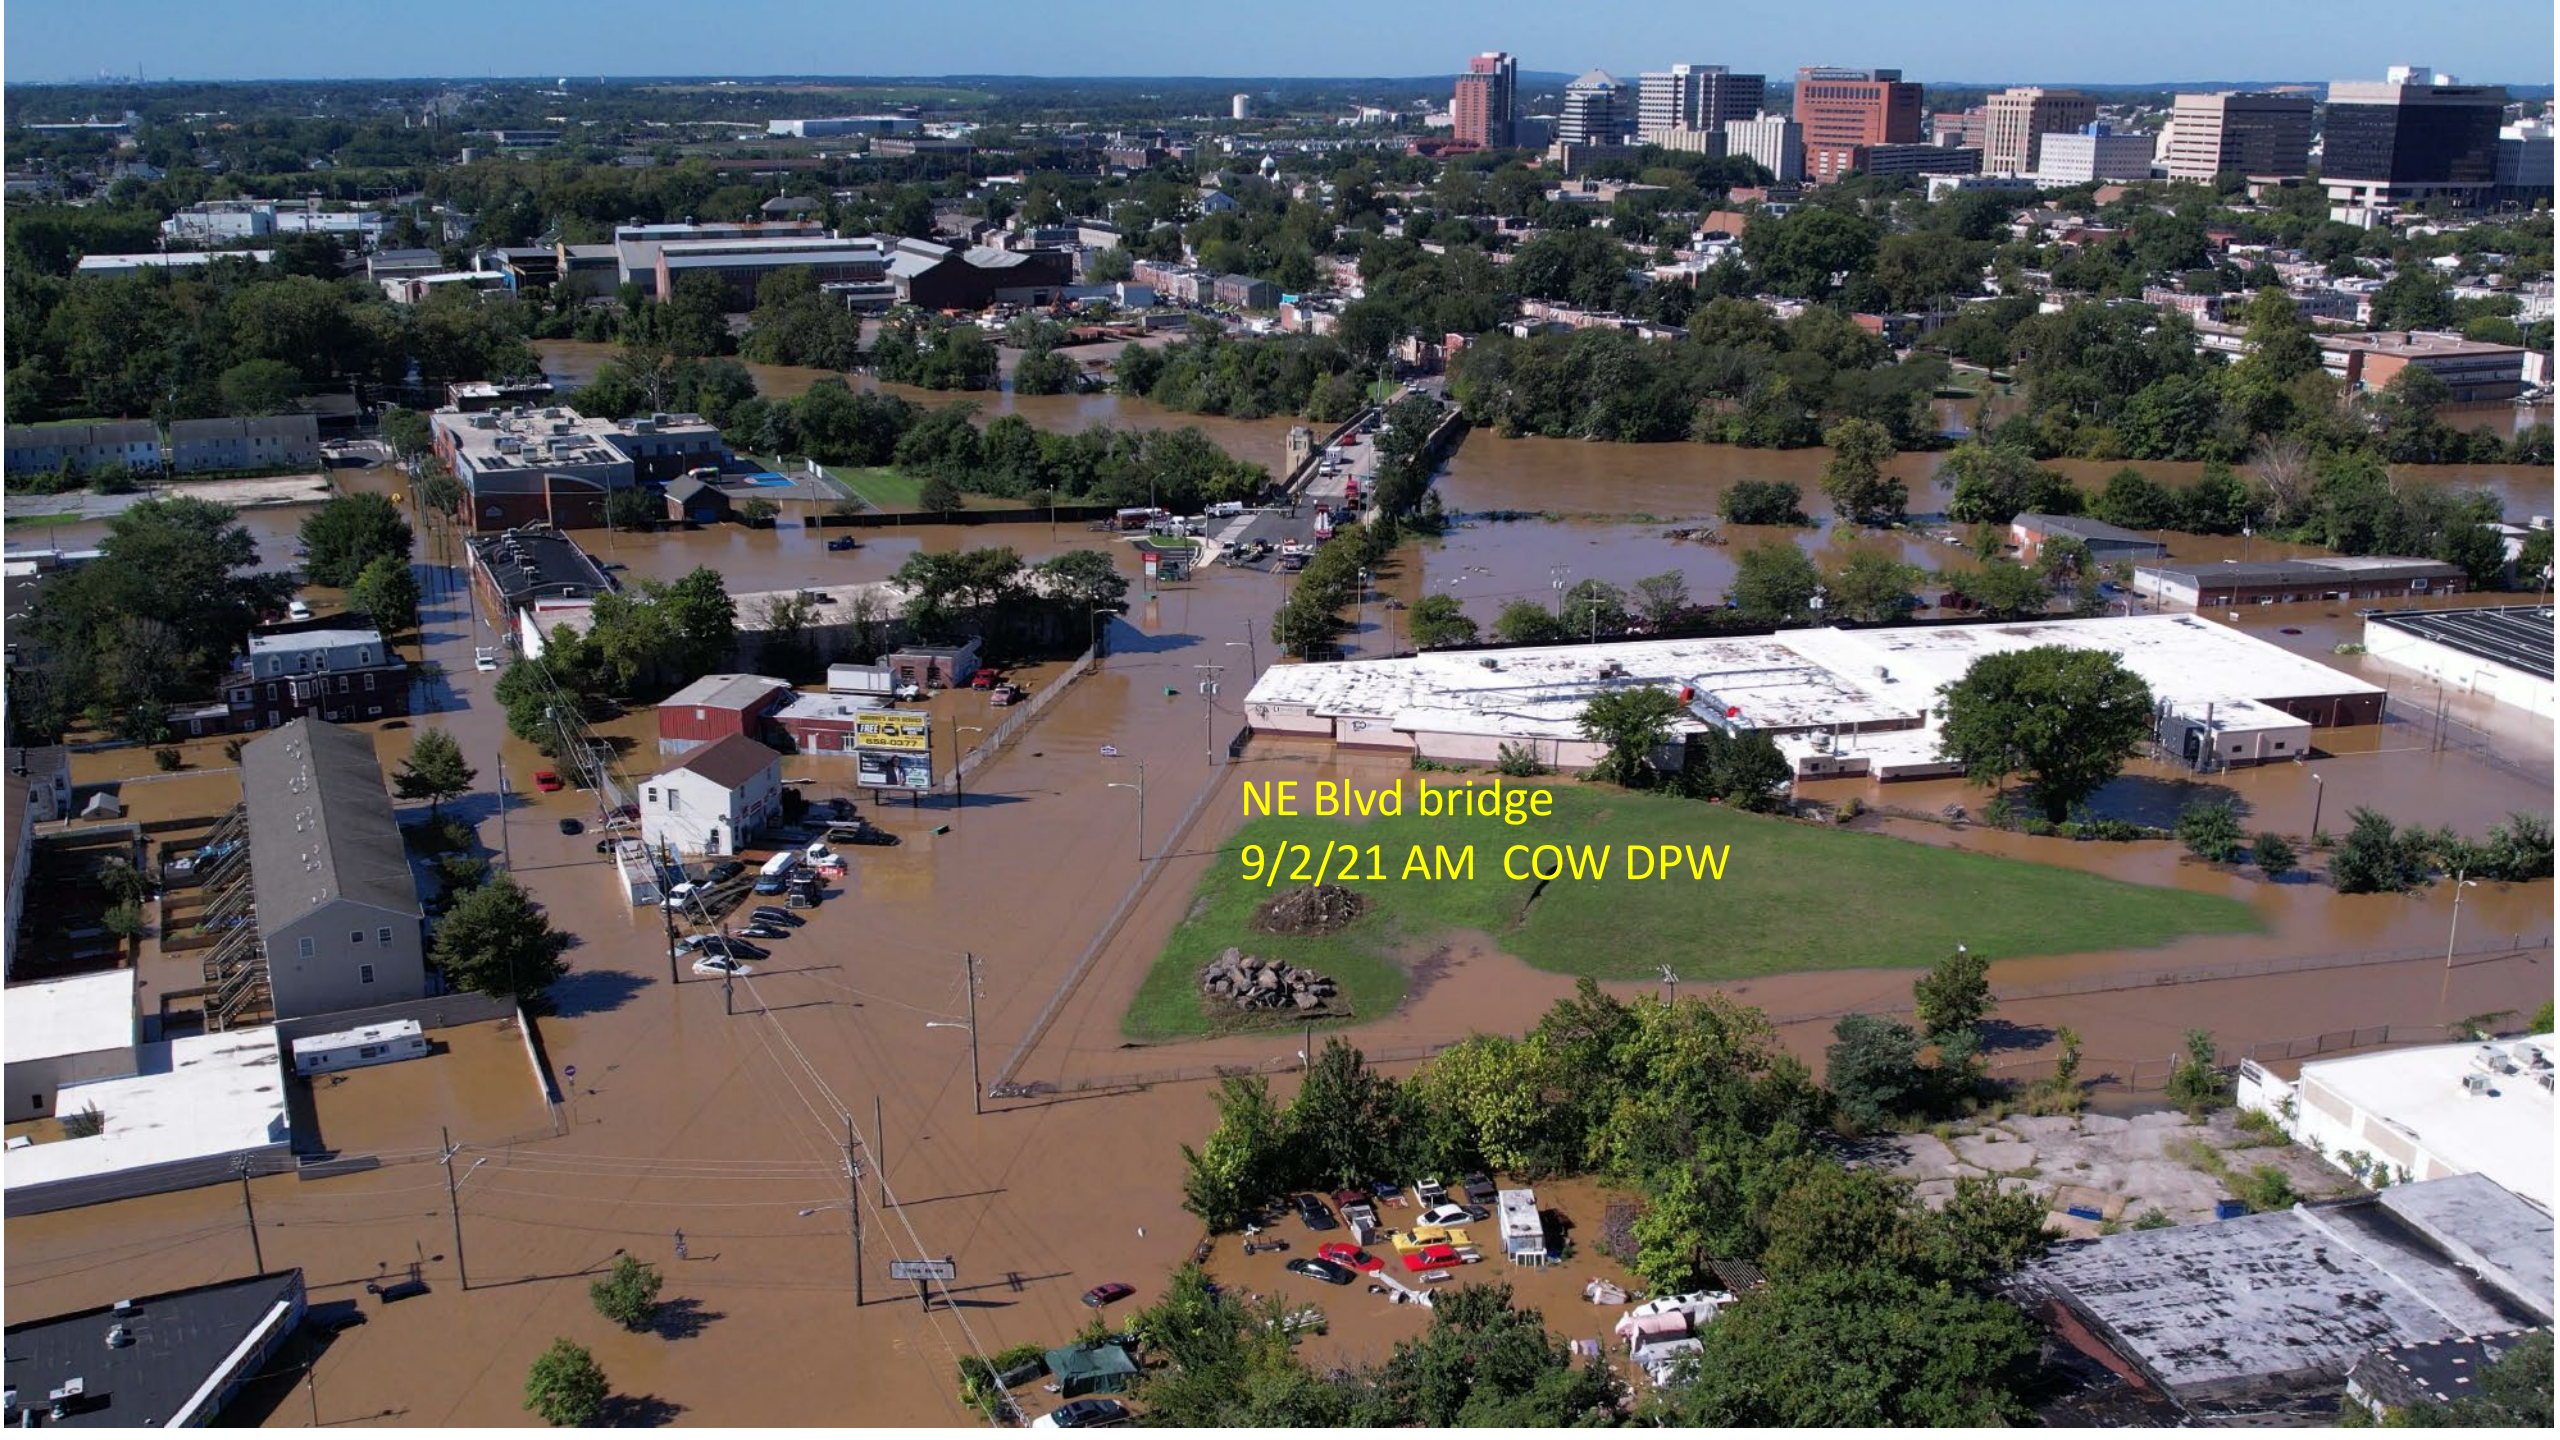
NE Blvd bridge
9/2/21 AM COW DPW

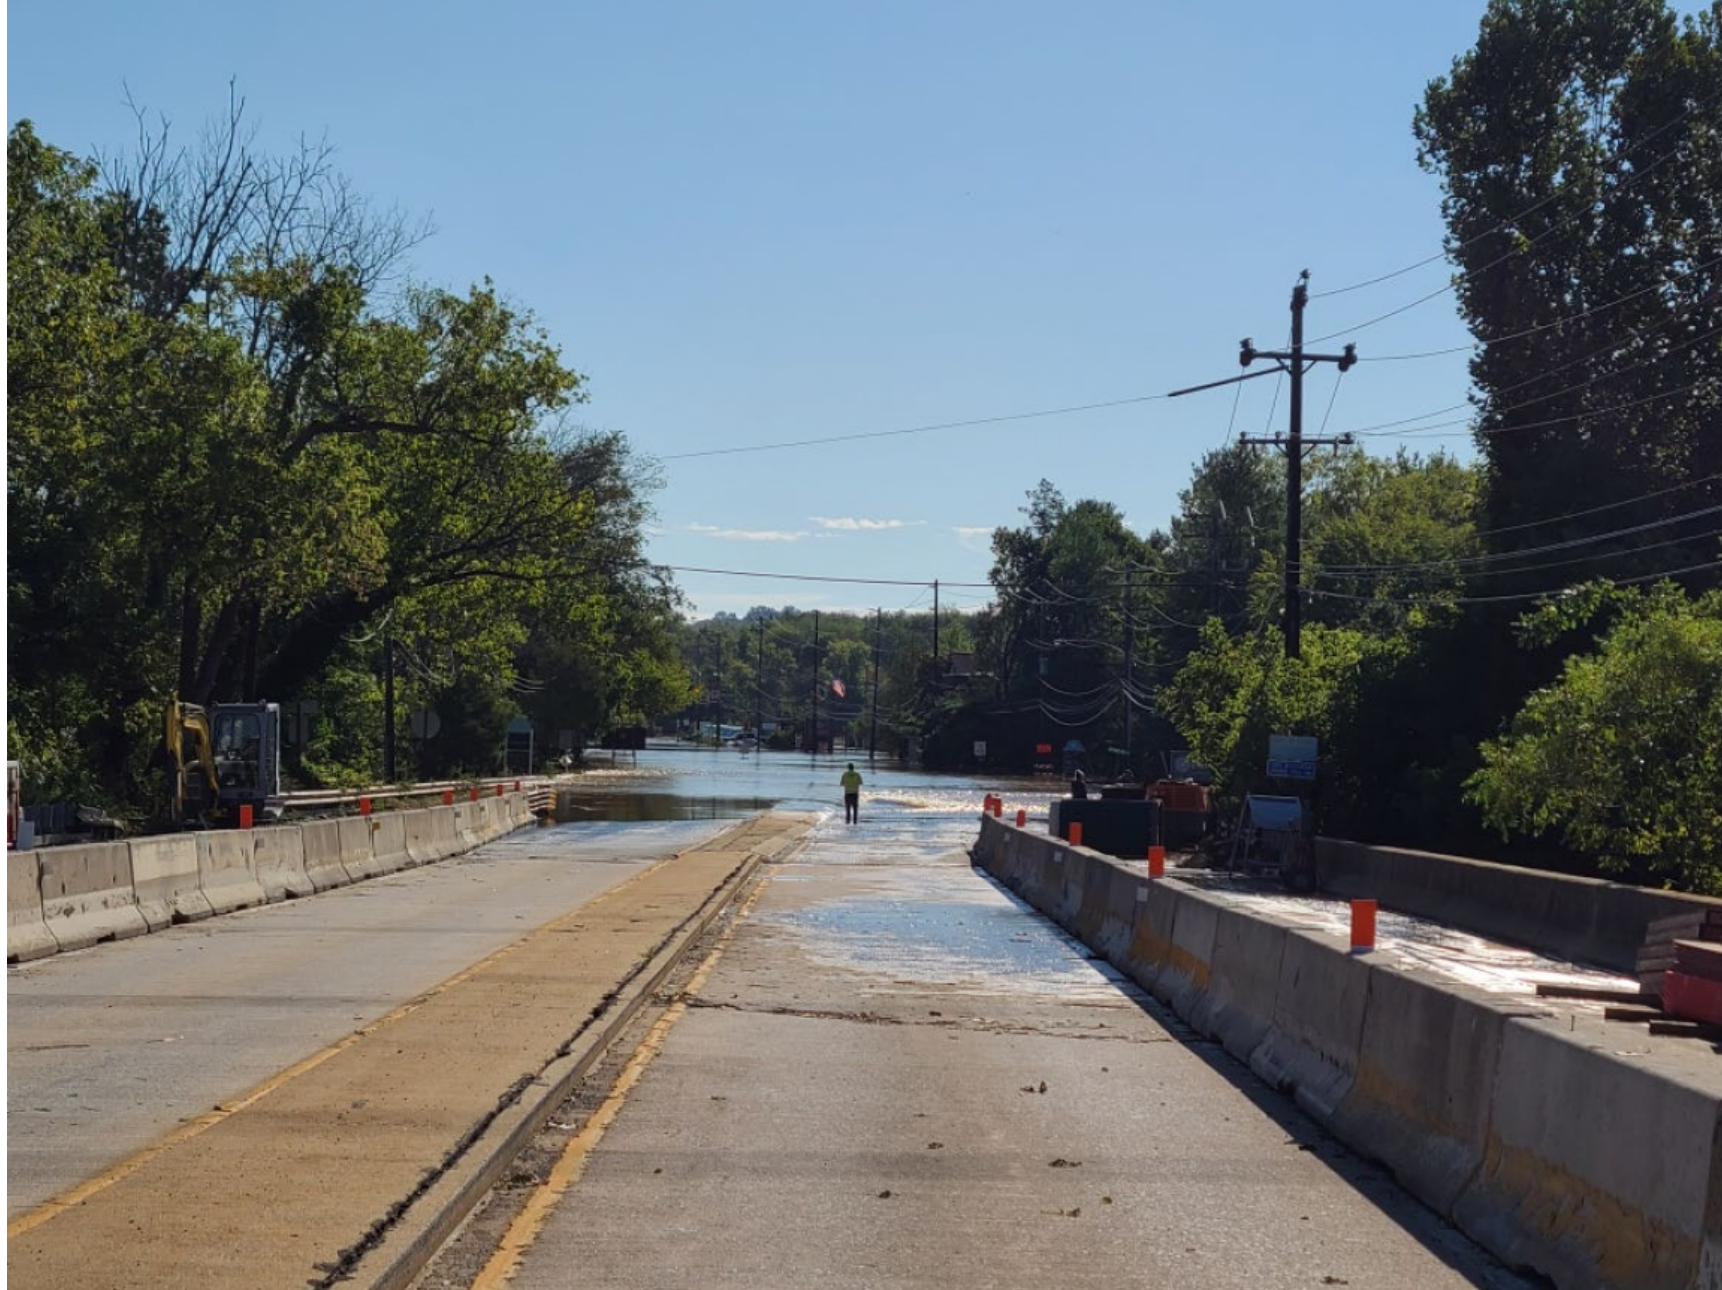
Ida highwater mark (elev. 172 ft) at Rte 1 bridge looking east at 8 am Sep 2, 2021 (BCMA).
