# Floods along the Brannvin

UDWRC Water Policy Seminar No. 1

Dec 10, 2021

University of Delaware  
Water Resources Center

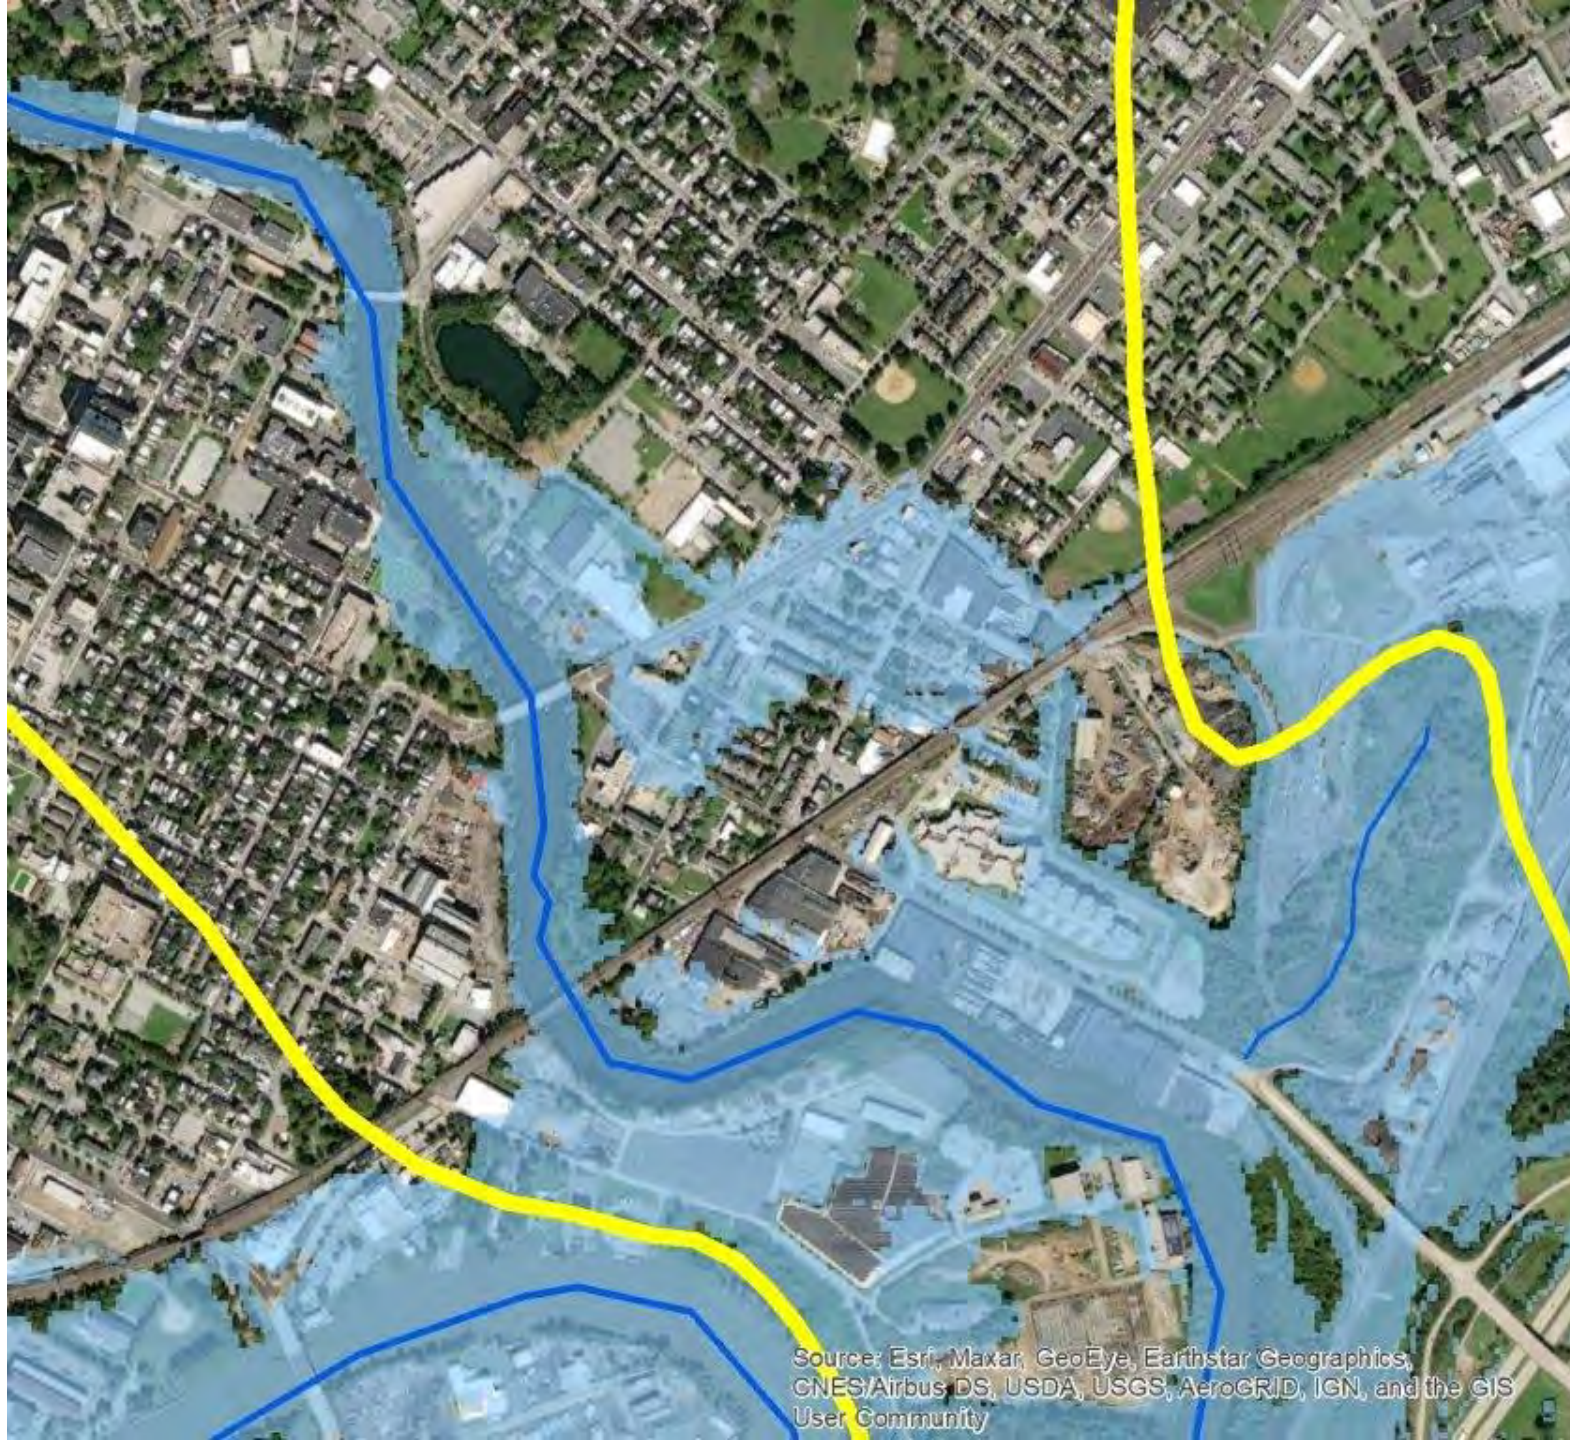
GIS topo map illustrates in blue the ground at El. 10 msl and less and depicts the overflow point upstream from the Northeast Blvd. Bridge this is the area where a low berm or dike would prevent overflow of the river.

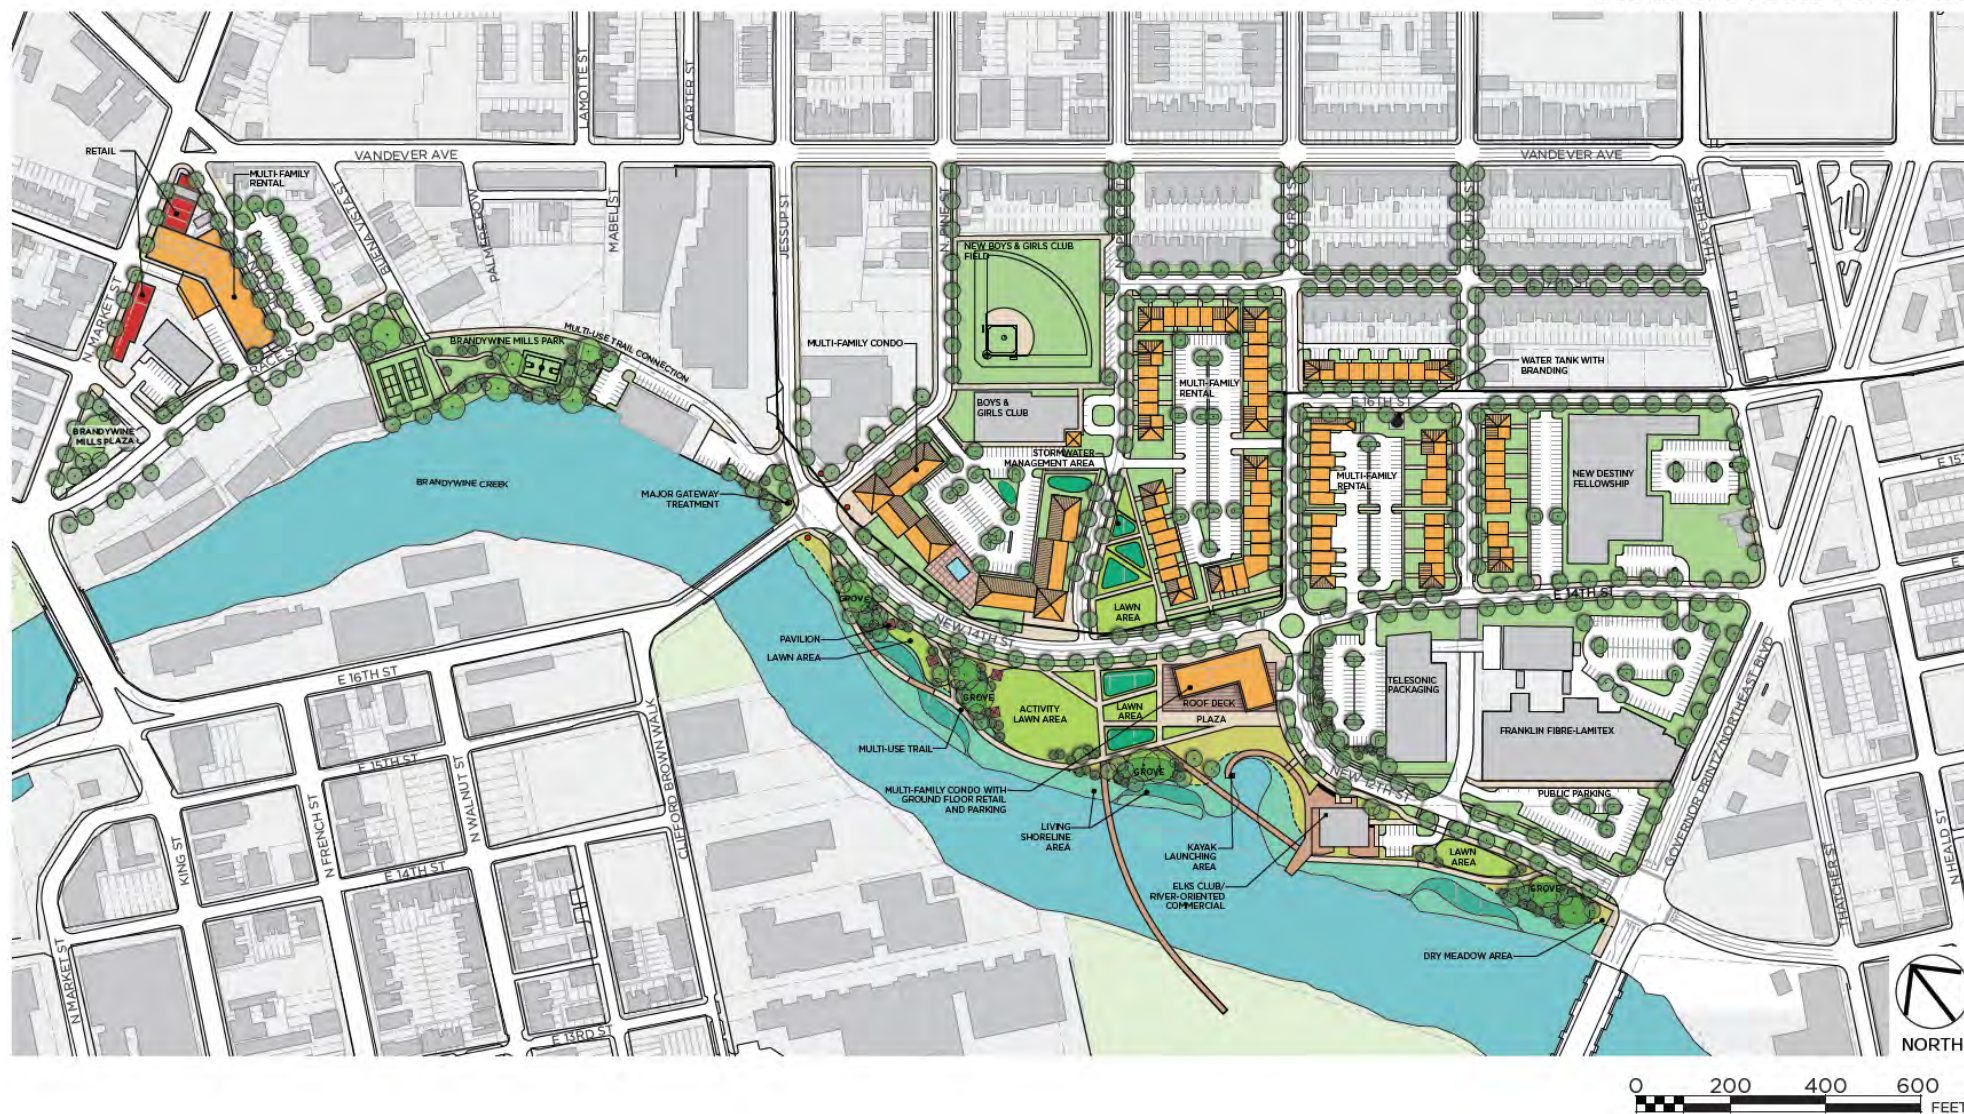
A low flood control dike can be created by simply raising the proposed pedestrian trail to 15 ft msl TOB from the E. 16<sup>th</sup> St bridge downstream to the NE Blvd. bridge.

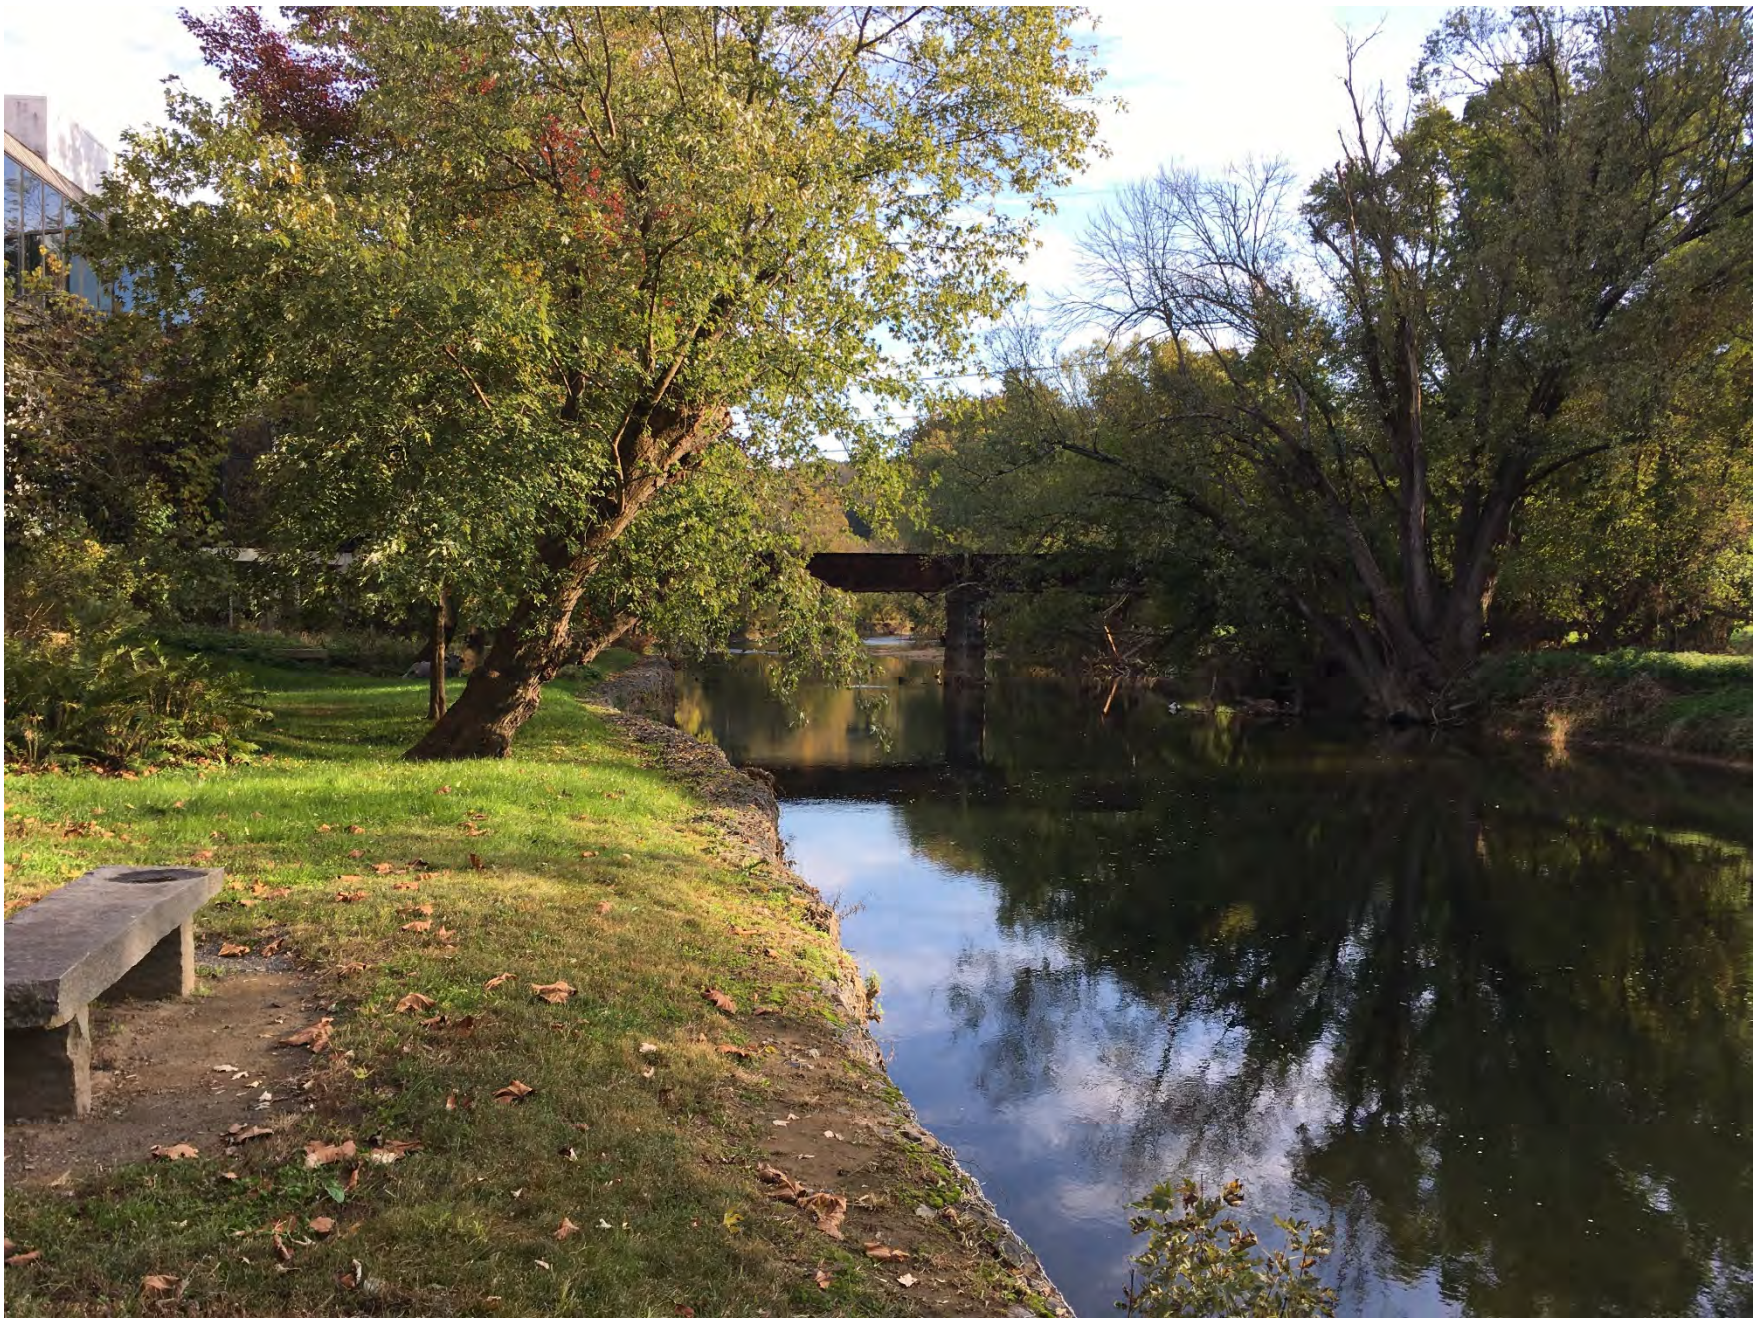
RR trestle looking downstream embankment to east and trestle to west note debris from Ida.

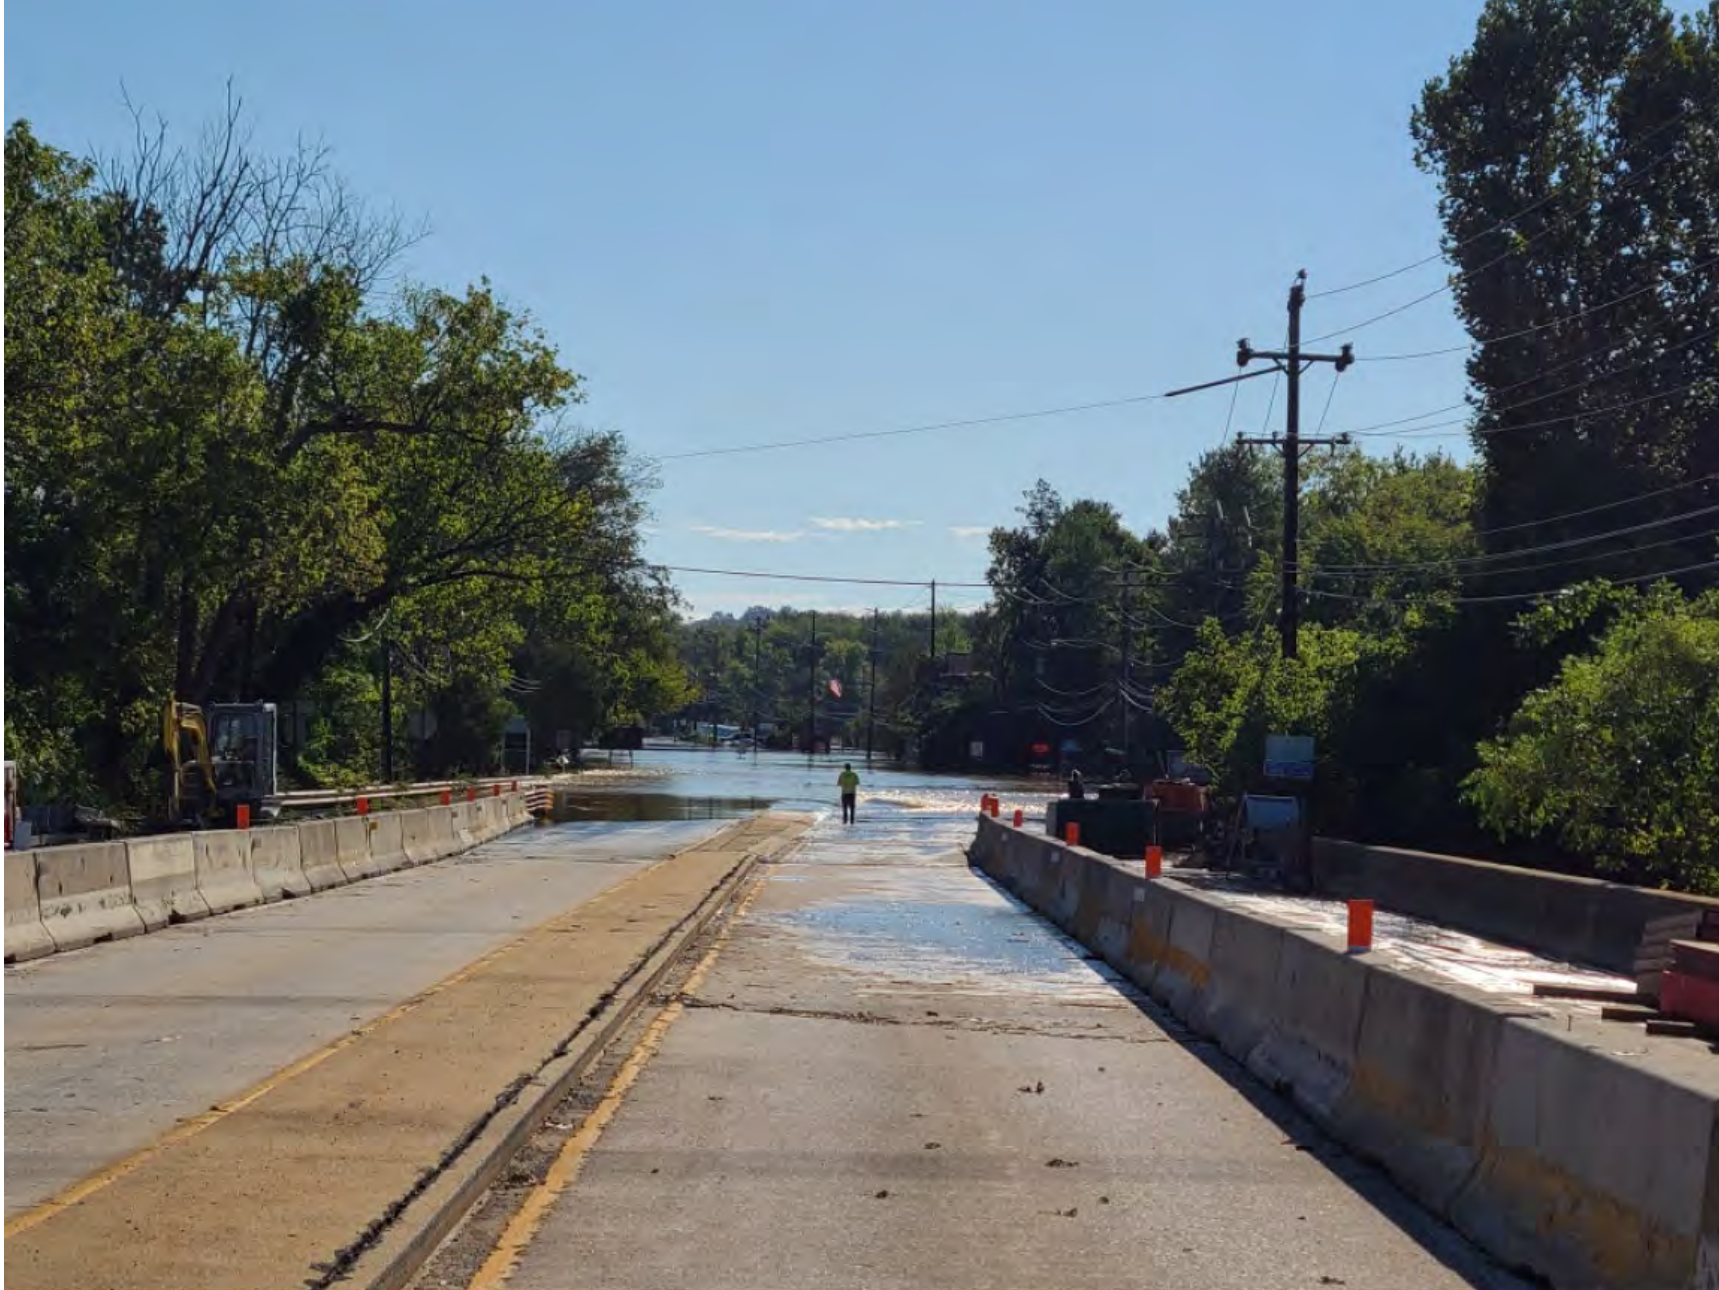
Ida highwater mark (elev. 172 ft) at Rte 1 bridge looking east at 8 am Sep 2, 2021 (BCMA).

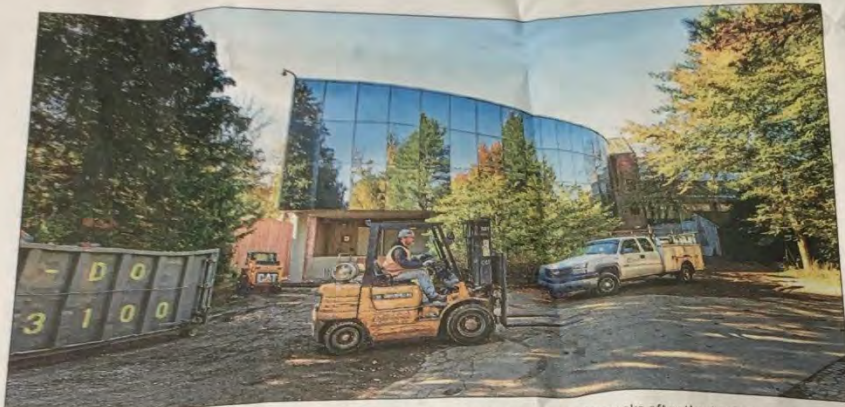
The Brandywine Museum, which sits along the banks of the Brandywine, remains closed 10 weeks after the flood as repairs are made. All the Wyeth paintings and other artworks were spared, but the museum complex suffered at least \$6 million in damage.

100-yr flood elev. = 167.0 ft below RR trestle, 170.6 ft upstream from trestle, and 171.0 ft at Rte 1 bridge. The USGS stream gage recorded peak stage 172.20 at RR trestle or 1.2 ft > 100-yr flood elev. 171.0 ft. The RR trestle and embankment to east causes at least 3.6 ft rise in flood elevation at the museum and more if debris clogged the RR bridge

Railroad trestle and embankment to east causes at least 3.6 rise in flood elevation to 170.6 ft at museum.  
If all/part of RR embankment to east were removed to grade it would reduce 100-yr flood elev to Elev 167 ft (green and salmon).  
RR trestle to west is elevated allowing floodwater to pass unimpeded on the floodplain.

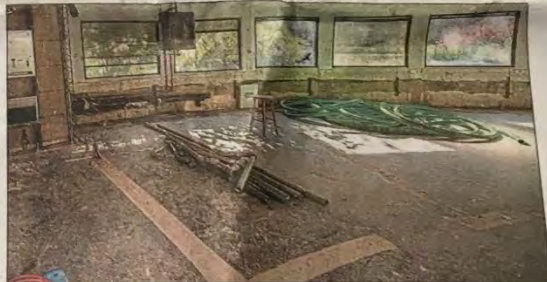
Floodwaters filled the lower level to the ceiling and damaged all 10 buildings. Above, the ground-floor museum offices. JOSE F. MORENO / Staff

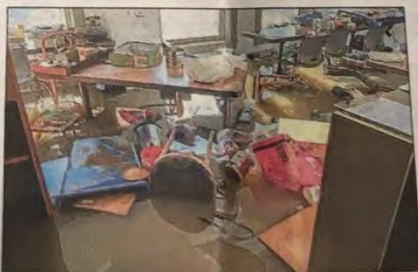
Another building at the Brandywine River Museum.

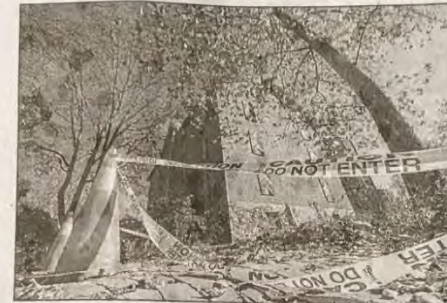
The Brandywine River Museum remains closed as the peak holiday season approaches.
