Blue Hen Creek: An Evaluation of Stream Habitat Restoration at the UD Experimental Watershed

March 31, 2004

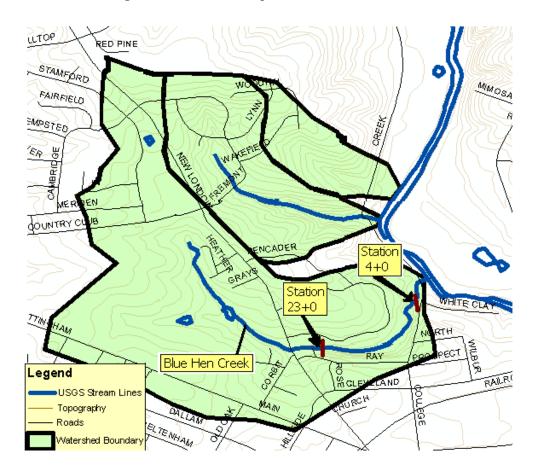
Figure 3.4: Station Endpoints on Blue Hen Creek

Blue Hen Creek was measured with a marked station being placed at every 100 feet, beginning at 4 + 0, or 400 feet from the mouth of the stream, and ending at 23 + 0, or 2300 feet from the stream's mouth. Figure 3.4 illustrates the station endpoints of 4 + 0 and 23 + 0 in spatial reference. At each of these stations photographs, observations of erosion, vegetation, water quality, channel stability, and habitat quality were recorded. These records were then used to select the sites most in need of restoration and to select the best restoration technique to help repair the section of the stream. The areas of Blue Hen Creek that were determined to be in need of restoration are sites 11 + 0 to 23 + 0. This section of the stream has the greatest need for restoration and stations 4 + 0 to 10 + 0 are in favorable conditions considering the surrounding land uses.

Almost the entire bank of Blue Hen Creek from station 11+0 to station 23+0 is covered in multiflora rose. In many cases the rose has or is in the process of choking the native trees to death. This type of habitat is inappropriate for native fauna and needs to be restored to a native vegetation habitat for the health of the stream and to re-create suitable habitat for native wildlife. Other areas along this section of Blue Hen Creek had other stream health problems that need to be addressed through restoration, which is why stations 11+0 to 23+0 were chosen as candidate restoration reaches for this project. Figure 3.5 shows some photographs of areas along Blue Hen Creek that are in need of restoration to bring the stream to its ideal conditions.

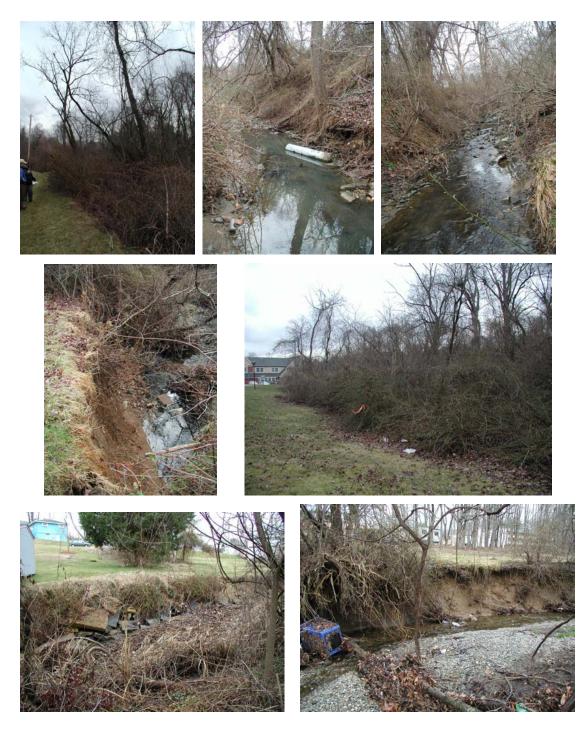
Clockwise from top left: Station 14+0-removal of multiflora rose by hand cutting and reforestation, Station 16+0- wing deflectors, Station 17+0-wing deflectors, Station 19+0-removal of multiflora rose by herbicide and reforestation, Station 23+0-root wads, Station 21+0- live stakes, and Station 18+0-coconut fiber roll and bank shaping

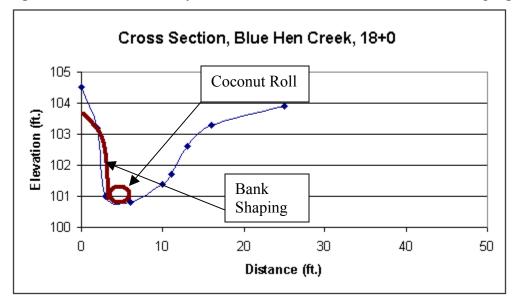
Figure 5.7: Cross Section of 18+0 with Coconut Fiber Roll and Bank Shaping

Treatment 5: Bank Shaping, Coconut Fiber Roll, and Reforestation at Station 18+0. The bank at this station is a shear drop down to the stream. Some bank shaping will be necessary to increase the effectiveness of the other restoration techniques being applied at this station. The coconut fiber roll will help protect the bank from further erosion problems from the bottom up and reforestation will provide erosion protection from the top down.

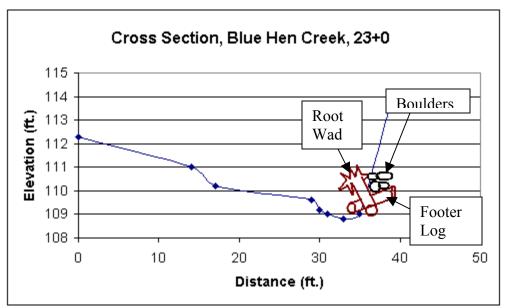
Figure 5.12: Cross Section of 23+0 with Root Wads

Treatment 8: Root Wads at Station 23+0. The bank at station 23+0 is severely eroded and will continue to do so without pushing the stream away from the right bank.
