**Fairfield Run: An Evaluation of Stream Habitat Restoration at the UD
Experimental Watershed**

March 31, 2004

Prepared by:

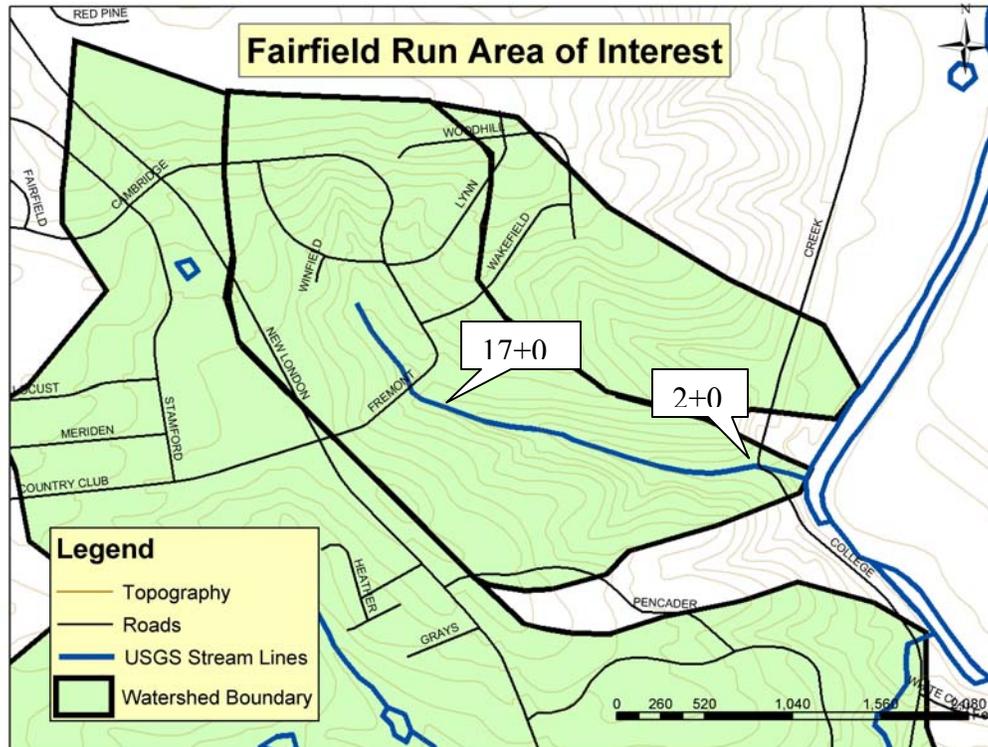
Figure 3.4: Area of Interest for Fairfield Run

The first restoration site chosen on Fairfield Run was the reach from 0+2 to 0+5. The downstream end of this reach was degraded by sediment backwashed from the White Clay Creek during storm events. The area from 4+0 to 5+0 was severely eroded on the right bank. The apparent cause of this erosion is that high flows are diverted towards the steep right bank by a sanitary sewer connection adjacent to the normal channel. The second reach chosen as a candidate for restoration was from 0+8 to 0+11. This area also had severe right bank erosion on the outside of meanders. The third reach chosen was from 14+0 to 16+0. This reach had poor bank stability with erosion on outside of meander bends on both banks and a narrow, downcutting channel. Figure 3.5 shows some of the photographs taken at the time of restoration reach selection.

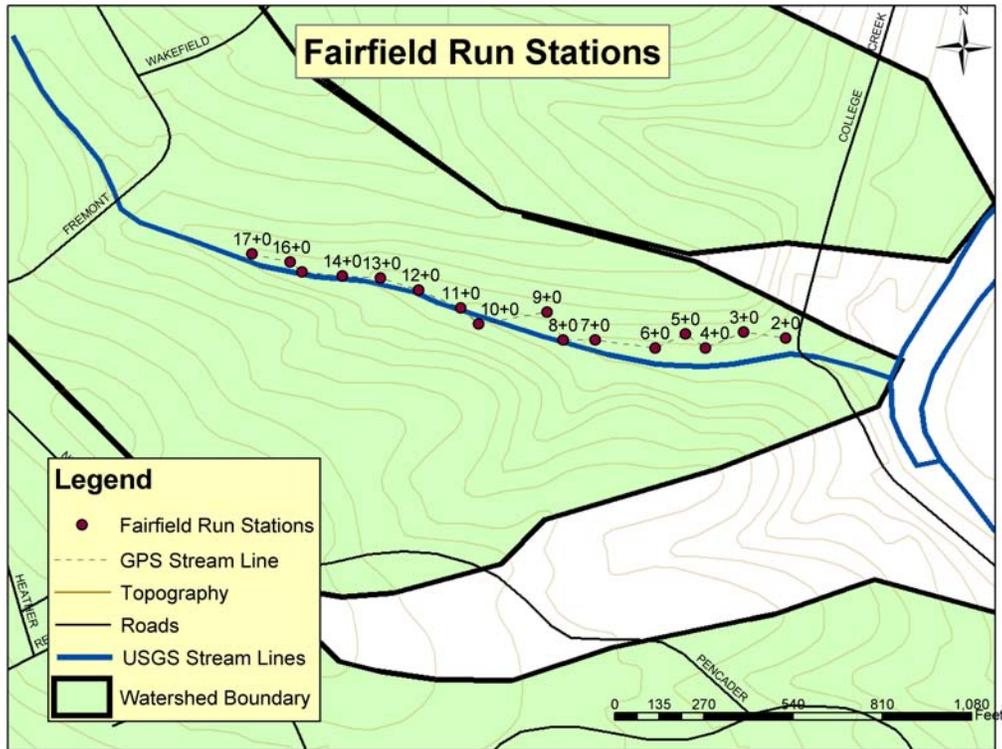
Figure 3.6: Fairfield Run Stations Map

The final step in restoration design was to plot latitude and longitude data collected in the field with a GPS receiver. These points were then added to the base map of the UD Experimental Watershed. Adding the coordinates to GIS allowed the researchers to correlate points in the field with maps. This information will also help future researchers locate positions in the field for restoration implementation and monitoring. USGS topographic maps tend to underestimate stream meandering. Therefore, a line connecting the points was added to show a more realistic approximation of the channel shape. While closer than the USGS stream line, coordinates taken only at every 100 feet still may underestimate meandering. Figure 3.6 shows the coordinate

points and the new stream line. This map was used as an overview for restoration planning.
